**David K. Smith**  
Professional Home Inspector Lic #21666

## PROPERTY INSPECTION REPORT

**Concerning:** \_\_\_\_\_, TX 75755  
(Address or Other Identification of Inspected Property)

**By:** David Smith, Lic #21666 05/01/2023  
(Name and License Number of Inspector) (Date)

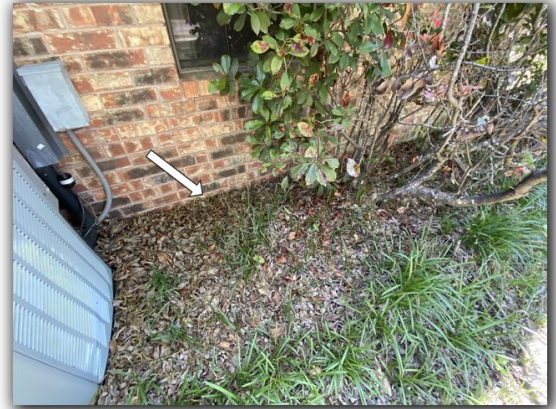
Soil levels against the exterior grade are considered to be too high at the time of inspection. When soil levels are high against the face of the foundation it promotes water penetration of the structure and insect infestation. This item should be corrected so there is some exposure of the foundation face. It is generally accepted that a brick veneer house should have about 4 inches of clearance. Wood siding houses should have approximately 6 inches of clearance.

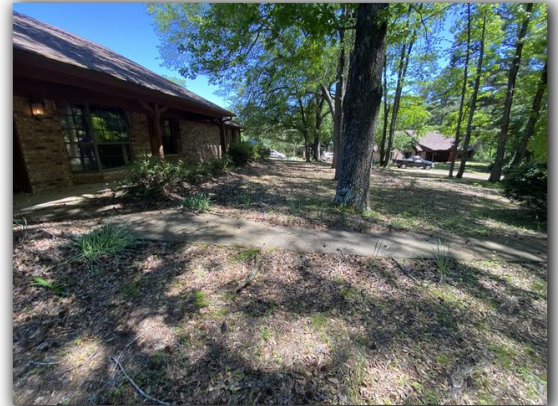
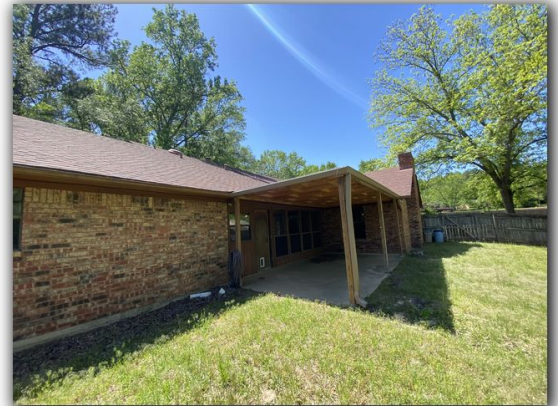
I observed where foliage found to be too close to the structure at time of inspection. It is recommended that bushes and vegetation should be at least 12 inches from wall contact. Recommend cutting or trimming noted vegetation allowing for appropriate barrier.

Monitor areas around perimeter of home after heavy rain to make sure water is draining away from structure.

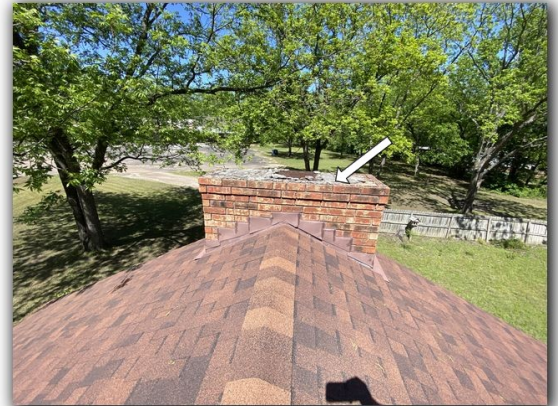
I observed where the chimney was missing its chimney cap at the time of inspection. The cap is needed to obviously keep rain water from making entry into chimney which can lead to many components of damage to chimney as well as unpleasant odors. Cap also Keeps animals out, reduces wind down drafts, and is also a spark arrestor. Recommend evaluation for possible repaired or replaced.

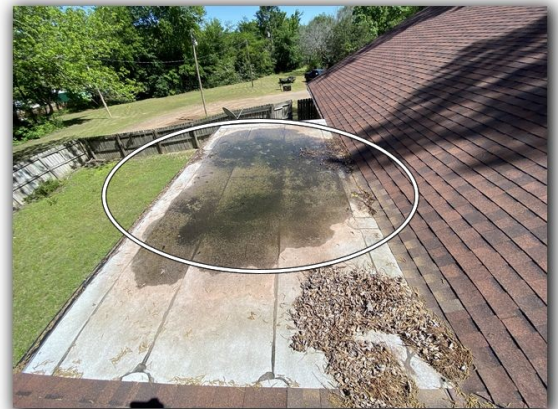
I observed an area over back porch with obvious pooled water at time of inspection. Rolled / bitumen roofing normally used on any grade of roof less than 2 pitch as should. Area presenting with flat roof which has allowed for pooling water. Noted water could eventually work its way through seams allowing for moisture entry onto wood decking and supports below affected areas. Also noted is the mechanical weight associated with water and debris. Recommend evaluation for repairs allowing roof area to drain water off as should.

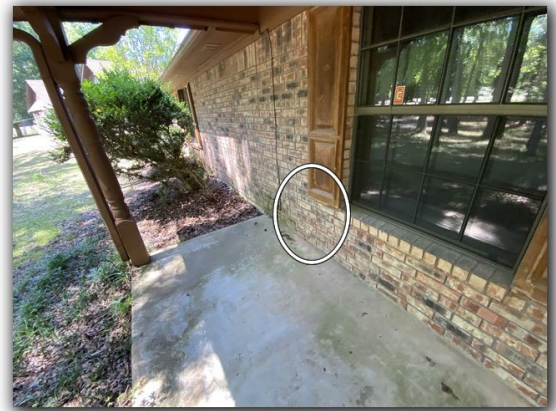
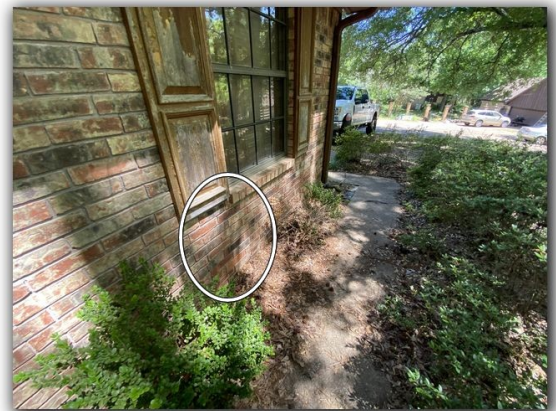
I observed various areas with mortar cracking in veneer siding at time of inspection. These cracks are typically due to thermal expansion and/or minor structural movement. Brick walls may expand (when heated) and contract (when cooled) and by doing so may do sufficiently enough to cause damage in mortar joints. These areas should be monitored for any noticeable changes that may occur.

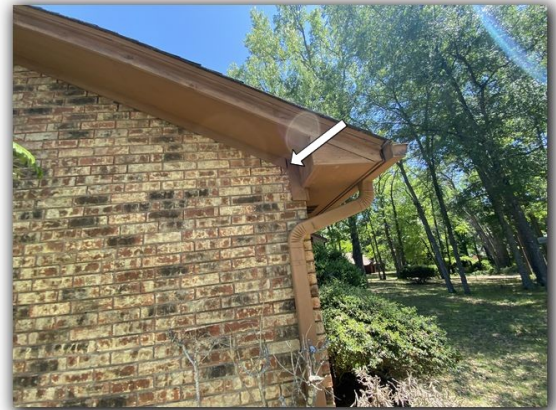
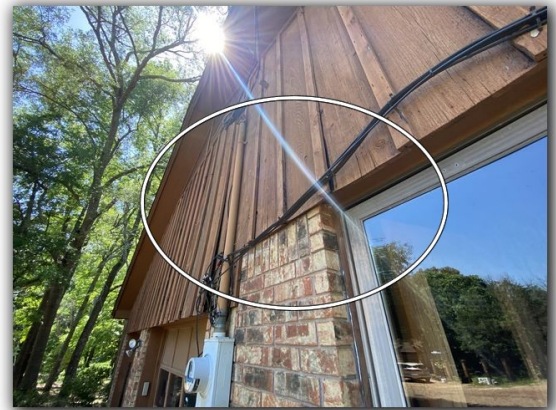
I observed various areas on exterior wood siding with minor openings noted at time of inspection. Areas noted create possible conducive conditions for water entry under the right conditions. Recommend evaluation for sealing noted gaps / separations with some fashion of water proofing material allowing home to work as efficiently as possible.

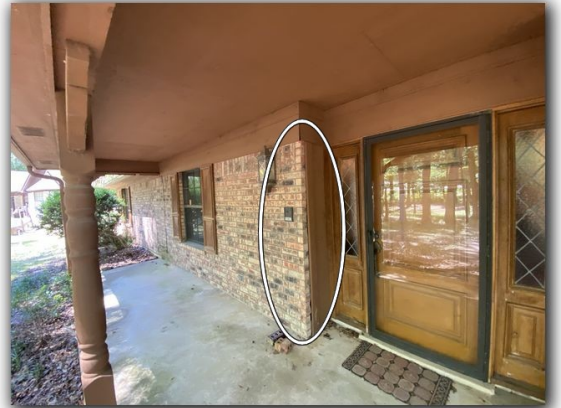
I observed gaps / separations noted near front porch / door trim surround(s) at time of inspection. Appears that trim board has dried and turned a bit creating noted opening. Area possible that brick has settled allowing for minor separation as well. Recommend sealing gap with some fashion of weather proofing material ( silicone ) keeping water from possibly making entry in walls behind trim / veneer.

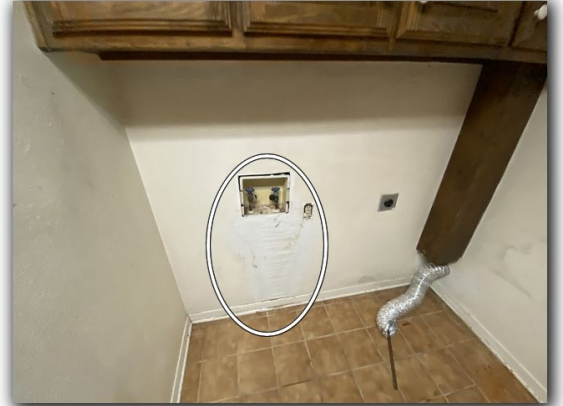
I observed minor seam crack(s) in the interior sheet rock walls at time of inspection. Areas noted appear to have been cause from settlement of the homes foundation and/or thermal expansion. Recommend monitoring noted areas for any noticeable changes

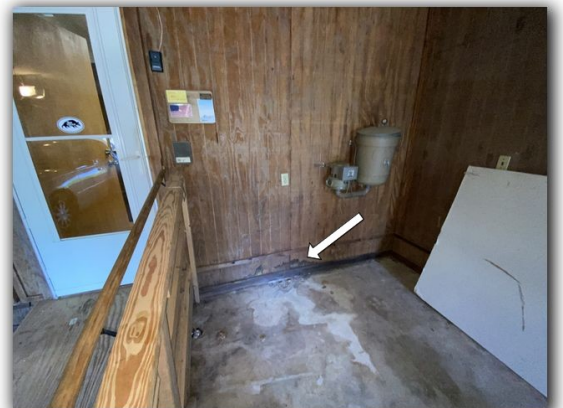
I observed an area of moisture staining noted in utility room at time of inspection. Further evaluation did not find any obvious evidence of moisture with moisture meter and thermal imager. Most likely leak with past washing machine connection that has since been removed. Recommend evaluation for repairs to damaged wall if desired monitoring noted areas for any noticeable changes.

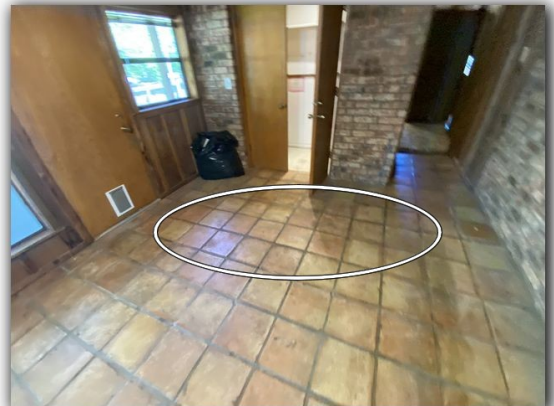
I observed minor tile cracks in various areas of home at time of inspection. Noted areas found with no obvious hollowed tiles during assessment. Area(s) appear to have been cause from normal settlement of the homes foundation, typical stress or shrinkage crack, and/or thermal expansion / shrinkage of cured concrete. Areas found do not exhibit horizontal movement (normal) found on all slabs without the proper control joints. Cracks should be monitored for any noticeable changes.

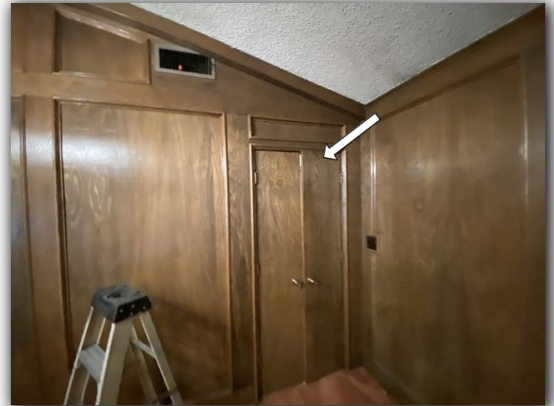
I observed where various doors in home appear to 'stick' when attempting to open/close at time of inspection. Recommend evaluation for possibly adjusting door(s) allowing door to work as should.

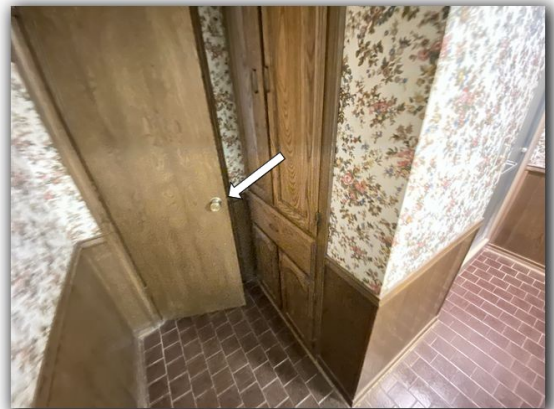
Master bathroom entry

I observed where ball assembly for double door found damaged at time of inspection. Typical when ball assembly loosens while in use. Note: inspector adjusted other door allowing ball assembly to work as should. Recommend evaluation for repairs allowing door(s) to work as

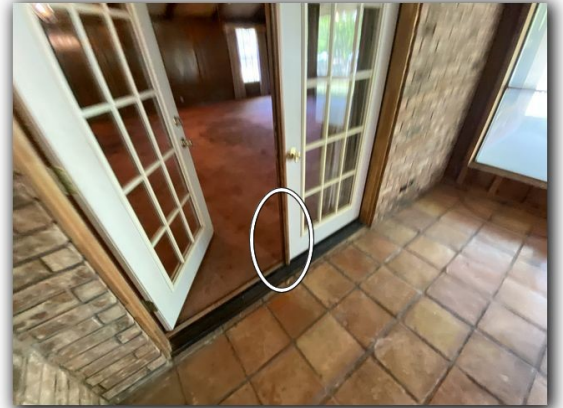
I observed where bottom flush bolt / lock would not engage / lock at time of inspection. Only top flush bolt working / locking as should. Recommend evaluation for possible repairs and/or replacement of damage flush bolt allowing door(s) to lock as should.

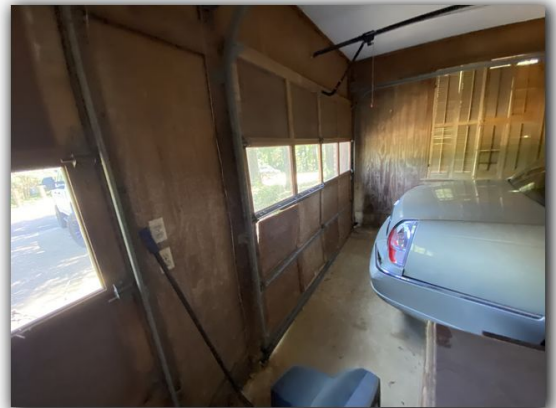
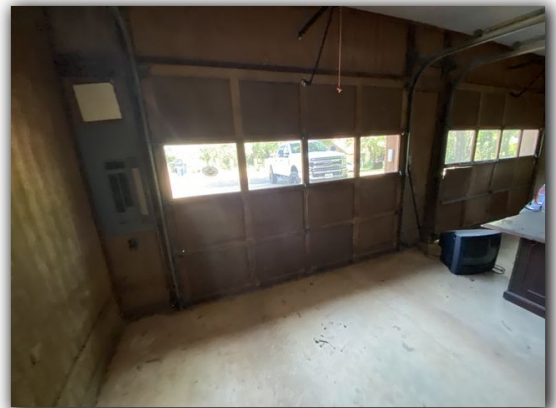
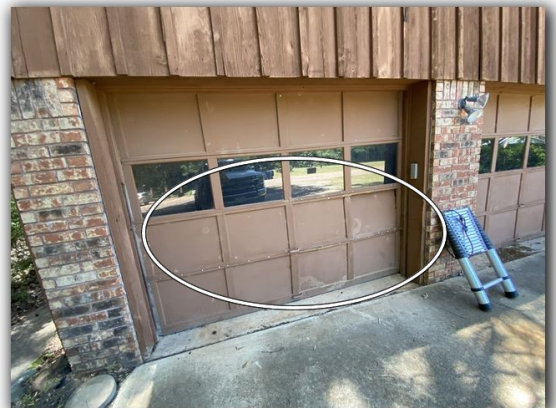
Type:  Metal  Wood  Fiberglass  Doors / panels are damaged

I observed areas of damage noted to at least 2 panels on outside garage door area at time of inspection. Damage appears to be cosmetic in nature. Note: garage door appears to perform as should with attempts. Recommend evaluation for repairs if desired monitoring for any noticeable changes.

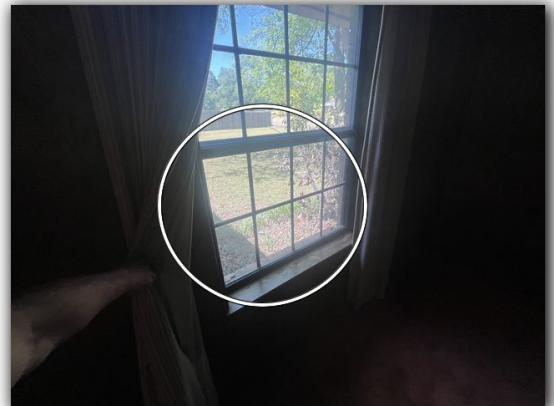
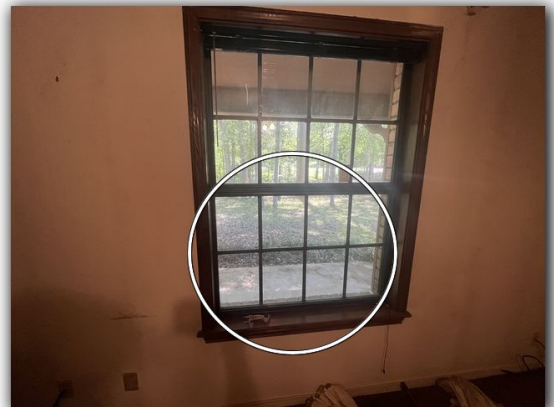
I observed where at least 2 bedroom window would not open at time of assessment. Possible that bottom latches need to be adjusted and/or tracks cleaned allowing unit to work as should. Windows in bedrooms / sleeping rooms should open allowing for functional emergency escape and rescue openings. Recommend evaluation for possible repairs if needed allowing for normal / safe function.

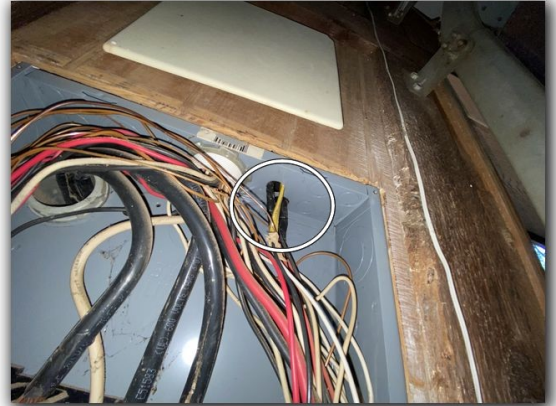
I observed wiring entering the panel without the proper protective bushing or grommets. Wiring that enters the panel should be solidly anchored and protected where it enters the panel by a bushing to prevent the sharp edges of the panel box from damaging the wiring and creating an equipment/safety hazard.

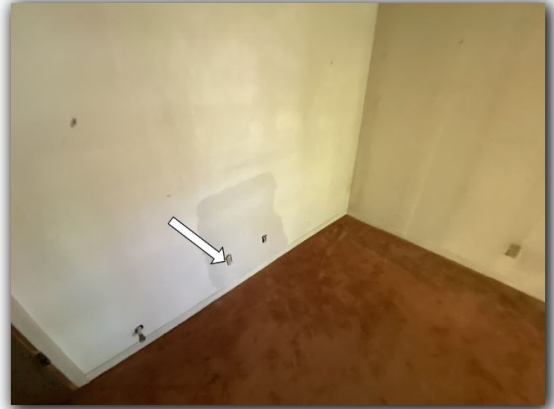
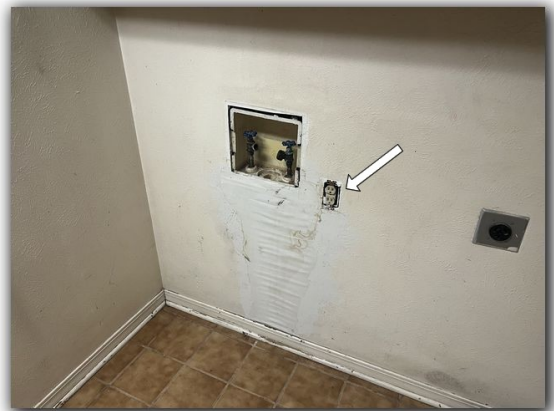
I observed various receptacles in home with missing face plates at time of inspection. Recommend evaluation for adding appropriate covers for added safety.

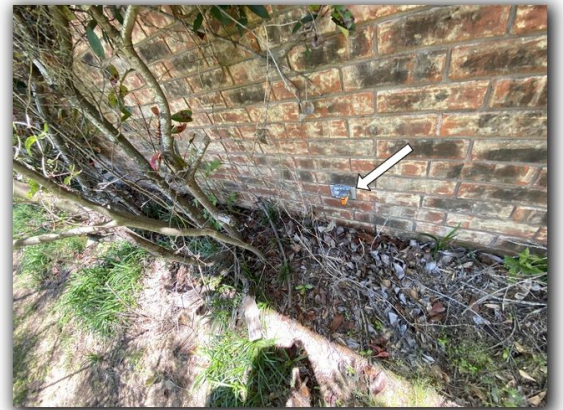
Missing GFCI protection on exterior of home

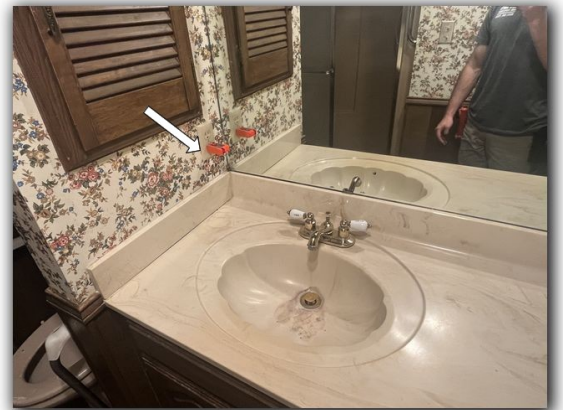
Missing GFCI protection in bathrooms

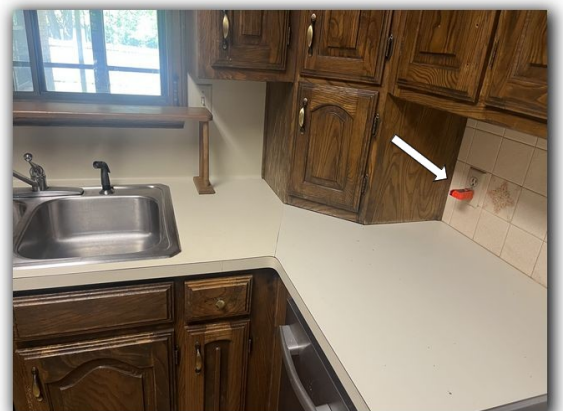
Missing GFCI protection in kitchen area

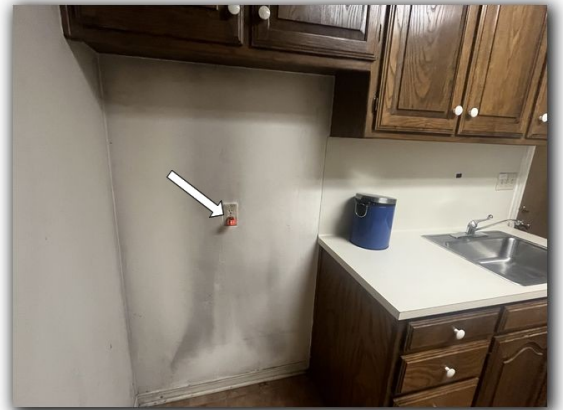
Utility room

No GFCI/ARC Fault protection at one or more location. This is considered a recognized safety hazard. GFCI protection was not provided in the home at locations where it now deemed necessary. GFCI protection may not have been required at the time the home was built, but for safety reasons it is recommended that GFCI protection be installed at all the following locations: • Bathrooms • Exterior • Garages • Crawlspace (at or below grade) • Unfinished basements • Kitchens • Laundry rooms • Within 6 feet of all plumbing fixtures. Recommend evaluation for possible repairs and / or replacement of deficient receptacles for added safety.

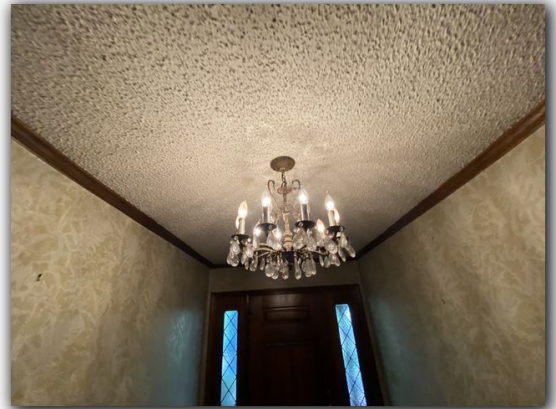
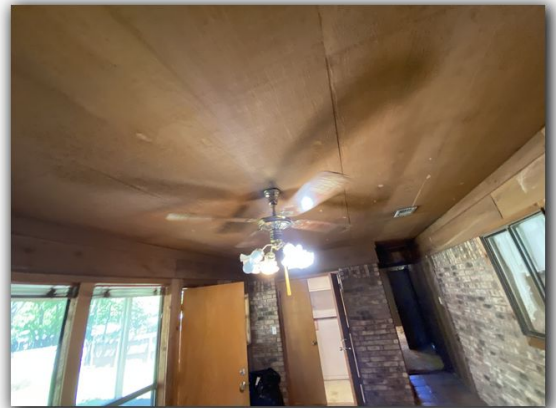
I observed where ceiling fan in living room was not working with attempts at time of inspection.

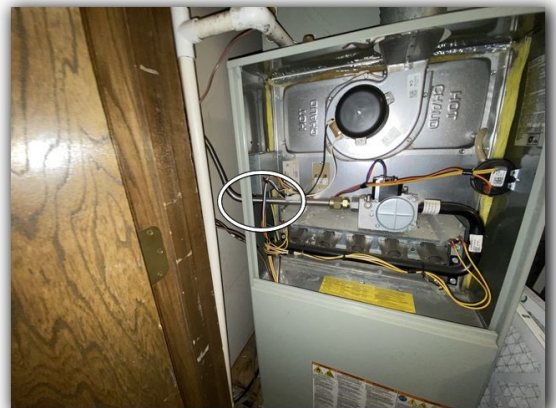
The gas supply flex connector was observed to be passing through the heating unit cabinet at time of inspection. Under today's current mechanical installation standards, this may no longer be an accepted practice. The gas connector flex line is thin wall tubing and as such any vibration from the the air handler rubbing on the connector could eventually result in a leak. **Note: grommet placed on flex line for protection may be as per manufacturer specifications.** A Recommendation is rigid black gas pipe passing through the heating unit cabinet.

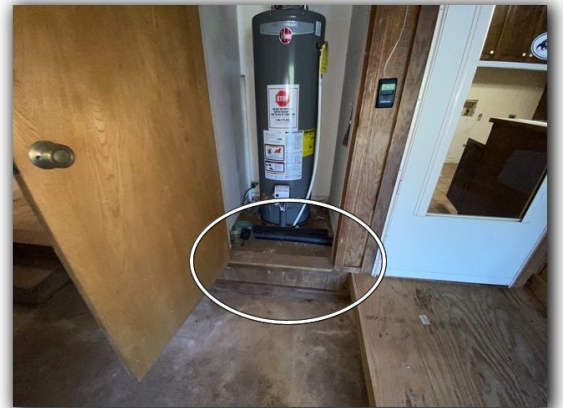
I observed where water heater located in closet installed with heater sitting on floor at time of inspection. Noted area with door that opens directly to garage area at time of assessment. Water heaters having an ignition source should be elevated so that the source of ignition is not less than 18" above the garage floor unless entry door to garage cannot be opened. This is not the case with this heater and location. Vapors from these liquids are heavier than air and may concentrate just above floor level posing a possible explosion hazard in garages with a water heater. Recommend evaluation from qualified contractor for appropriate repairs allowing for normal and safe function

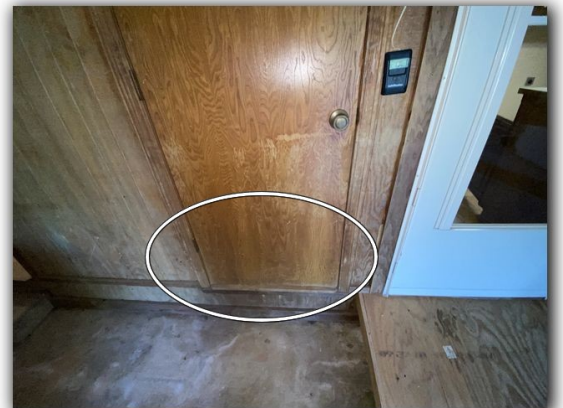
I observed where water heater located / installed inside interior closet at time of inspection. **Noted were no obvious openings for appropriate air movement. Typically confined space should be provided with at least two permanent openings communicating directly with on another allowing for sufficient air flow for normal combustion.** Enclosed area found creates conducive conditions for incomplete combustion creating possible elevated Carbon Monoxide numbers as well as allowing for possible down draft. Recommend evaluation for possible installation of some sort of vent system ( typically placed in door / ceiling ) allowing for at least 2 openings per manufacturer specification.

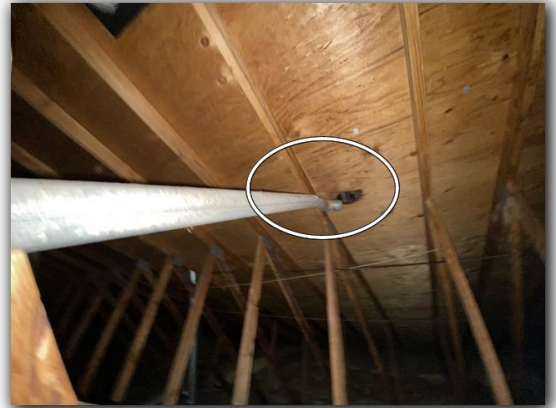
Note: this is common when home has new roof installed.

I observed where water heater exhaust flue appears to be displaced / separated / damaged in attic area at time of inspection. Noted area obviously allowing conducive conditions for water heater exhaust to discharge into attic area which could create possible fire hazard. Discharge into attic also creating conducive conditions for elevated carbon monoxide introduced creating unsafe and dangerous build up. Recommend evaluation for obvious repairs allowing water heater to perform as safely as possible.

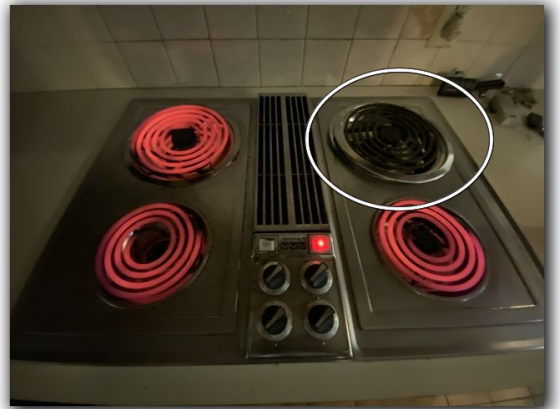
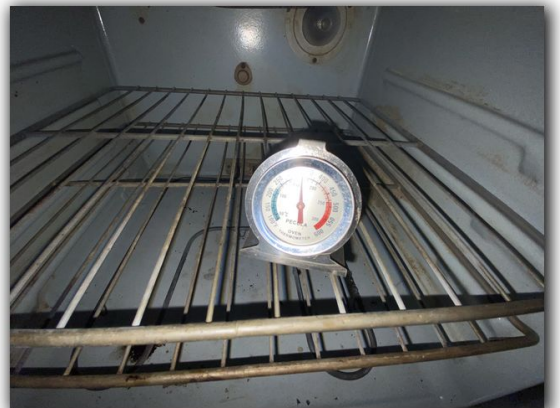
I observed where right rear burner may not be working appropriately at time of inspection.
