PROPERTY INSPECTION REPORT

Concerning: 1234, Somewhere, TX 75601
(Address or Other Identification of Inspected Property)

By: David Smith, Lic #21666 05/05/2023
(Name and License Number of Inspector) (Date)

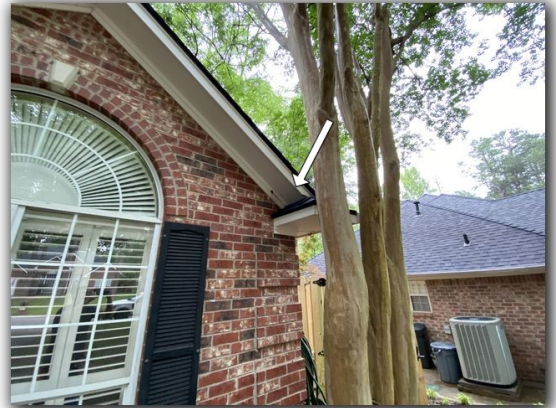
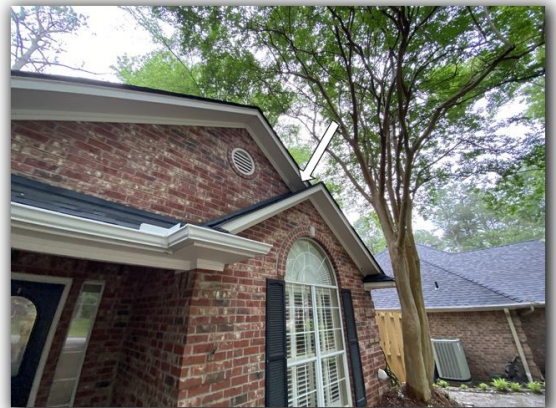
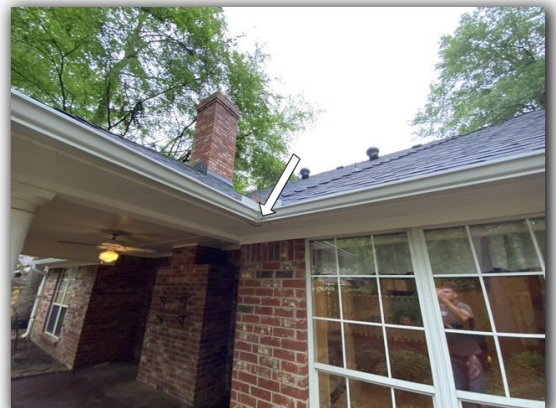
I observed various area with minor cosmetic damage noted to wood fascia / frieze boards under soffit areas at time of inspection. Noted damage appears to be from possible squirrels and/or birds. Recommend evaluation for keeping areas painted allowing for appropriate weather protection monitoring noted areas for any noticeable changes.

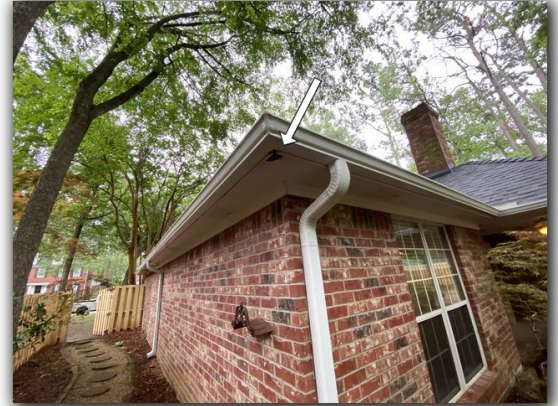
I observed various areas found with moisture damage near home soffit and fascia boards at time of inspection. Noted areas are common with debris filled gutters which can allow water to spill over allowing moisture contact or in this case could be from silicone that has worn away from seamed gutters. Area is painted which is added protection. Recommend evaluation for possible repairs if desired.

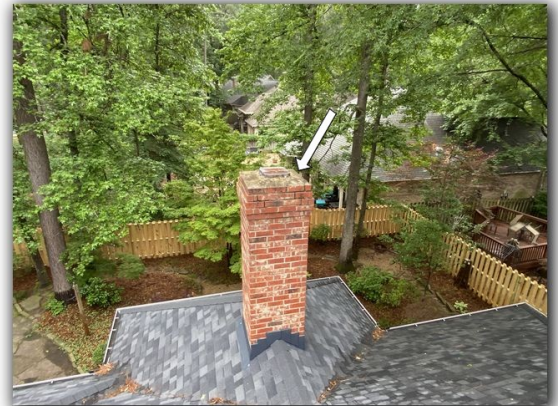
I observed where the chimney was missing its chimney cap at the time of inspection. The cap is needed to obviously keep rain water from making entry into chimney which can lead to many components of damage to chimney as well as unpleasant odors. Cap also Keeps animals out, reduces wind down drafts, and is also a spark arrestor. Recommend evaluation for possible repaired or replaced.

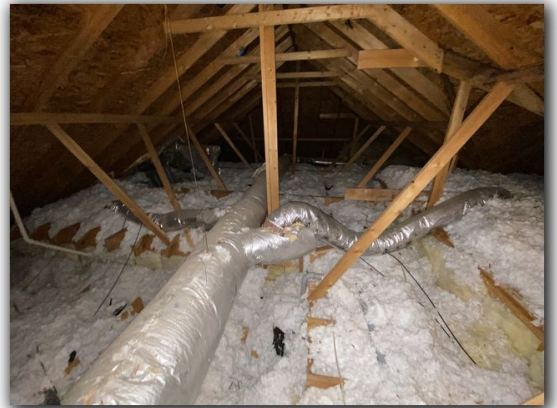
I observed an area in attic over living room near chimney where it appears that a leak might have occurred at some point in roof area at time of inspection. Further evaluation did not find any obvious evidence of moisture entry with hands on dry wood supports. Note: heavy rain night before inspection which would have allowed for water entry if active leak. Home presenting with new roof which most likely remedied any past moisture entry concerns. Recommend monitoring noted areas for any noticeable changes.

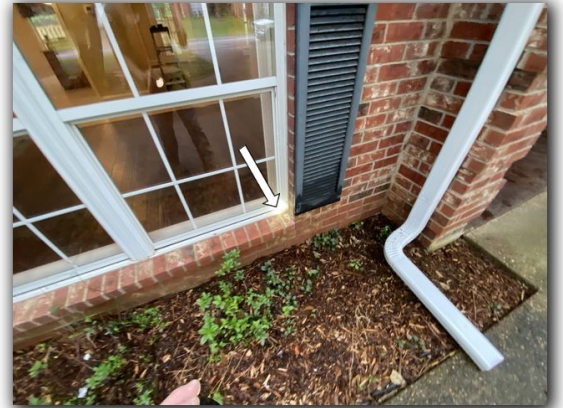
I observed areas with possible moisture damage noted in front dining room area at time of inspection. Further evaluation did not find obvious evidence of moisture when assessed with moisture meter and thermal camera. Attic area did not find any obvious evidence of moisture with roof area finding where newer roof has been installed. Noted areas of damage near large window which may be the reason for areas of moisture. Inside roof valleys could have allowed water to flow off roof striking brick ledge near windows allowing water entry at some point. Silicone noted near bottom corners of windows at time of assessment. Roof valleys terminate into vertical walls above affected areas with no obvious evidence of moisture noted in attic area. Taller flashing added to inside valleys which would keep water from pooling and making entry into home as well. Noted areas of moisture damage appear to be on trim made of MDF which swells with very limited amounts of water contact. All indications show that every possible entry point for water has been remedied. Heavy rain night before inspection with no obvious evidence of moisture entry. Recommend repairs to trim if desired monitoring noted areas for any noticeable changes.

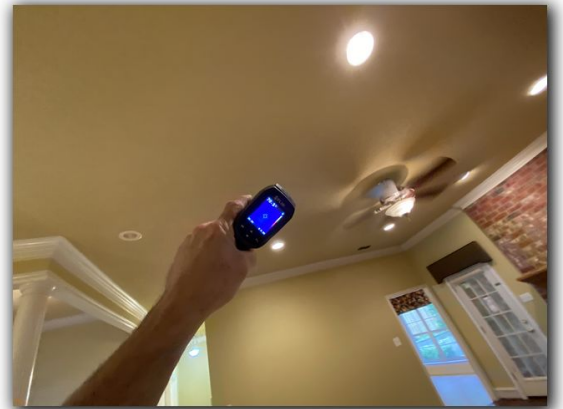
I observed an area an possible moisture staining / moisture damage noted in master closet area at time of inspection. Further evaluation did not find obvious evidence of moisture when assessed with moisture meter and thermal camera. Attic area found evidence of moisture on insulation below water heater roof termination. Home presenting with new roof with no obvious evidence of water entry at time of inspection with heavy rain night before inspection. Most likely newer roof as remedied any past moisture entry issues. (Note: inspector can not verify this at time of inspection.) Recommend repairs to ceiling if desired monitoring noted areas for any noticeable changes.

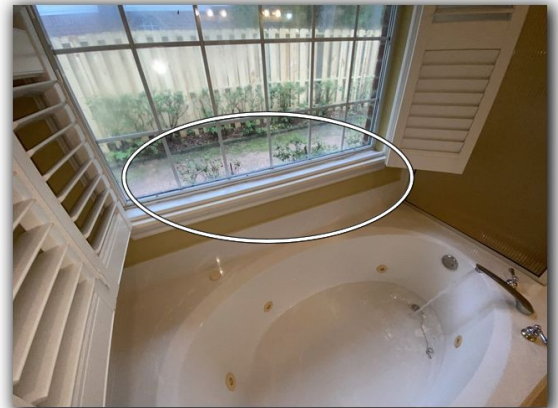
Master bathroom area

- Various screens missing on home at time of inspection. Screens found in garage area.

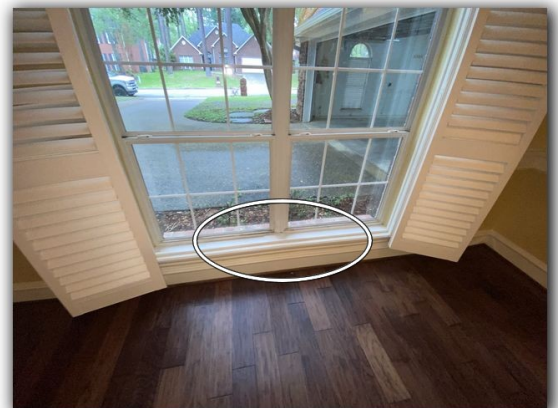
I observed various areas of moisture damage noted to window sills in home at time of inspection. This is common and can be caused by several different factors. Damage found in various locations in home which could be possible water entry around windows but does not appear likely. Damage is isolated to areas near actual window itself. Damage appears to be from condensation buildup near windows in combination with window sills having been made out of

MDF material. (Note: MDF and water do not mix.) Higher humidity levels in home (with various damaged window seals) allow moisture to form on windows which in turn make contact with found window sills. Recommend evaluation for possible repairs to sills if desired.

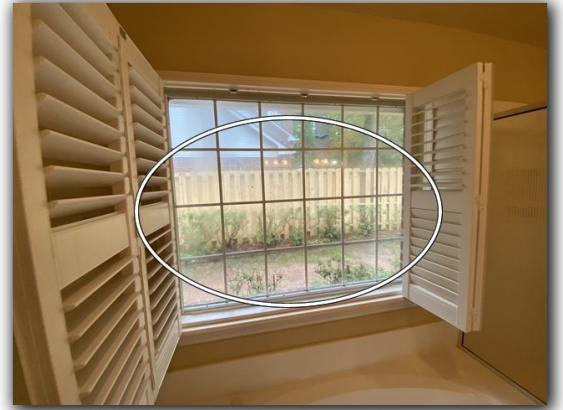
Master bathroom window

I observed areas of damage noted to double pane insulated windows in home at time of inspection. Typically seen on south and west facing homes, the seals on noted windows fail allowing moist air between the glass panes at time of inspection. When this happens the air condenses allowing for fogging appearance. This will generally appear in cooler months of the year. Recommend monitoring conditions and / or making repairs if desired.

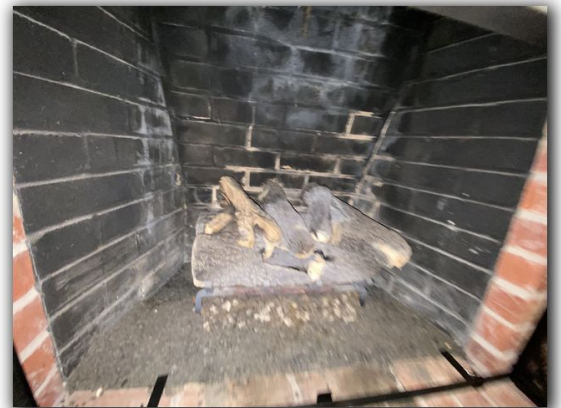
- I observed where gas log / insert fire place missing damper clamp at time of inspection. A damper clamp is recommended by code when artificial gas logs or a log lighter are present in an open fireplace. Damper clamps keep the chimney's damper from closing allowing dangerous gases to escape the firebox in the case of a gas leak.

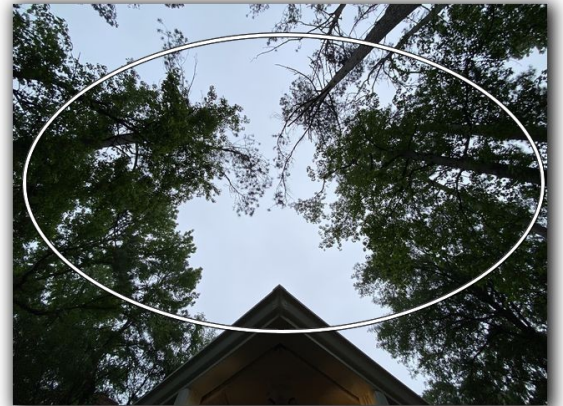
I observed where larger tree in front / back yard with obvious large limbs over home at time of inspection. Various lower limbs appear to be damaged possibly dead. Possible that falling limbs could come in contact with home / roof structure. Recommend possible evaluation from tree specialist / arborist to assess for possible removal of unsafe limbs if needed.

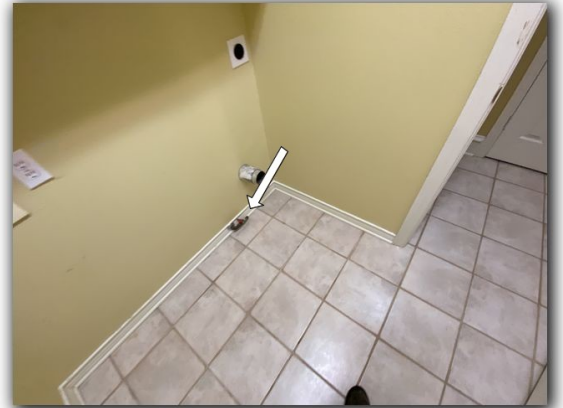
I observed an area found with open gas lines in home at time of inspection. Areas such as these could create conducive conditions for accidental openings allowing gas to flow freely into home. Recommend evaluation for covering noted gas valves with appropriate caps keeping home as safe as possible.

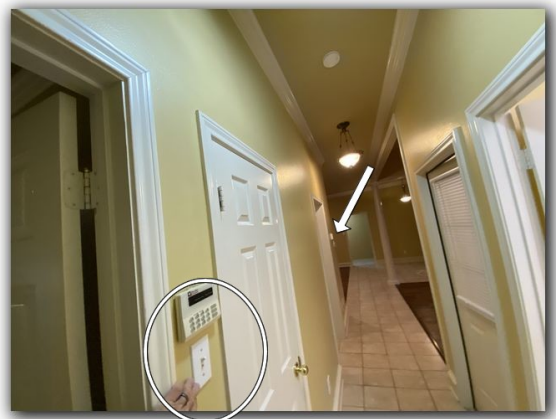
I observed where door bell button does not appear to work with attempts at time of inspection.

I observed where 3 way switch for hallway off kitchen was found to be deficient at time of inspection. If switch in hallway was in up position then switch near living room then hallway light could be turned on and off with switch near master bedroom. If switch in down position near living room then switch would not turn light on or off in hallway. Note: tape was placed over switch to keep from being used. This is typically a wiring issue that may have occurred during installation / rough in work with construction of home. Recommend evaluation for possible repairs if needed

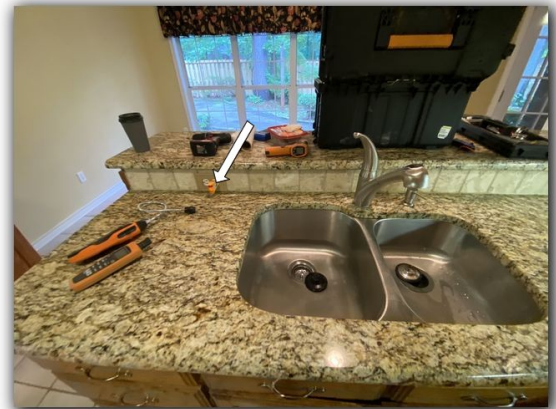
Missing GFCI protection in kitchen area. Noted receptacle presenting with an open ground. Receptacle does not appear to have been wired correctly allowing receptacle to trip as should.

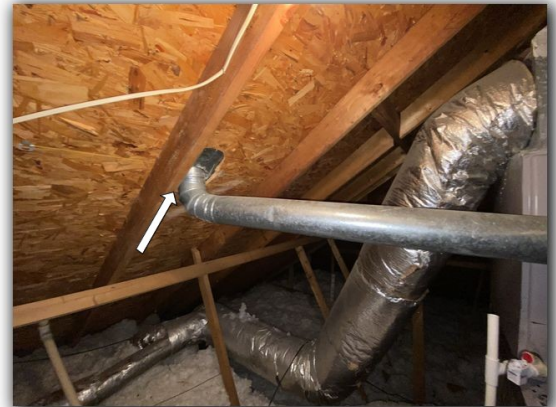
I observed where furnace flue in contact with wood roof decking in attic area at time of inspection. Note: temperatures of the vent pipe could transferred to the surrounding area (wood) and all the materials that are in the vent pipe vicinity. Noted rise in temperature could be conducive for possible fire under the right conditions. Inspector unable to verify whether flue pipe is insulated at time of assessment. Double walled flues typically may need 1 - 3 inch clearance. Recommend evaluation for possible repairs allowing appropriate buffer per manufacturer specifications.

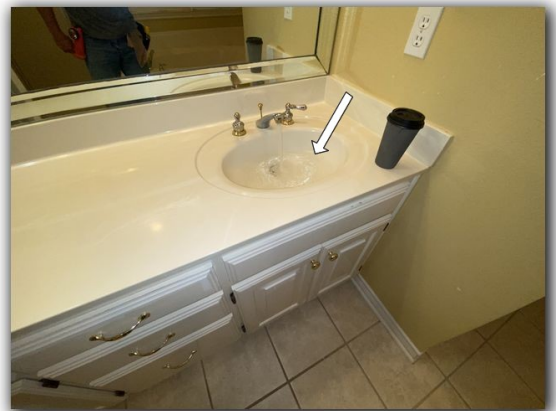
I observed where right side master bathroom sink found to drain slowly at time of inspection. Area of concern appears to be isolated to noted fixture with volume test in home with other plumbing fixtures allowing for drainage as should. Recommend evaluation for possible repairs allowing possible debris / blockage to be removed allowing for normal function.

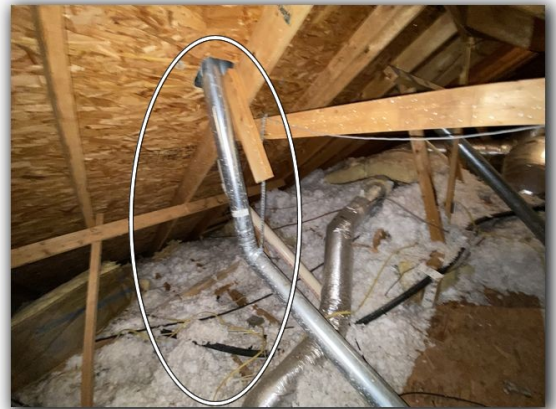
I observed where water heater flue in contact with wood roof purlin support in attic area at time of inspection. Note: temperatures of the vent pipe could transferred to the surrounding area (wood) and all the materials that are in the vent pipe vicinity. Noted rise in temperature could be conducive for possible fire under the right conditions. Inspector unable to verify whether flue pipe is insulated at time of assessment. Double walled flues typically may need 1 - 3 inch clearance. Recommend evaluation for possible repairs allowing appropriate buffer per manufacturer specifications.

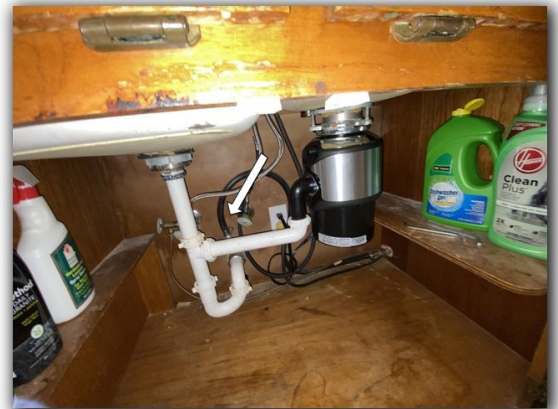
I observed where dishwasher drain has been installed incorrectly. As it is now, wastewater from sink can be allowed to siphon into dishwasher. Recommend placing a high loop or air gap to prevent potential back flow contamination of the dishwasher.

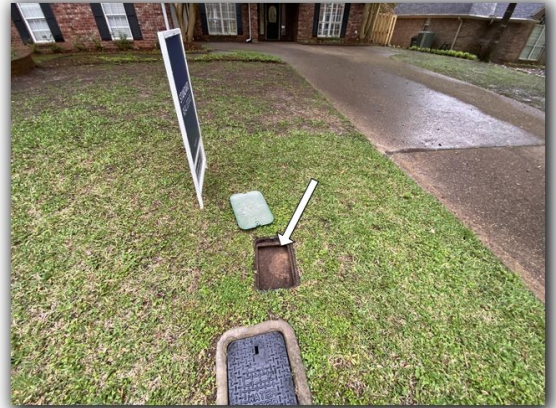
I observed back flow preventer found completely covered with dirt at time of inspection. While unit may work properly when covered the moist dirt could eventually rust away shut off valves on back flow keeping one from shutting down irrigation system if needed or desired. Recommend evaluation for possible repairs if needed removing noted areas of dirt of unit

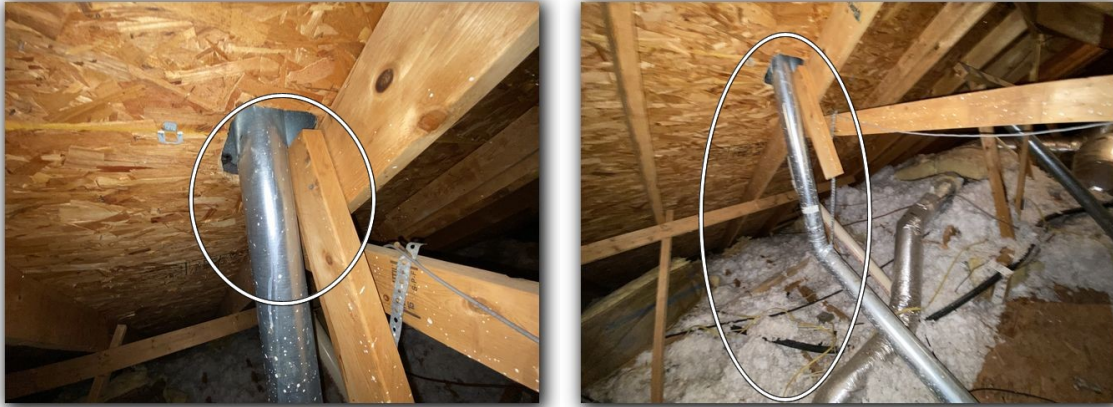
Noted rise in temperature could be conducive for possible fire under the right conditions. Inspector unable to verify whether flue pipe is insulated at time of assessment. Double walled flues typically may need 1 - 3 inch clearance. Recommend evaluation for possible repairs allowing appropriate buffer per manufacturer specifications.

I observed where water heater flue in contact with wood roof purlin support in attic area at time of inspection. Note: temperatures of the vent pipe could transferred to the surrounding area (wood) and all the materials that are in the vent pipe vicinity. Noted rise in temperature could be conducive for possible fire under the right conditions. Inspector unable to verify whether flue pipe is insulated at time of assessment. Double walled flues typically may need 1 - 3 inch clearance. Recommend evaluation for possible repairs allowing appropriate buffer per manufacturer specifications.

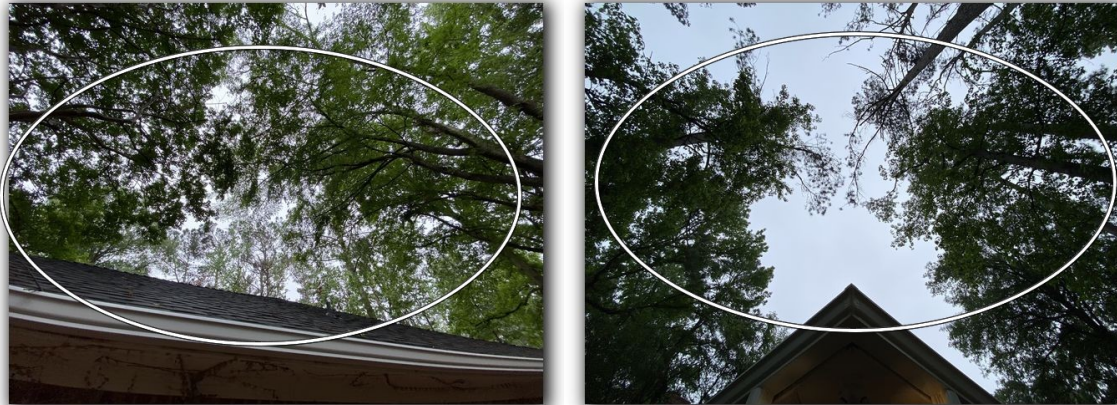
I observed where larger tree in front / back yard with obvious large limbs over home at time of inspection. Various lower limbs appear to be damaged possibly dead. Possible that falling limbs could come in contact with home / roof structure. Recommend possible evaluation from tree specialist / arborist to assess for possible removal of unsafe limbs if needed.

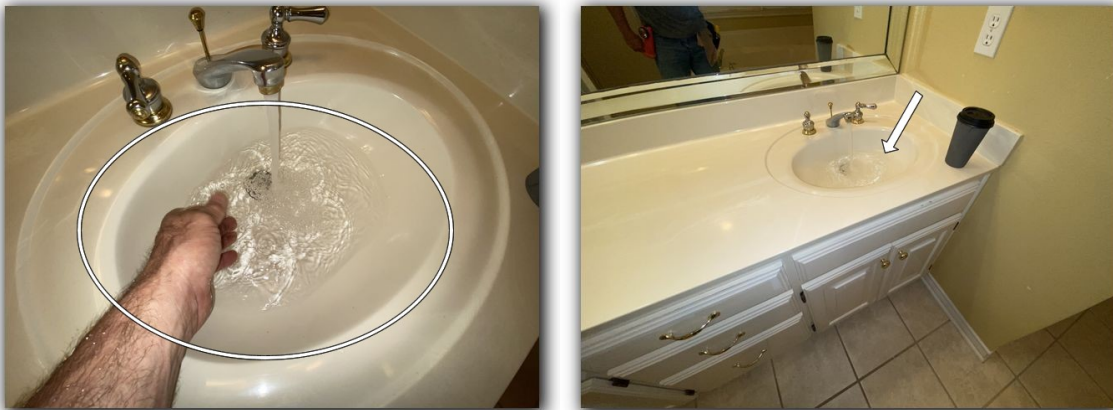
I observed where right side master bathroom sink found to drain slowly at time of inspection. Area of concern appears to be isolated to noted fixture with volume test in home with other plumbing fixtures allowing for drainage as should. Recommend evaluation for possible repairs allowing possible debris / blockage to be removed allowing for normal function.
