David K. Smith
Professional Home Inspector Lic #21666

PROPERTY INSPECTION REPORT

Concerning: 1234 Drive, Somewhere, TX 75605
(Address or Other Identification of Inspected Property)

By: David Smith, Lic #21666 04/07/2023
(Name and License Number of Inspector) (Date)

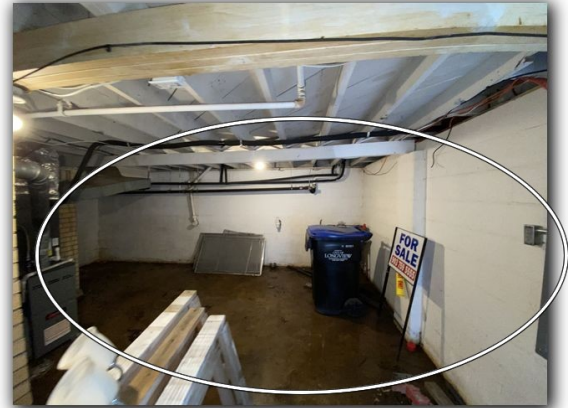
No ventilation in basement area

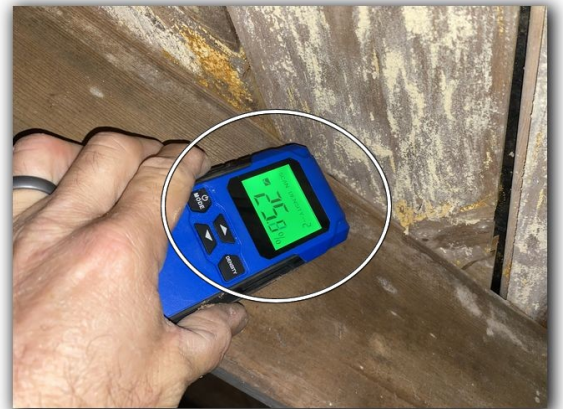
I observed where home presented with inadequate ventilation by *today's standards* for new construction. Typically a good rule of thumb would recommend ventilation openings of not less than 1 square foot for each 150 square feet of crawl space. Noted conditions found with little ventilation openings with minor horizontal air flow noted. Recommend evaluation for adding appropriate ventilation into crawlspace allowing home to work as efficiently as possible. *Note: a great addition would be a possible moisture barrier placed on ground under home preventing unwanted moisture from making access to exposed areas of crawl space.*

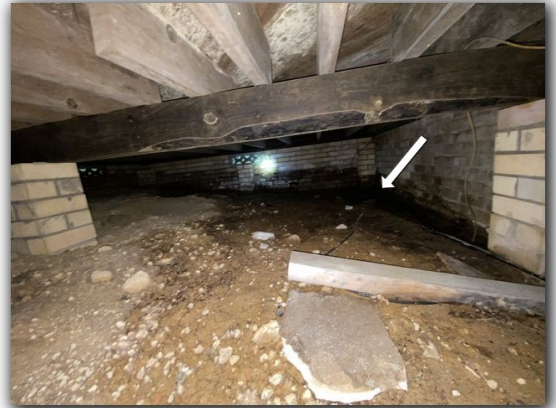
- Crawlspace vent noted near grade level.
- I observed an area of pooled water under master bedroom area at time of inspection. It appears that water can make entry near left rear corner of home through crawl space vent that is ground / grade level. Recommend evaluations for repairs allowing water to move away from home as should.

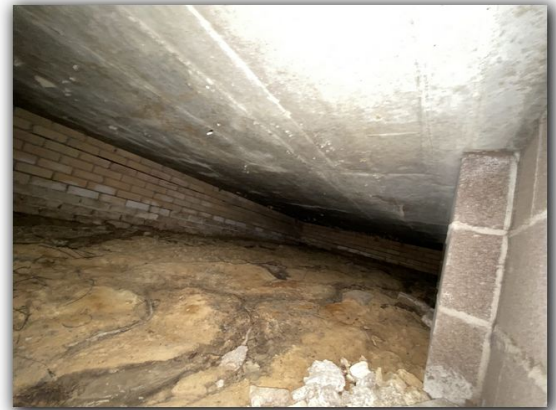
15-25 percent moisture found under home. Less than 27 percent found within normal limits.

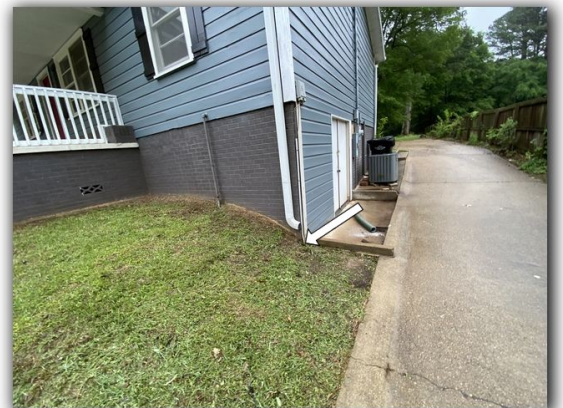
- Gutters / down spouts found draining too close to the structure at the time of inspection. Water terminating near slab / veneer underpinning can create conducive conditions for possible undermining. Recommend termination point at least 16-24 inches from foundation. Recommend installing extensions onto gutters or adding splash blocks allowing water to move away from home efficiently.

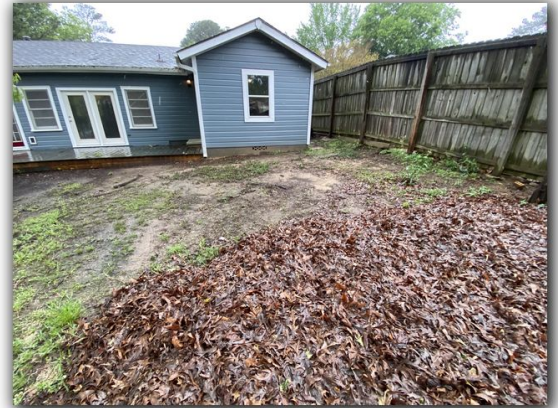
Monitor areas around perimeter of home after heavy rain to make sure water is draining away from structure.

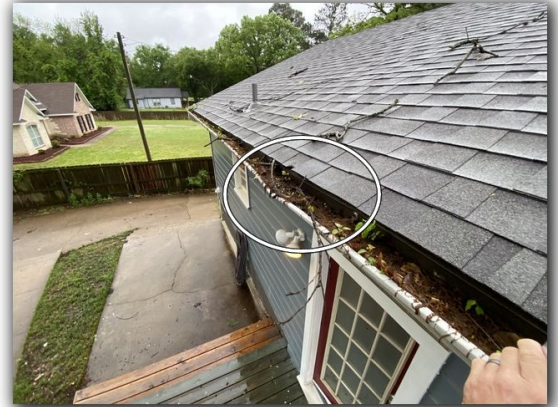
I observed an area of roof with damage from past limb strike at time of inspection. Noted area of damage to gutter as well.

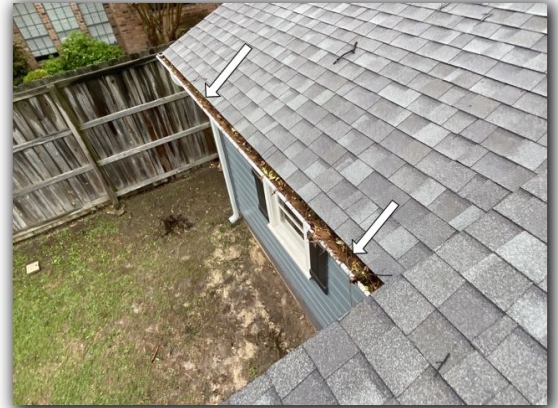
I observed where gutters filled with areas of debris at time of inspection. Debris in gutters are create conducive conditions for water penetrations and / or mechanical failure due to extreme water/debris weight or possible water leaking into living space / soffit areas. Recommend cleaning of gutters allowing water to flow / terminate from roof area as should.

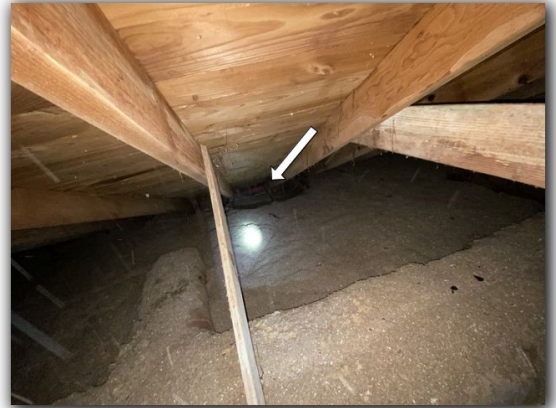
I observed an area over kitchen / dining room area where insulation appears to have been removed at time of inspection. Area noted has only sheet rock separating home living area from a possibly very hot or very cold attic. Recommend evaluation for replacing missing insulation allowing home to work as efficiently as possible.

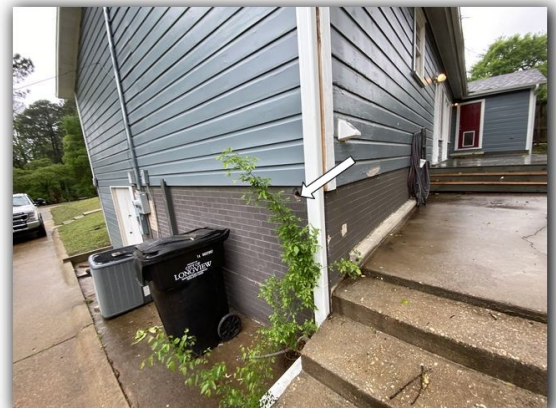
I observed various areas on exterior brick veneer underpinning with minor openings noted at time of inspection. Areas noted create possible conducive conditions for water entry under the right conditions. Recommend evaluation for sealing noted gaps / separations with some fashion of water proofing material allowing home to work as efficiently as possible.

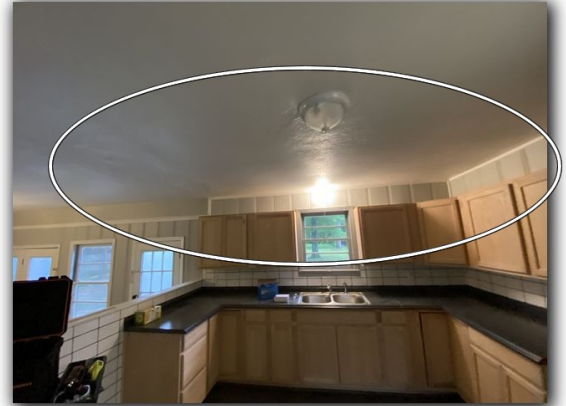
Note: areas on ceiling in kitchen appears to be where upper cabinets pulled at some point. This is not considered to be any issues.

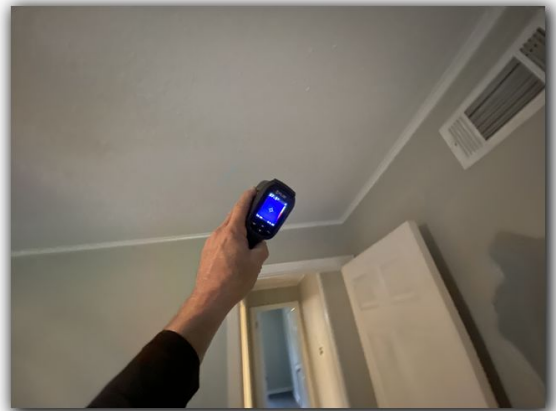
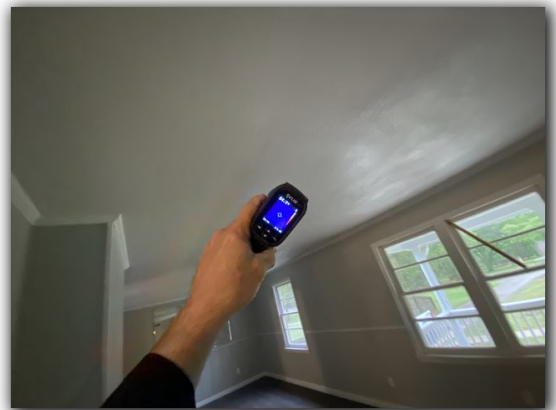
I observed an area an possible moisture staining / moisture damage noted over laundry area at time of inspection. Further evaluation did not find obvious evidence of moisture when assessed with moisture meter and thermal camera. Attic area found evidence of moisture with roof area finding where newer roof has been installed. Appears that roof has received possible limb strike from tree above. Most likely newer roof as remedied any past moisture entry issues. (Note: inspector can not verify this at time of inspection.) Recommend repairs to ceiling if desired monitoring noted areas for any noticeable changes.

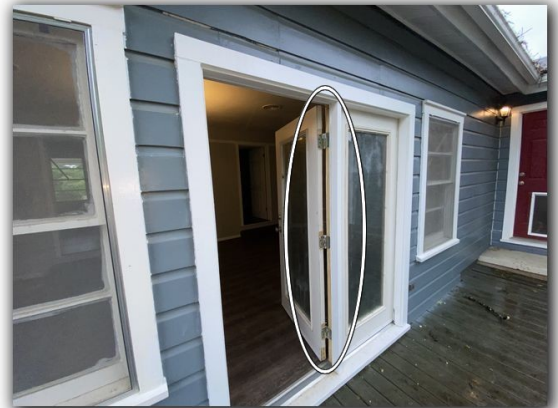
- Basement double doors have had door jams cut and replaced leaving areas of exposed wood.

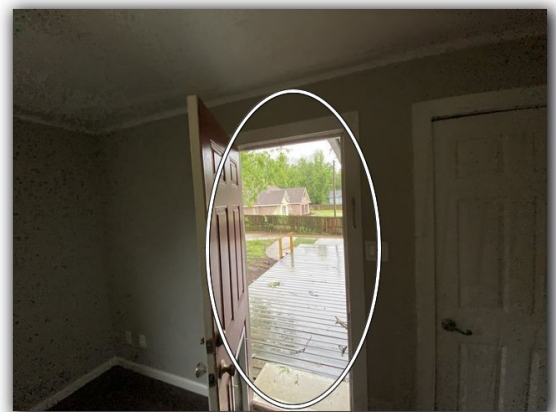
I observed where rear single entry / exit door near back of home found with door that appears to 'stick' when attempting to open/close at time of inspection. Recommend evaluation for possibly adjusting door(s) allowing door to work as should. Note: weather stripping near bottom of door may not be appropriate at time of inspection. Areas of weather stripping in place but inspector could still see day light near bottom of door when door closed.

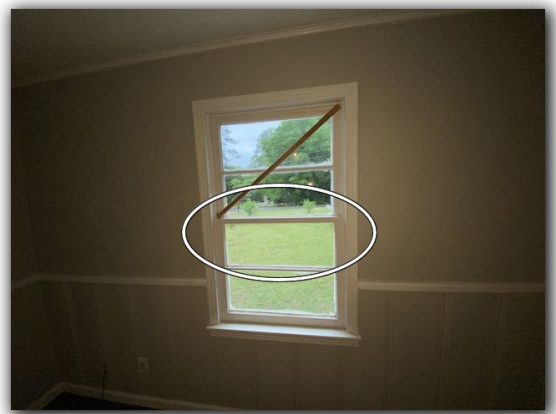
Various screens missing on home at time of inspection.

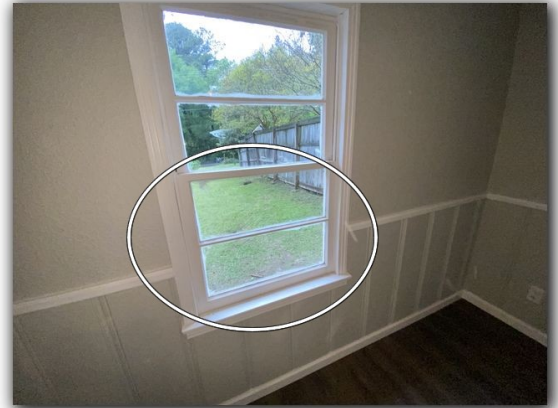
I observed where wood pane cased windows found to be painted shut at time of assessment. Windows in bedrooms / sleeping rooms should open allowing for functional emergency escape and rescue openings. Recommend evaluation for possible repairs if needed allowing for normal / safe function.

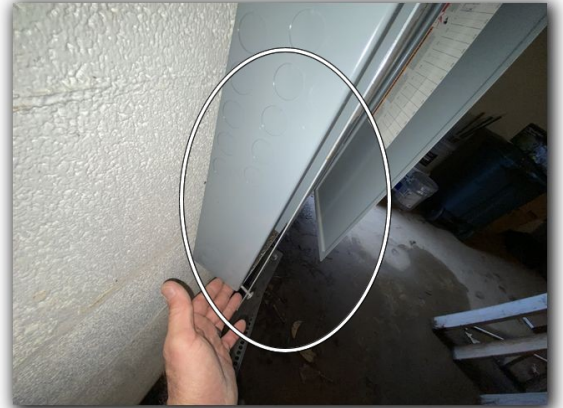
I observed where panel cover screws do not hold panel cover in place as should. It appears that securing screws are too small for cover. Attempts to screw in allowed screws to 'pop out' when installed. Recommend evaluation for repairs allowing load center panel cover to be covered as should.

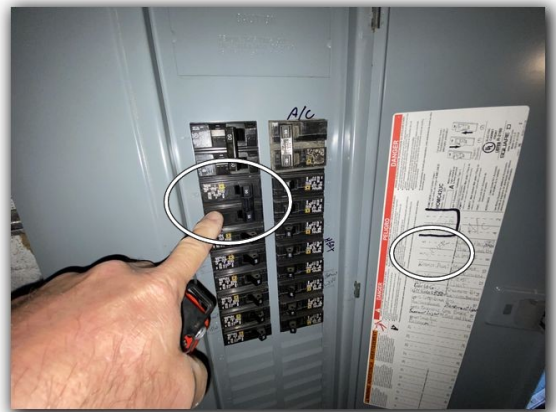
I observed where dryer receptacle does not appear to be working at time of inspection. Note: power on to dryer receptacle on panel. Recommend evaluation for repairs allowing receptacle to work as should.

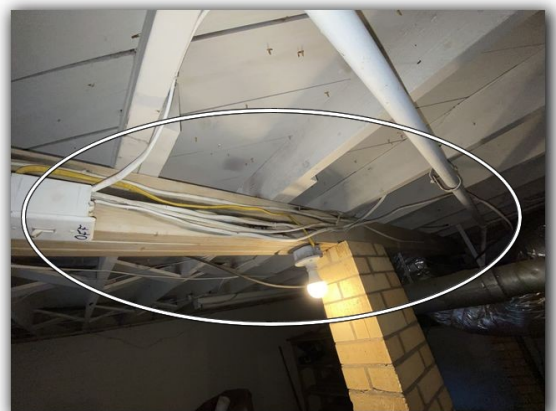
I observed various areas in attic presenting with open junction boxes and/or inappropriate splices made to wiring at time of inspection. Areas noted should be made up in approved or appropriate junction boxes. Recommend evaluation for repairs.

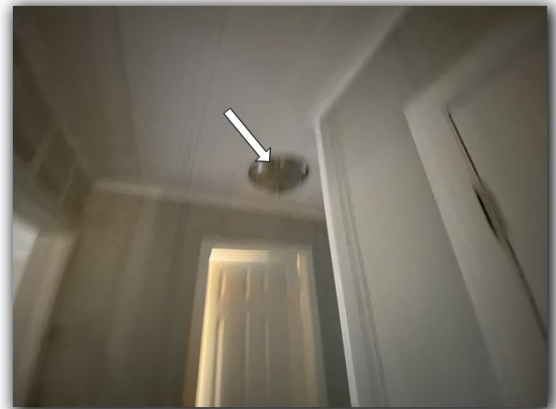
Kitchen light would not turn on with attempts

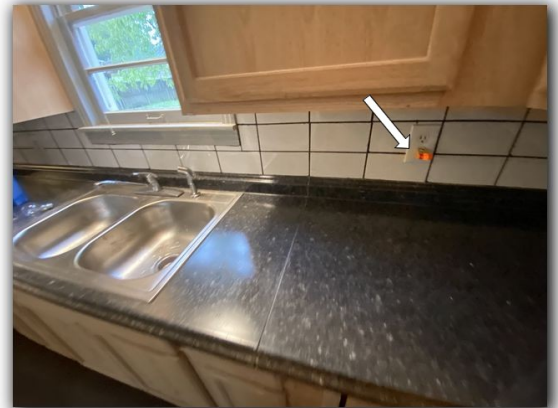
Missing GFCI protection in kitchen area

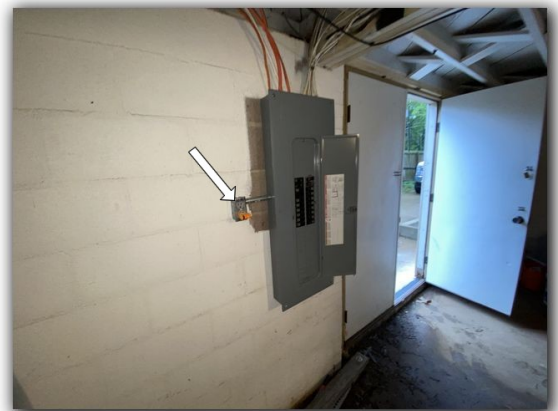
Missing GFCI protection in basement area

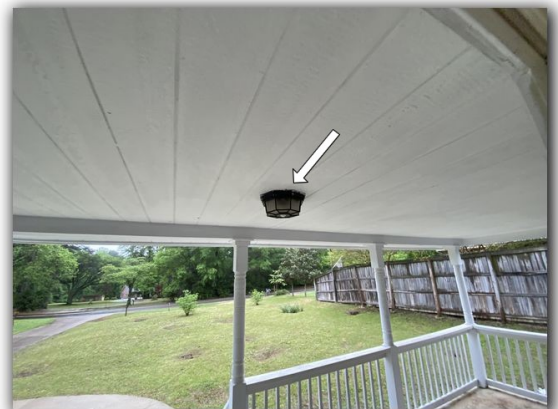
Front porch light would not turn on with attempts

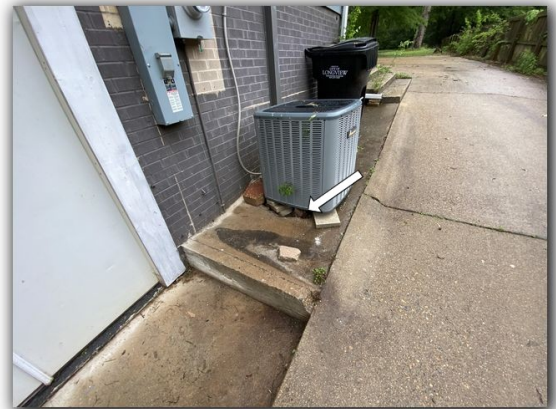
I observed where outside unit sitting on pieces of cement block(s) at time of inspection. Noted condition could allow for movement over time which could cause harm to outside unit. Typically outside condenser unit placed on solid flat surface or pad.

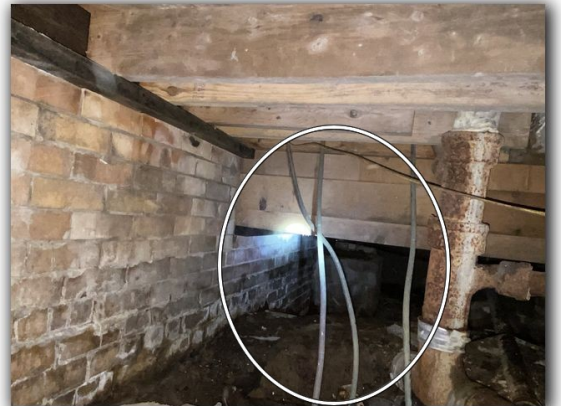
I observed where water lines under home were without adequate insulation at time of inspection. Areas such as this crawlspace could be exposed to freezing temperatures creating conducive conditions for possible pipes to burst. Recommend evaluation for appropriate

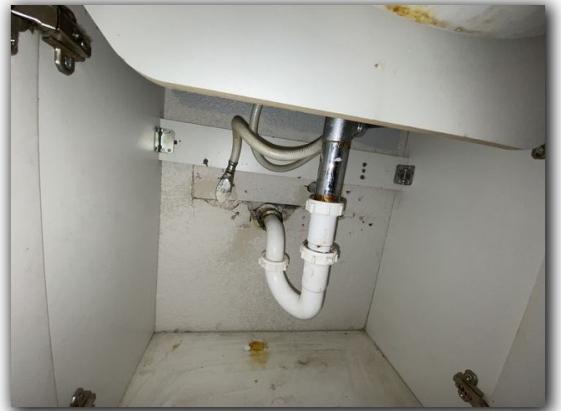
I observed where master bathroom sink drain stop was not installed appropriately at time of inspection. Recommend evaluation for installing drain stop per manufacturer specifications allowing drain stop to work as should.

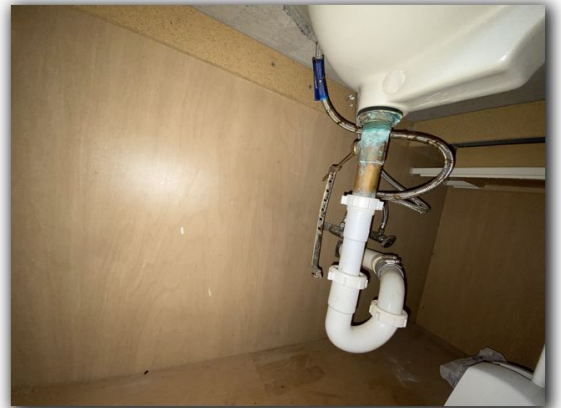
I observed where hallway bathroom sink drain stop was not installed appropriately at time of inspection. Recommend evaluation for installing drain stop per manufacturer specifications allowing drain stop to work as should.

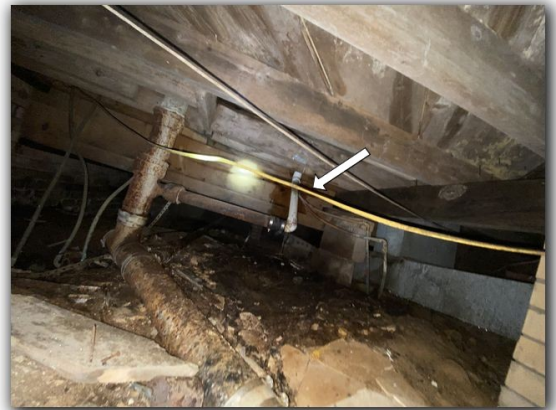
I observed an obvious leak under master bathroom shower drain line at time of inspection. Inspector performs volume test in home running water for approximately 30 minutes. Obvious water under master bathroom shower and on ground. Recommend evaluation for repairs allowing shower drain to work as should.

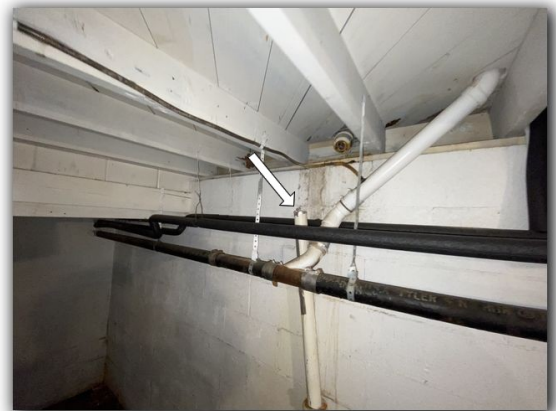
I observed where plumbing vent stack found in basement area with foil tape covering covering opening at time of inspection. This may not be appropriate and could deteriorate over time allowing unpleasant fumes to make entry into basement area.

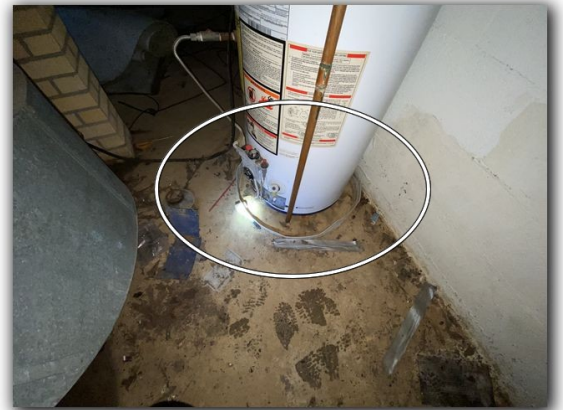
- Water heater sitting on basement floor without any drainage found for emergency catch pan or TP drain line. If heater were to fail water could fill basement area.

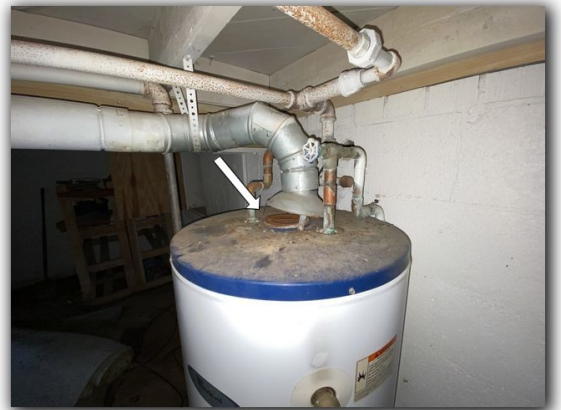
I observed where water heater draft hood appears to be displaced at time of inspection. Noted area obviously allowing conducive conditions for water heater exhaust to discharge into heater closet which could create possible fire hazard. Discharge into also creating conducive conditions for possible down draft without appropriate atmospheric pressure moving gasses to exterior allowing for possible elevated Carbon Monoxide build up. Recommend evaluation for obvious repairs allowing water heater to perform as safely as possible.

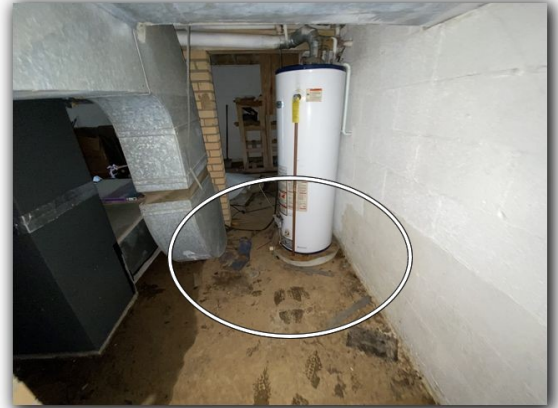
I observed where water heater located in basement sitting on floor at time of inspection. Water heaters having an ignition source should be elevated so that the source of ignition is not less than 18" above the garage / basement / stoarge floor unless entry door to garage cannot be opened. This is not the case with this heater and location. Vapors from these liquids are heavier than air and may concentrate just above floor level posing a possible explosion hazard in garages with a water heater. Recommend evaluation from qualified contractor for appropriate repairs allowing for normal and safe function

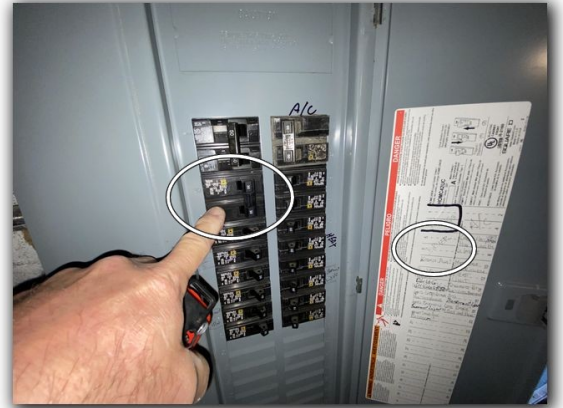
I observed where dryer receptacle does not appear to be working at time of inspection. Note: power on to dryer receptacle on panel. Recommend evaluation for repairs allowing receptacle to work as should.

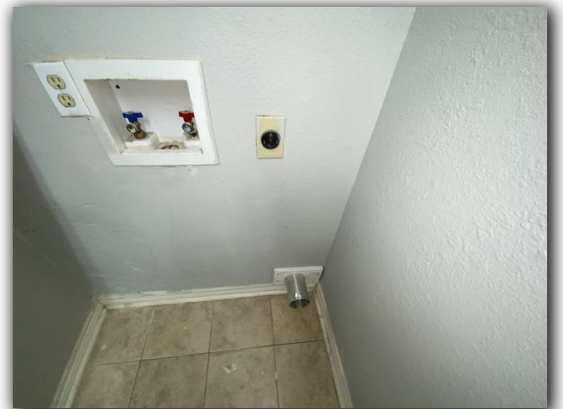
Dryer not connected at time of inspection.

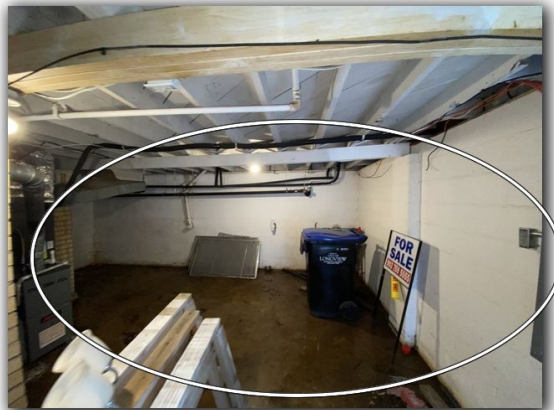
No ventilation in basement area

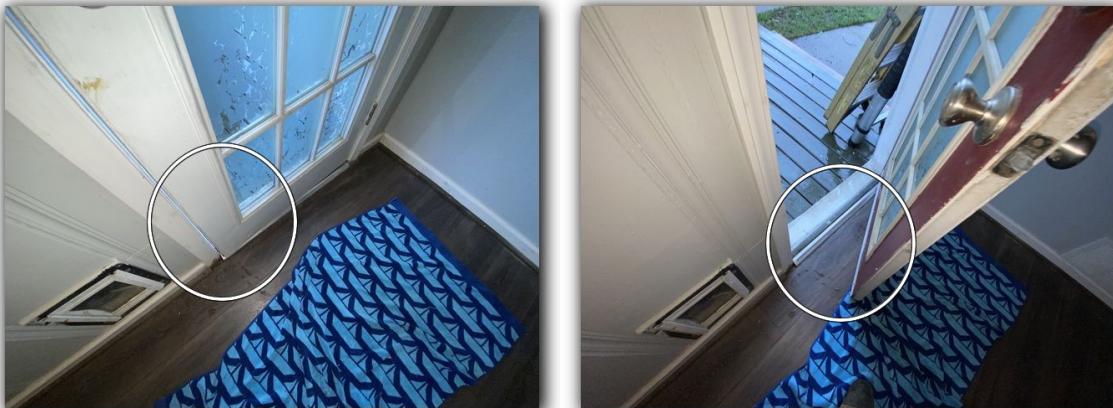
I observed where rear single entry / exit door near back of home found with door that appears to 'stick' when attempting to open/close at time of inspection. Recommend evaluation for possibly adjusting door(s) allowing door to work as should. Note: weather stripping near bottom of door may not be appropriate at time of inspection. Areas of weather stripping in place but inspector could still see day light near bottom of door when door closed.
