Home inspection for

PROPERTY INSPECTION REPORT

By: David Smith, Lic #21666 01/12/2023
(Name and License Number of Inspector) (Date)

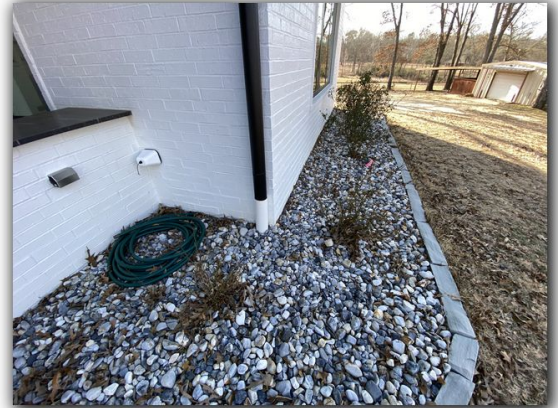
Views of grade around home

Comments: The general grading around the house foundation perimeter appears to function at time of inspection.

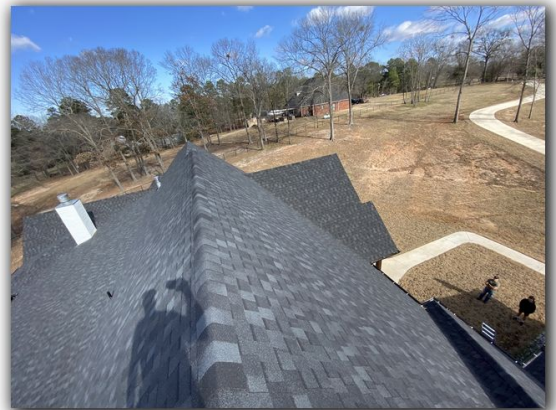
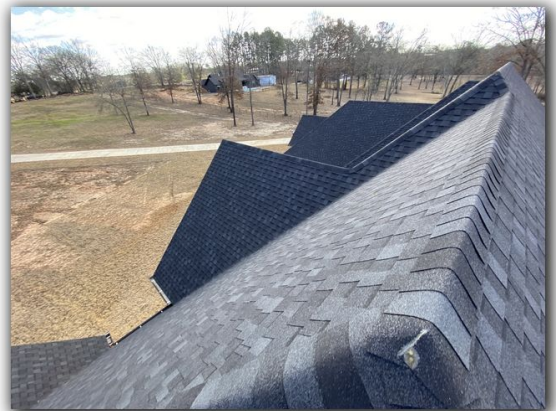
Views of roof area

This structure appears to have a possible 25-30 year asphalt shingle roof and was estimated to be in the 1st third of its life. The roof was inspected from walking roof level as well as portions of the roof being inspected from inside the attic space. **Any roofing deficiencies noted in this section should have qualified roofer / contractor evaluate for possible repairs if needed.**

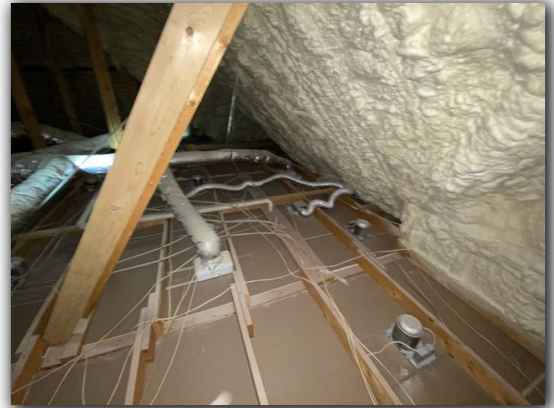
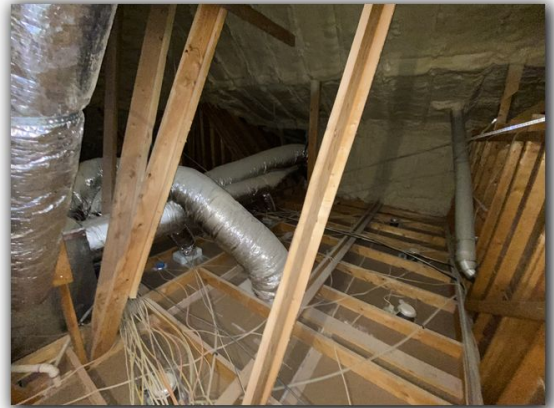
I observed where it appears attic ventilation may not sufficient at time of inspection. Soffit vents noted along exterior of home in garage area but no other means of air movement noted. Note: home presenting with spray foam application which does not allow / need ventilation in such areas. Garage area is conventional build and would need appropriate vertical ventilation. Without appropriate ventilation several things can occur. Poor ventilation could significantly reduce the life of the roof due to the excessive heat as well as lead to moisture build-up in the attic which can reduce the effectiveness of the insulation and/or lead to possible mold/mildew issues. Recommend evaluation of attic area for possible ventilation concerns.

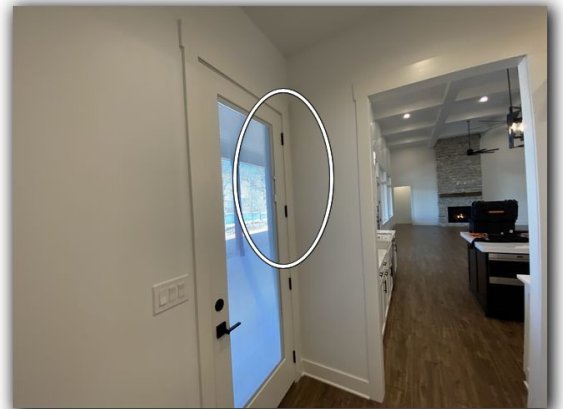
I observed where various doors in home did not present with door stops at time of assessment. This is not a deficiency but would be a great idea to have in place to keep doors from swinging open possibly striking wall near door.

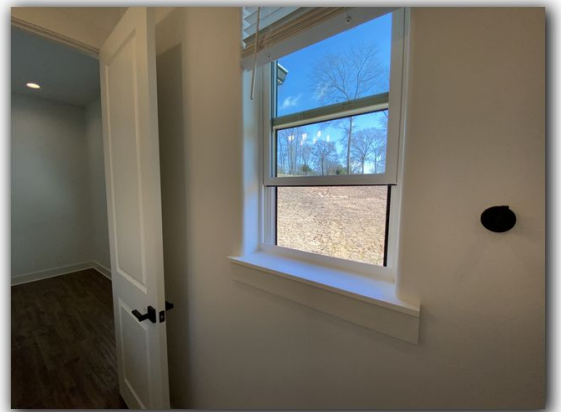
Views of windows open and operational

- Various screens missing on windows in home at time of inspection.

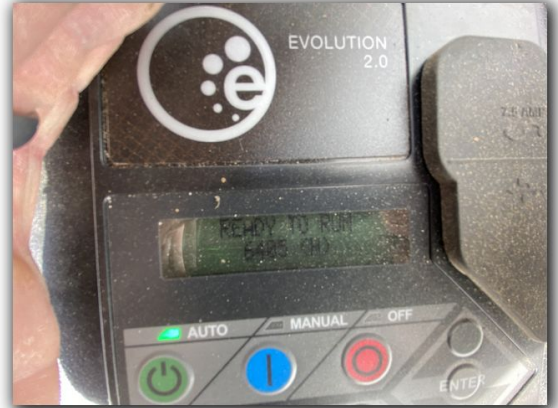
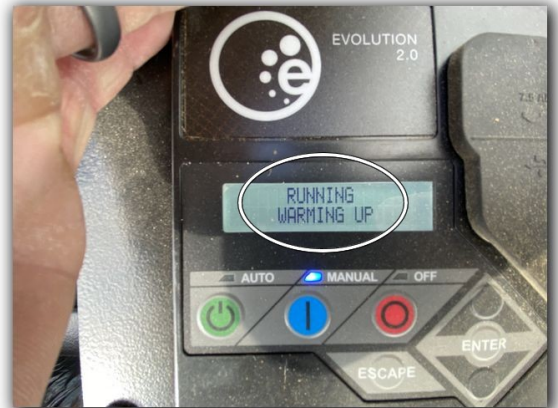
Generac 24 kw generator working as should.

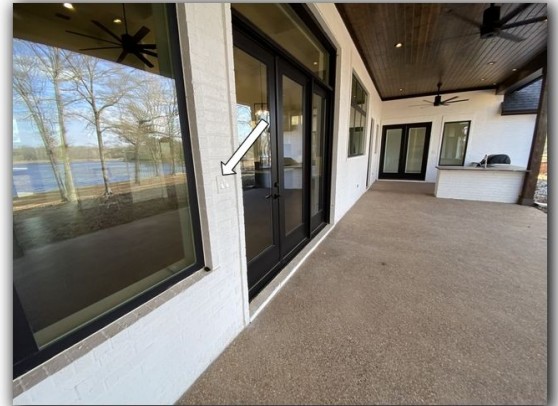
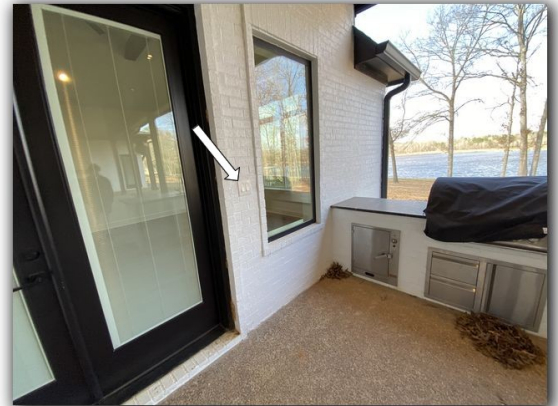
I observed where outdoor receptacle covers were missing at time of inspection. Recommend replacing with appropriate outdoor outlet cover that is watertight allowing for safe and normal use.

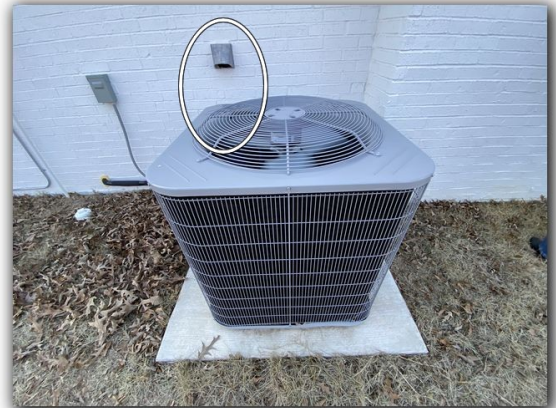
I observed where dryer vent discharge found within a few feet of outdoor condenser units at time of inspection. It is recognized that dryer vents terminate at least 6 feet away from outdoor unit. Reason is that dryer vent pushing heat and humidity at a unit that is trying to reject heat. Would consider possible air deflectors for dryer vent hoods that can DIVERT the exhaust from a dryer in any suitable direction.

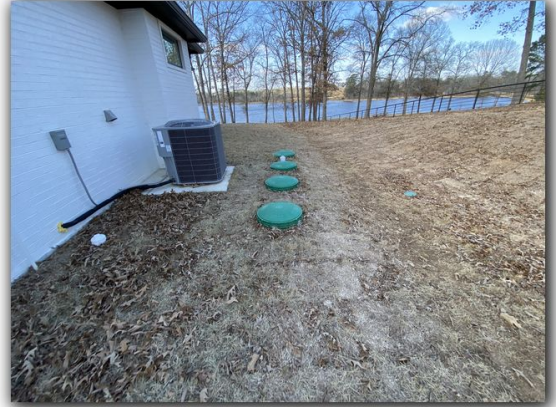
Comments: Volume test performed with water tub fixtures run for approx. 30 minutes at time of inspection with no noticeable visual or olfactory evidence of effluent seepage or flow at the surface of the ground.

Unable to verify aerobic system at time of inspection. Manual activation was not installed on unit at time of assessment. Volume test performed with water in all fixtures in home run for approximately 30 minutes. Possible that water flow was not enough to fill 1000 gallons worth of tanks found installed. Note: system should still be under warranty if needed.

Note: septic tank(s) should be pumped out every 2 to 4 years depending on type of system and family size. If it has been over two years consider having tank(s) pumped out.
