**David K. Smith**  
Professional Home Inspector Lic #21666

## PROPERTY INSPECTION REPORT

**Concerning:** \_\_\_\_\_, TX 75755  
(Address or Other Identification of Inspected Property)

**By:** David Smith, Lic #21666 05/01/2023  
(Name and License Number of Inspector) (Date)

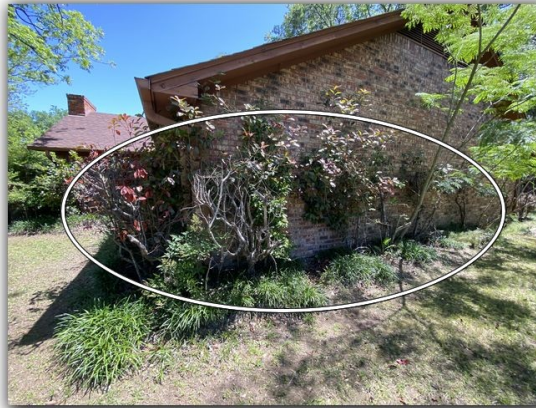
I observed where foliage found to be too close to the structure at time of inspection. It is recommended that bushes and vegetation should be at least 12 inches from wall contact. Recommend cutting or trimming noted vegetation allowing for appropriate barrier.

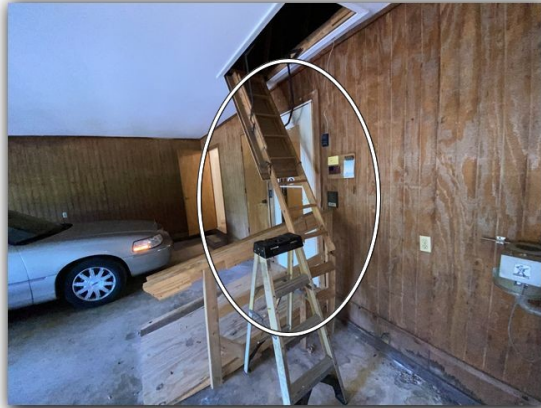
I observed attic could not be accessed without use of ladder at time of inspection. Ramp in place for home entry off garage keeping access door from fully extending as should. Recommend evaluation for possible repairs if needed.

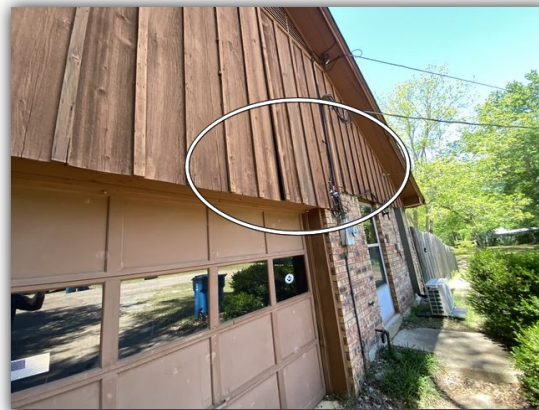
I observed various areas on exterior wood siding with minor openings noted at time of inspection. Areas noted create possible conducive conditions for water entry under the right conditions. Recommend evaluation for sealing noted gaps / separations with some fashion of water proofing material allowing home to work as efficiently as possible.

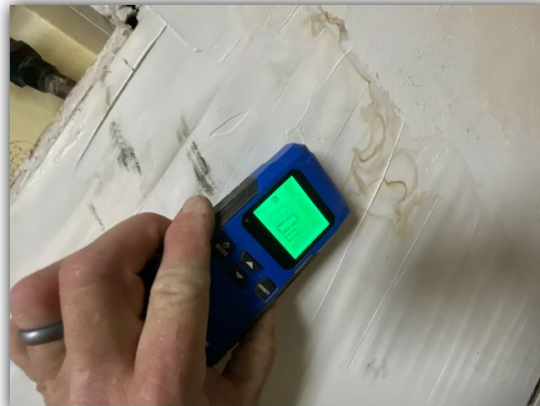
I observed an area of moisture staining noted in utility room at time of inspection. Further evaluation did not find any obvious evidence of moisture with moisture meter and thermal imager. Most likely leak with past washing machine connection that has since been removed. Recommend evaluation for repairs to damaged wall if desired monitoring noted areas for any noticeable changes.

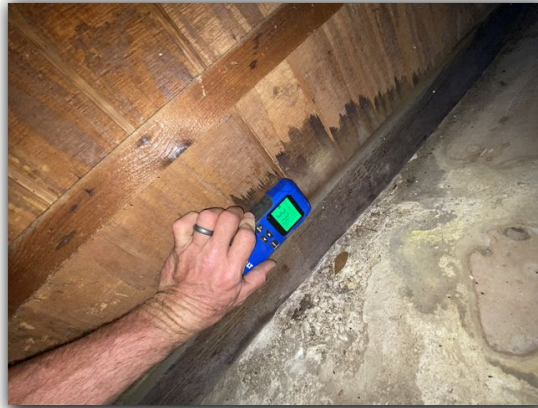
I observed an area of moisture staining noted in garage area at time of inspection. Further evaluation did not find any obvious evidence of moisture with moisture meter and thermal imager. No obvious areas for moisture from adjacent wall noted. Areas of damage to cement flooring most likely from some fashion of acid. Either from stored material or possibly batteries. Recommend evaluation for repairs to damaged wall if desired monitoring noted areas for any noticeable changes.

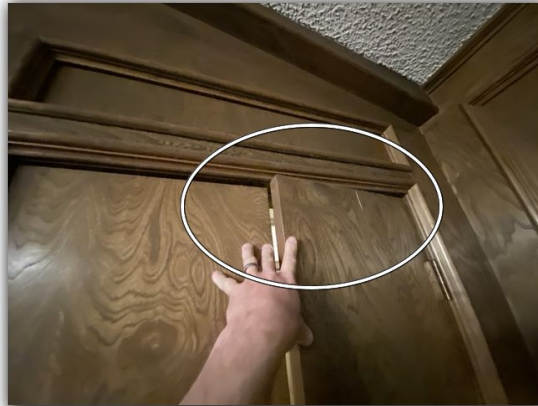
I observed where various doors in home appear to 'stick' when attempting to open/close at time of inspection. Recommend evaluation for possibly adjusting door(s) allowing door to work as should.

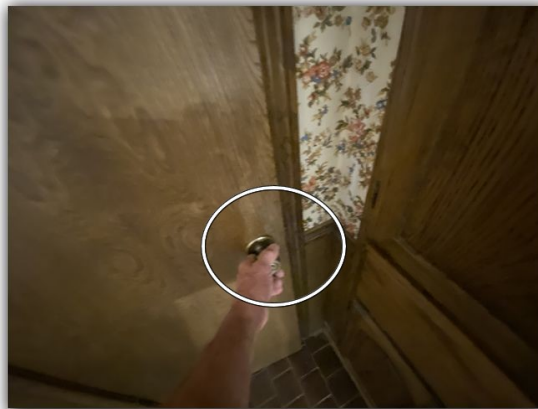
Master bathroom entry

I observed where ball assembly for double door found damaged at time of inspection. Typical when ball assembly loosens while in use. Note: inspector adjusted other door allowing ball assembly to work as should. Recommend evaluation for repairs allowing door(s) to work as

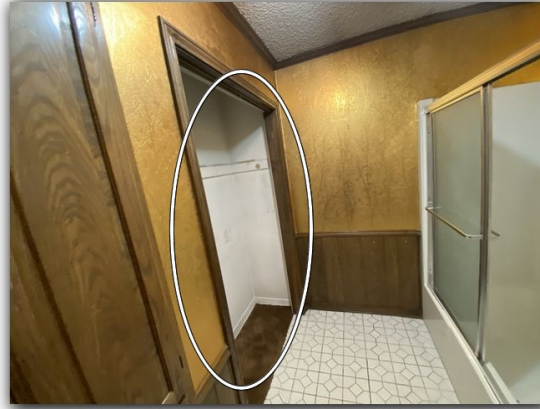
Hallway bathroom closet

I observed where various missing doors inside home at time of inspection.

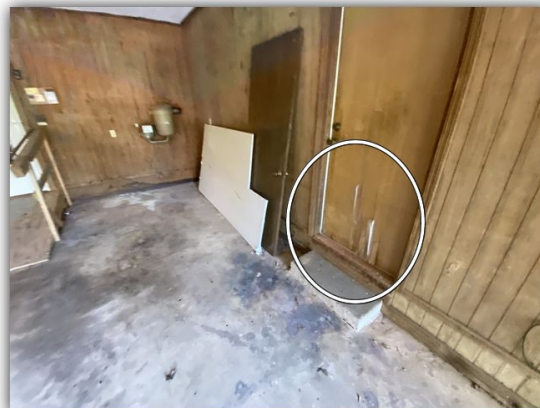
I observed various doors presenting with cosmetic damage at time of inspection.

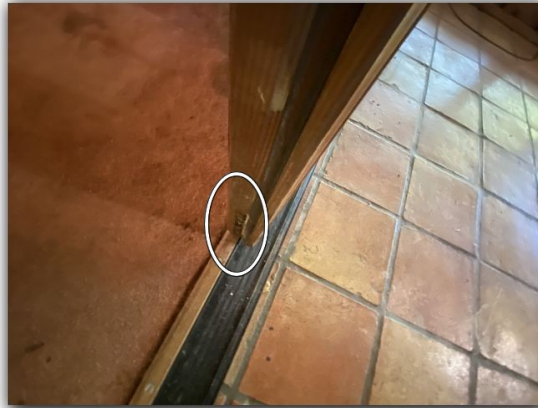
I observed where bottom flush bolt / lock would not engage / lock at time of inspection. Only top flush bolt working / locking as should. Recommend evaluation for possible repairs and/or replacement of damage flush bolt allowing door(s) to lock as should.

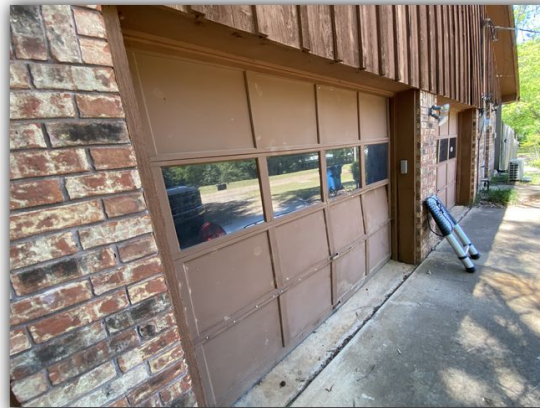
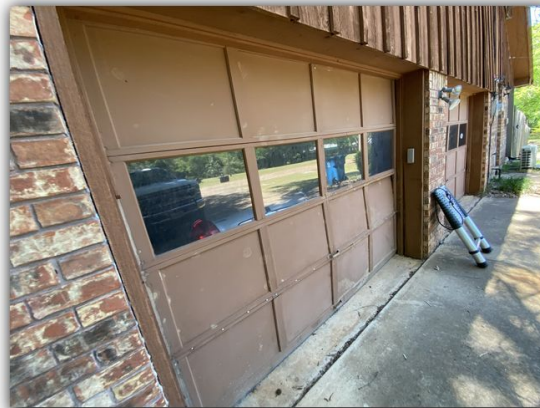
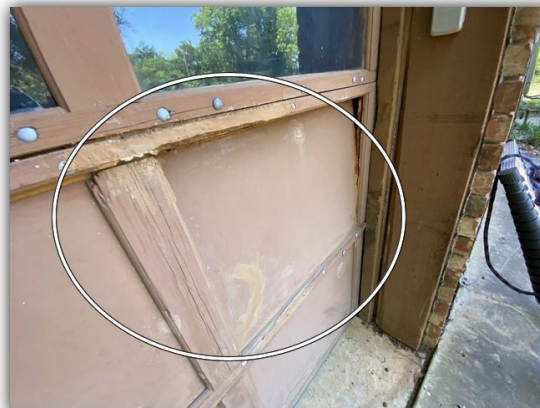
Type:  Metal  Wood  Fiberglass  Doors / panels are damaged

I observed areas of damage noted to at least 2 panels on outside garage door area at time of inspection. Damage appears to be cosmetic in nature. Note: garage door appears to perform as should with attempts. Recommend evaluation for repairs if desired monitoring for any noticeable changes.

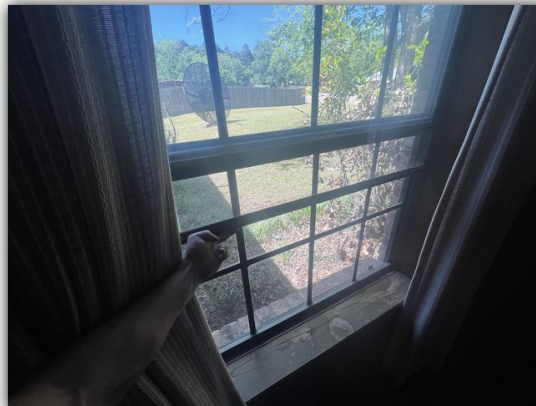
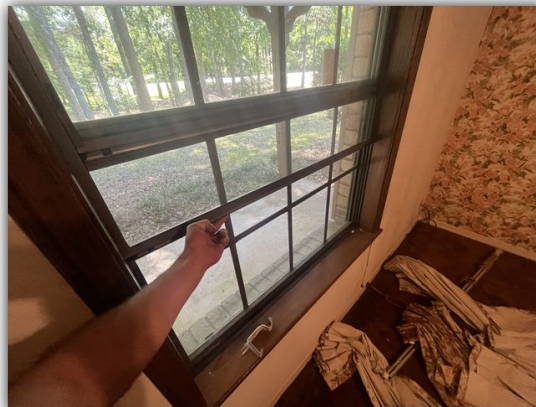
I observed where at least 2 bedroom window would not open at time of assessment. Possible that bottom latches need to be adjusted and/or tracks cleaned allowing unit to work as should. Windows in bedrooms / sleeping rooms should open allowing for functional emergency escape and rescue openings. Recommend evaluation for possible repairs if needed allowing for normal / safe function.

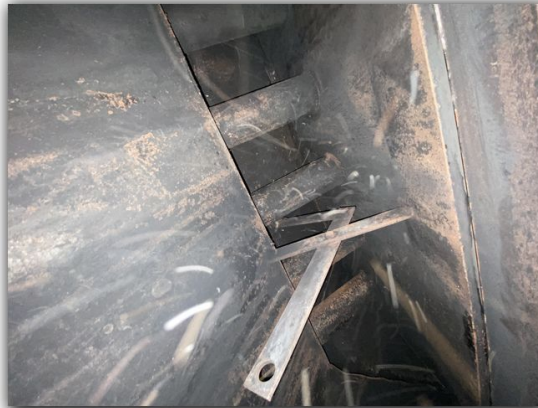
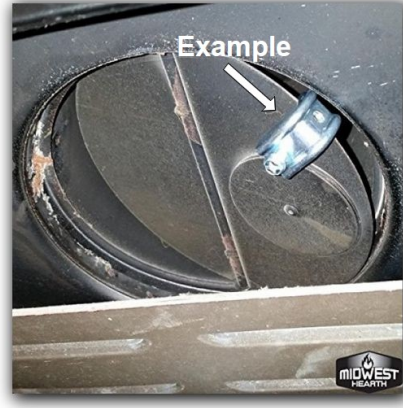
*Example of damper clamp*

I observed where gas log / insert fire place missing damper clamp at time of inspection. A damper clamp is recommended by code when artificial gas logs or a log lighter are present in an open fireplace. Damper clamps keep the chimney's damper from closing allowing dangerous gases to escape the firebox in the case of a gas leak.

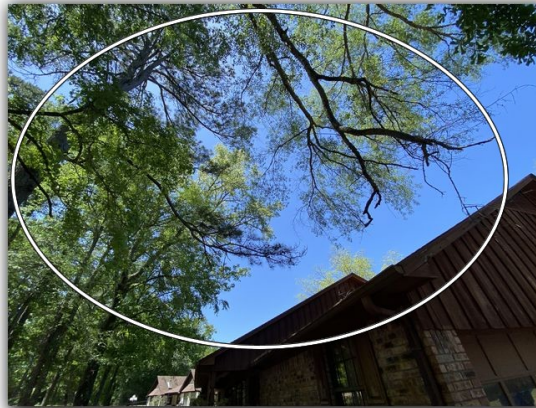
I observed where larger tree in front yard with obvious large limbs over home at time of inspection. Possible that falling limbs could come in contact with home / roof structure. Recommend possible evaluation from tree specialist / arborist to assess for possible removal of unsafe limbs if needed.

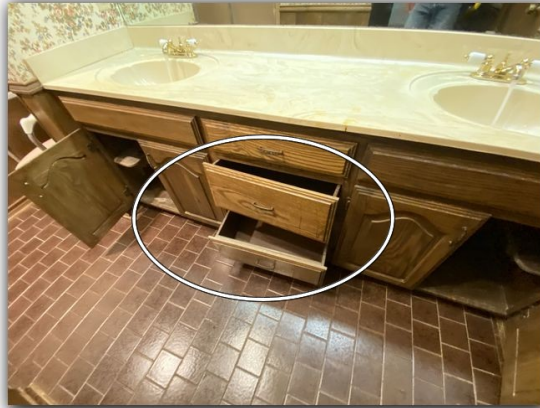
I observed where at least 2 drawers were off their tracks in master bathroom at time of inspection.

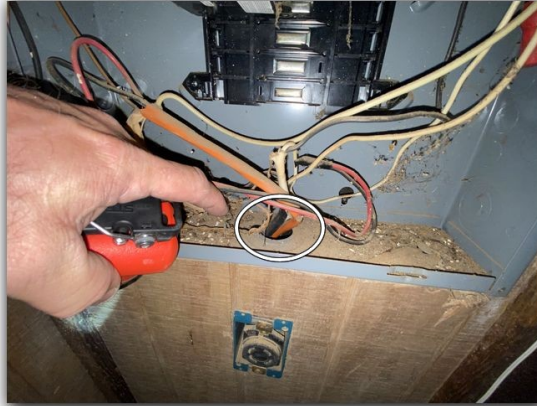
I observed wiring entering the panel without the proper protective bushing or grommets. Wiring that enters the panel should be solidly anchored and protected where it enters the panel by a bushing to prevent the sharp edges of the panel box from damaging the wiring and creating an equipment/safety hazard.

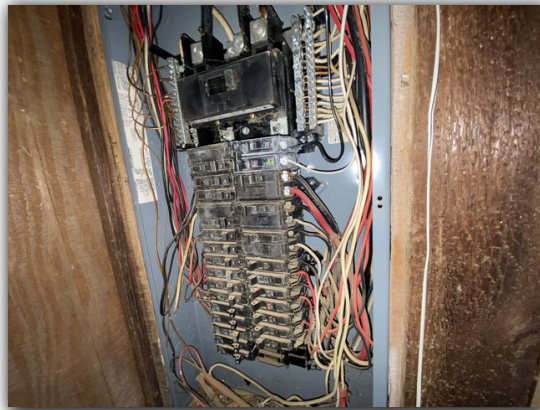
Buyer Advisory Notice: Today's building standards require that AFCI devices be used for all circuits serving family rooms, dining rooms, living rooms, parlors, libraries, dens, bedrooms, sunroom's, recreation rooms, closets, hallways, or similar rooms or areas. This may not have been required at the time of construction,

Please read the "Consumer Notice Concerning Hazards Or Deficiencies" document and the "Arc Fault Information" document located at the attachment page near the beginning of the report". Yours are not installed to today's standards .

Please read the OPI statement on the first page of this report! This home does not meet current arc-fault circuit-interrupter (AFCI) requirements. This is an "as-built" condition, Some items reported as Deficient may be considered upgrades to the property. For more information, refer to Texas Real Estate Consumer Notice Concerning Recognized Hazards, form OP-I.

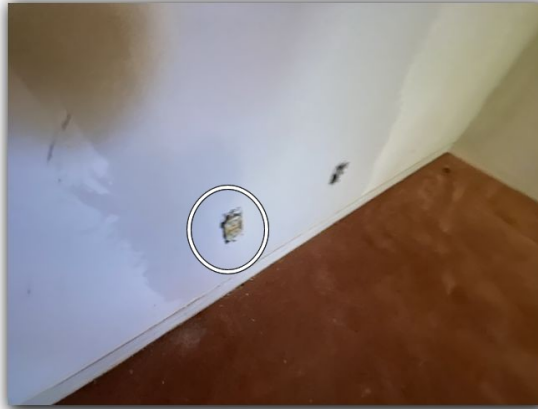
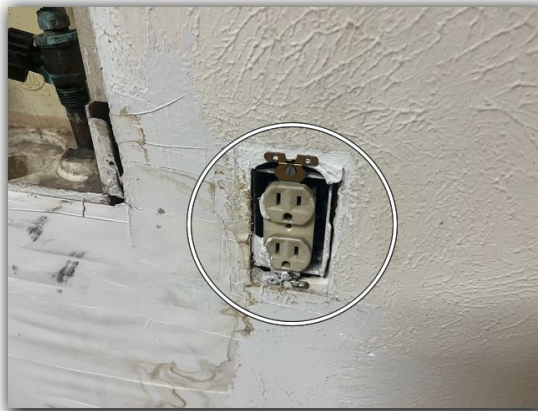
I observed various receptacles in home with missing face plates at time of inspection. Recommend evaluation for adding appropriate covers for added safety.

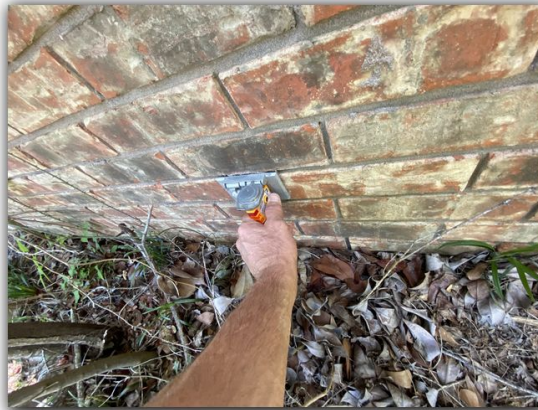
Missing GFCI protection on exterior of home

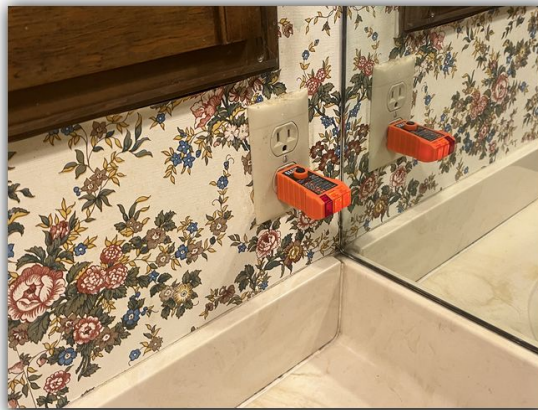
Missing GFCI protection in bathrooms

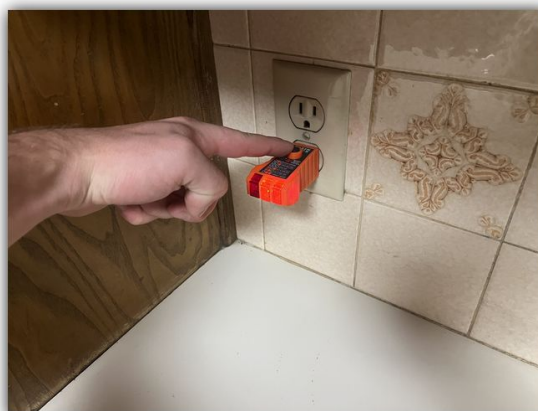
Missing GFCI protection in kitchen area

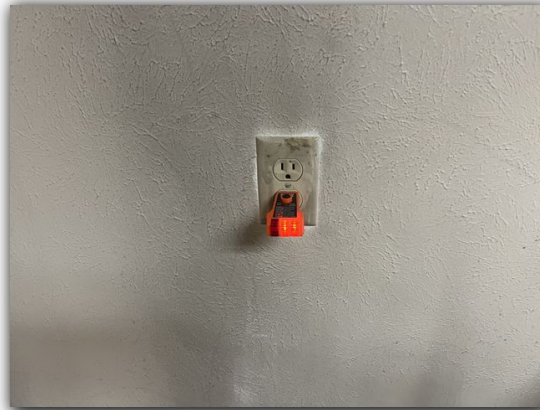
Utility room

No GFCI/ARC Fault protection at one or more location. This is considered a recognized safety hazard. GFCI protection was not provided in the home at locations where it now deemed necessary. GFCI protection may not have been required at the time the home was built, but for safety reasons it is recommended that GFCI protection be installed at all the following locations: • Bathrooms • Exterior • Garages • Crawlspace (at or below grade) • Unfinished basements • Kitchens • Laundry rooms • Within 6 feet of all plumbing fixtures. Recommend evaluation for possible repairs and / or replacement of deficient receptacles for added safety.

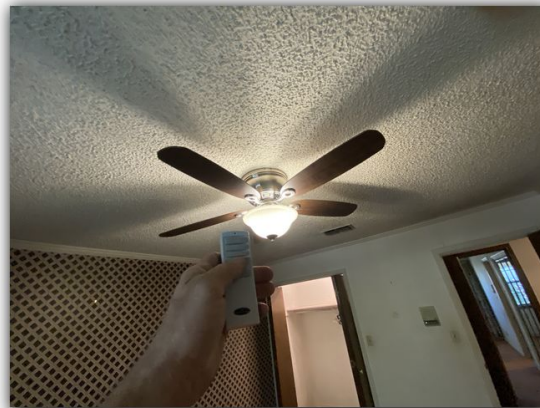
I observed where remote for front left bedroom ceiling fan did not have batteries at time of assessment. Inspector could not verify ceiling fan.

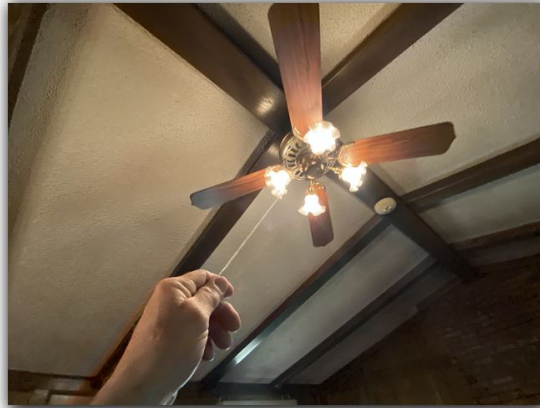
I observed where ceiling fan in living room was not working with attempts at time of inspection.

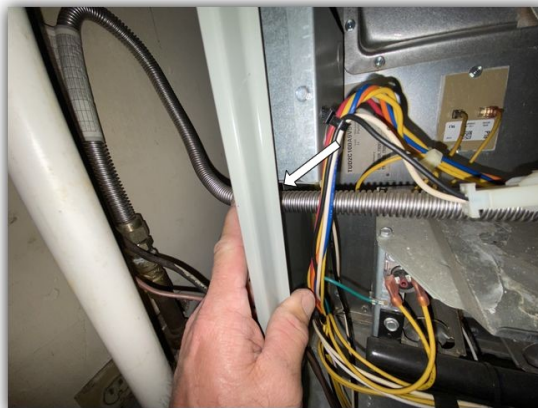
The gas supply flex connector was observed to be passing through the heating unit cabinet at time of inspection. Under today's current mechanical installation standards, this may no longer be an accepted practice. The gas connector flex line is thin wall tubing and as such any vibration from the the air handler rubbing on the connector could eventually result in a leak. **Note: grommet placed on flex line for protection may be as per manufacturer specifications.** A Recommendation is rigid black gas pipe passing through the heating unit cabinet.

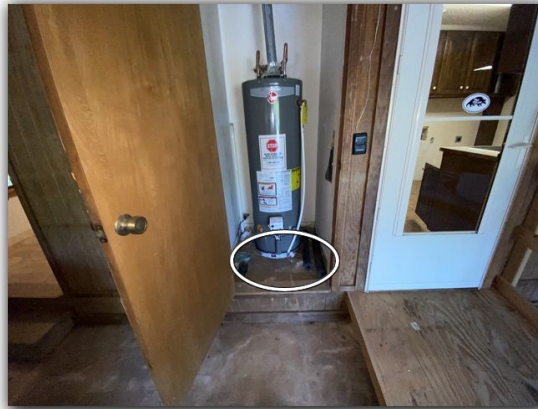
Note: water heater installed in garage area in utility closet. Technically speaking if heater were to fail for any reason water should terminate out of the garage with slope of garage floor. With that being said, the heater is elevated and shares a wall to living area so installation of pan that drains appropriately as well as Temperature Pressure relief drain line drained appropriately would be a consideration.

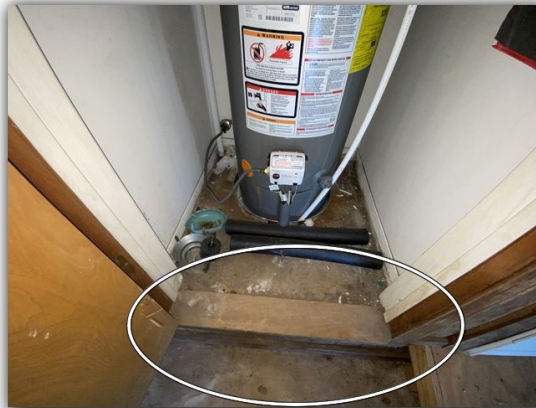
I observed where water heater located in closet installed with heater sitting on floor at time of inspection. Noted area with door that opens directly to garage area at time of assessment. Water heaters having an ignition source should be elevated so that the source of ignition is not less than 18" above the garage floor unless entry door to garage cannot be opened. This is not the case with this heater and location. Vapors from these liquids are heavier than air and may concentrate just above floor level posing a possible explosion hazard in garages with a water heater. Recommend evaluation from qualified contractor for appropriate repairs allowing for normal and safe function

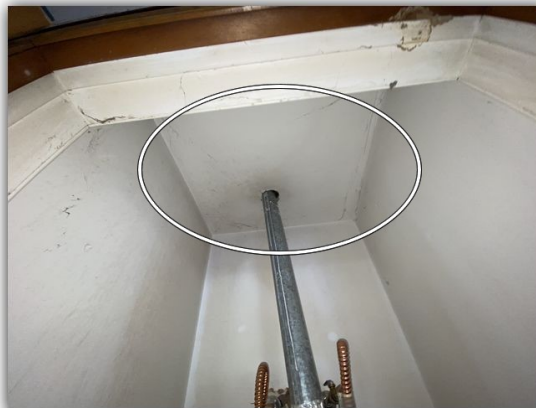
I observed where water heater located / installed inside interior closet at time of inspection. **Noted were no obvious openings for appropriate air movement. Typically confined space should be provided with at least two permanent openings communicating directly with on another allowing for sufficient air flow for normal combustion.** Enclosed area found creates conducive conditions for incomplete combustion creating possible elevated Carbon Monoxide numbers as well as allowing for possible down draft. Recommend evaluation for possible installation of some sort of vent system ( typically placed in door / ceiling ) allowing for at least 2 openings per manufacturer specification.

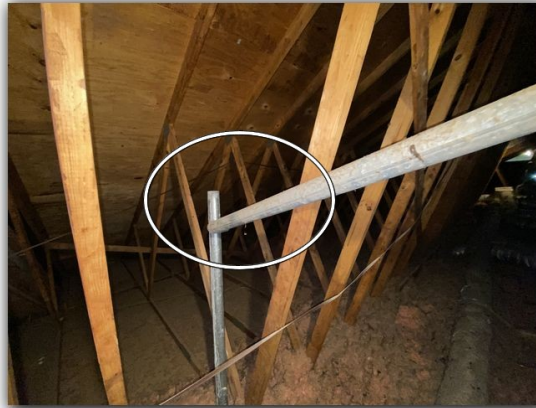
Note: this is common when home has new roof installed.

I observed where water heater exhaust flue appears to be displaced / separated / damaged in attic area at time of inspection. Noted area obviously allowing conducive conditions for water heater exhaust to discharge into attic area which could create possible fire hazard. Discharge into attic also creating conducive conditions for elevated carbon monoxide introduced creating unsafe and dangerous build up. Recommend evaluation for obvious repairs allowing water heater to perform as safely as possible.

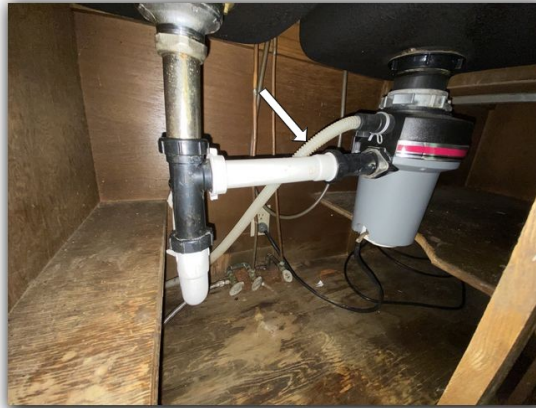
Example of correct installation

- I observed where dishwasher drain has been installed incorrectly. As it is now, wastewater from sink can be allowed to siphon into dishwasher. Recommend placing a high loop or air gap to prevent potential back flow contamination of the dishwasher.

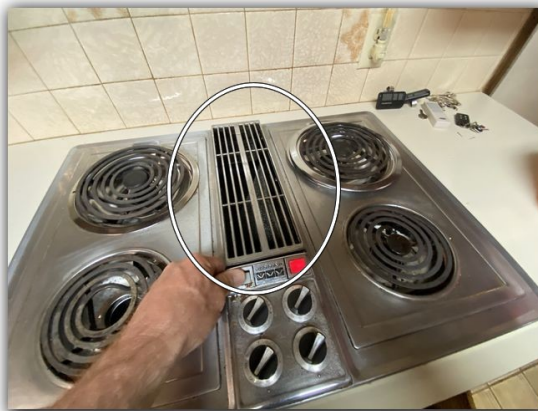
I observed where the range hood exhaust does not appear to be working with attempts at time of inspection.

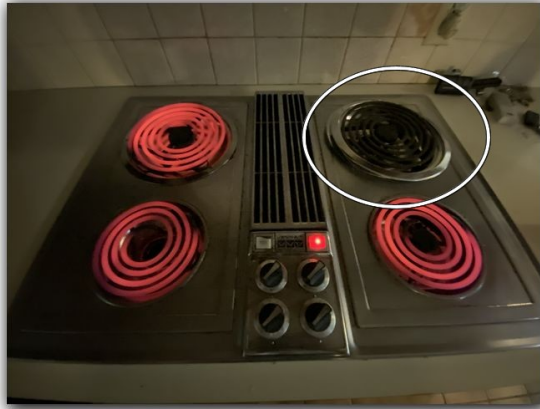
I observed where right rear burner may not be working appropriately at time of inspection.

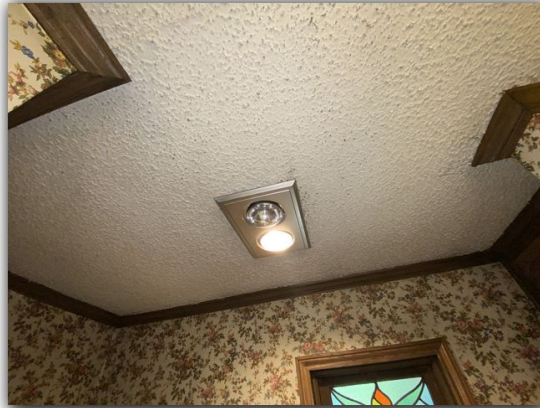
Bathroom heaters working as should.

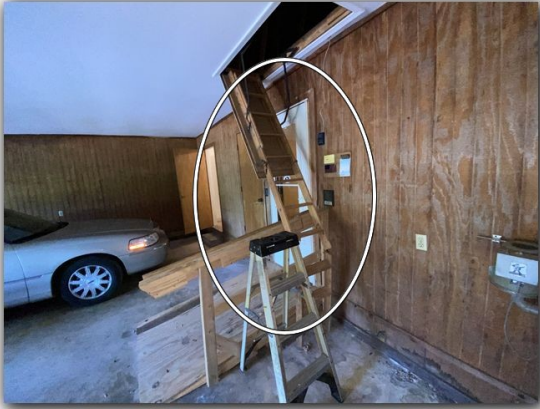
I observed attic could not be accessed without use of ladder at time of inspection. Ramp in place for home entry off garage keeping access door from fully extending as should. Recommend evaluation for possible repairs if needed.

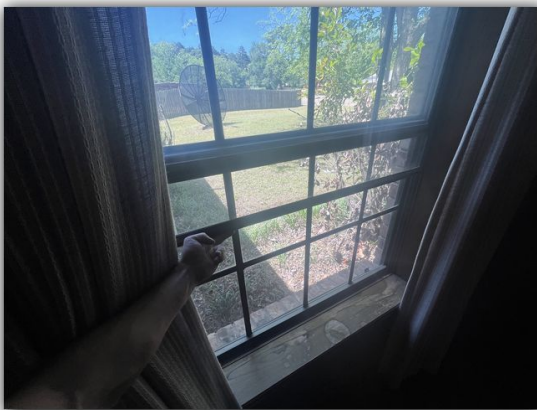
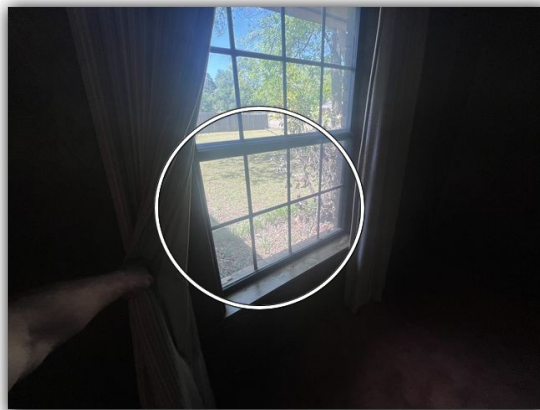
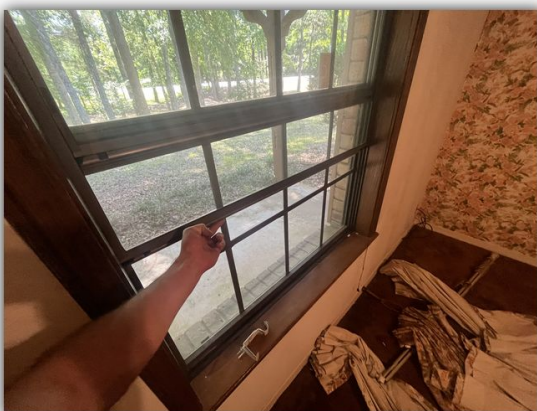
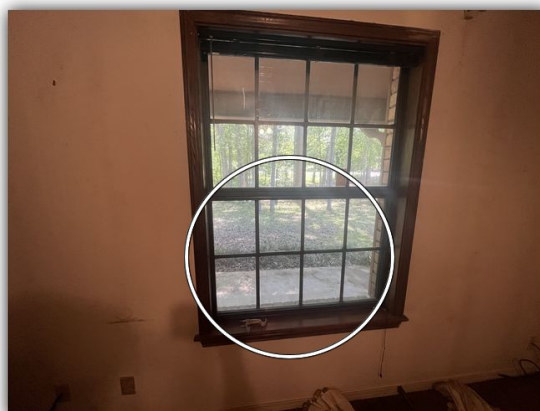
I observed where at least 2 bedroom window would not open at time of assessment. Possible that bottom latches need to be adjusted and/or tracks cleaned allowing unit to work as should. Windows in bedrooms / sleeping rooms should open allowing for functional emergency escape and rescue openings. Recommend evaluation for possible repairs if needed allowing for normal / safe function.

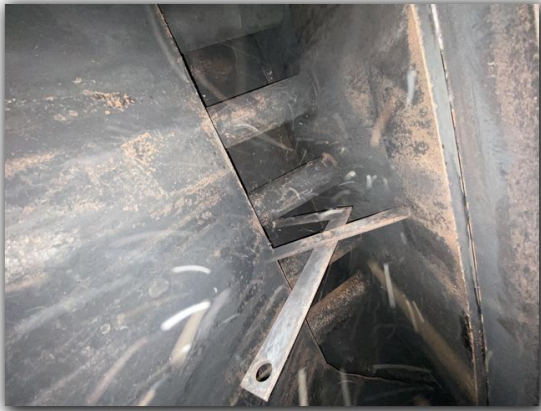
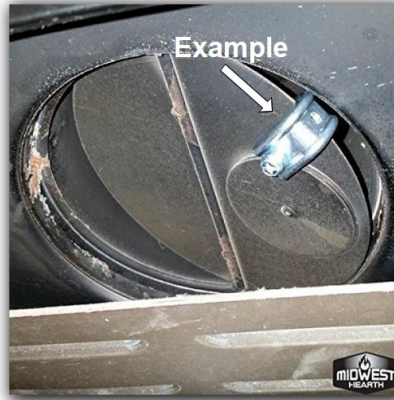
*Example of damper clamp*

- I observed where gas log / insert fire place missing damper clamp at time of inspection. A damper clamp is recommended by code when artificial gas logs or a log lighter are present in an open fireplace. Damper clamps keep the chimney's damper from closing allowing dangerous gases to escape the firebox in the case of a gas leak.

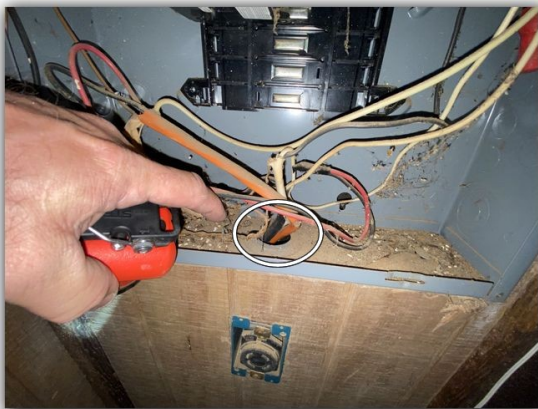
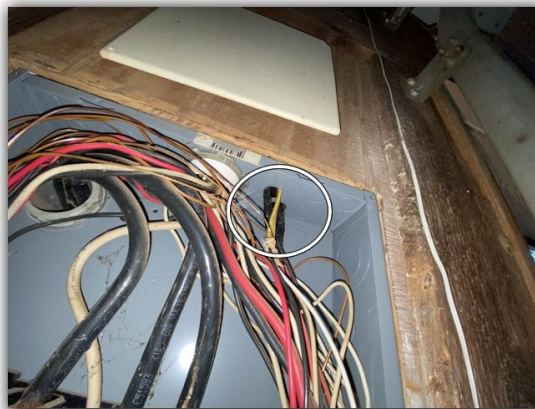
- I observed wiring entering the panel without the proper protective bushing or grommets. Wiring that enters the panel should be solidly anchored and protected where it enters the panel by a bushing to prevent the sharp edges of the panel box from damaging the wiring and creating an equipment/safety hazard.

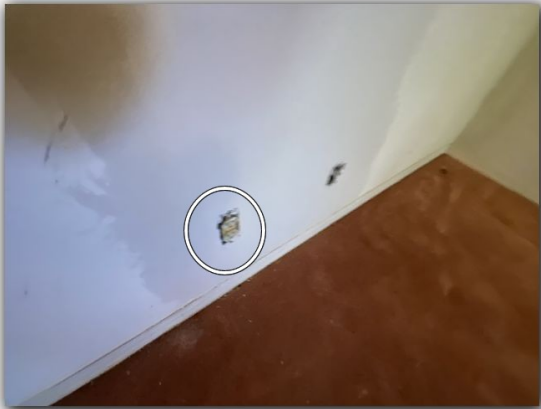
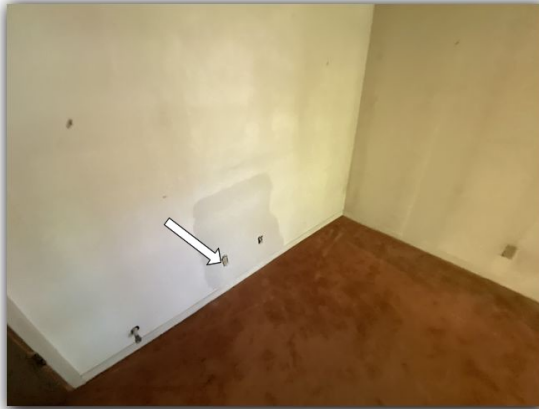
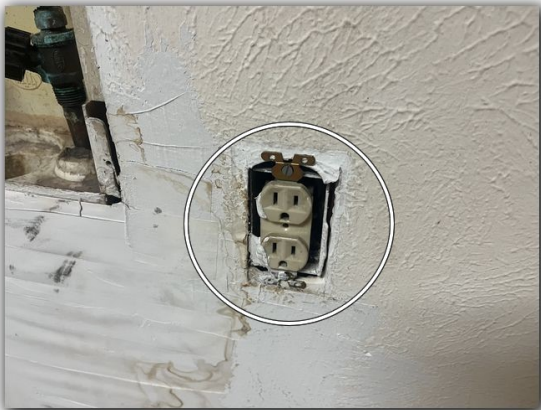
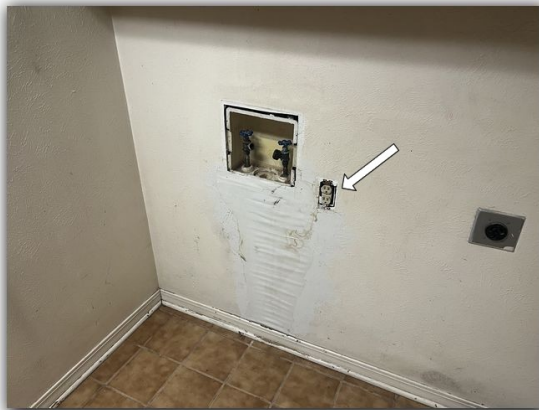
I observed various receptacles in home with missing face plates at time of inspection. Recommend evaluation for adding appropriate covers for added safety.

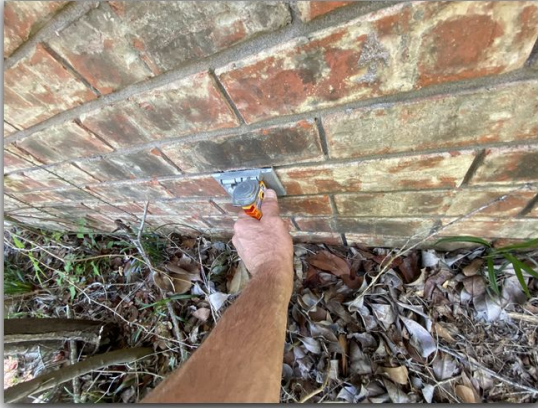
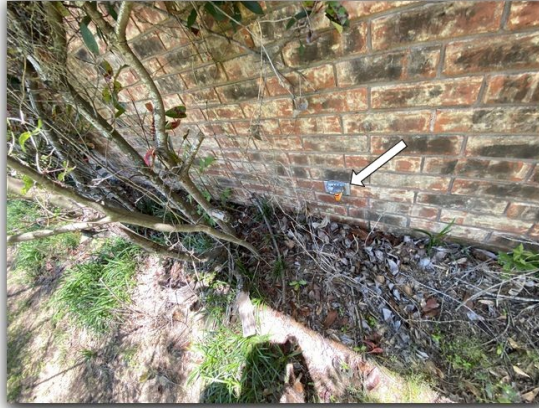
Missing GFCI protection on exterior of home

No GFCI/ARC Fault protection at one or more location. This is considered a recognized safety hazard. GFCI protection was not provided in the home at locations where it is now deemed necessary. GFCI protection may not have been required at the time the home was built, but for safety reasons it is recommended that GFCI protection be installed at all the following locations: • Bathrooms • Exterior • Garages • Crawlspace (at or below grade) • Unfinished basements • Kitchens • Laundry rooms • Within 6 feet of all plumbing fixtures. Recommend evaluation for possible repairs and / or replacement of deficient receptacles for added safety.

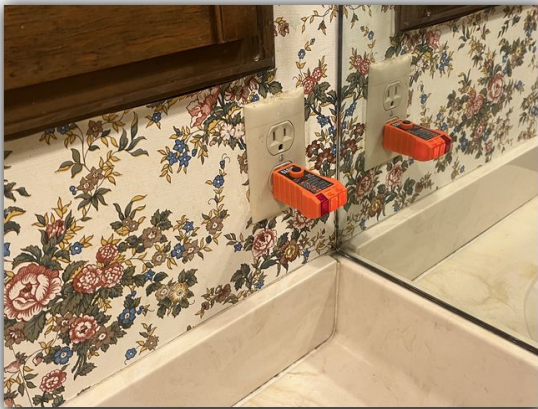
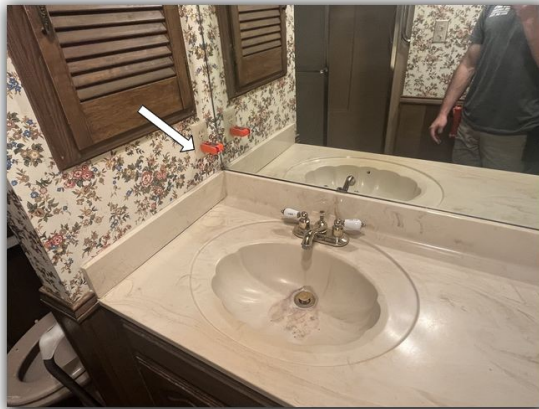
Missing GFCI protection in bathrooms

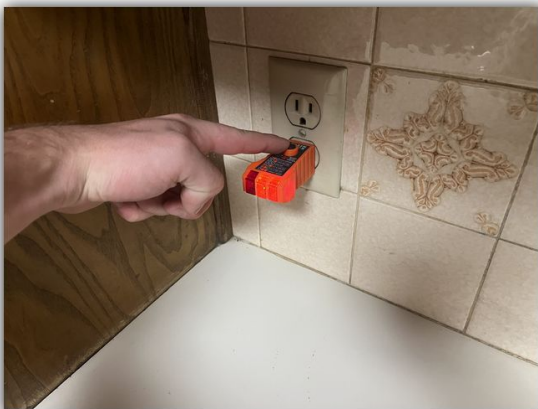
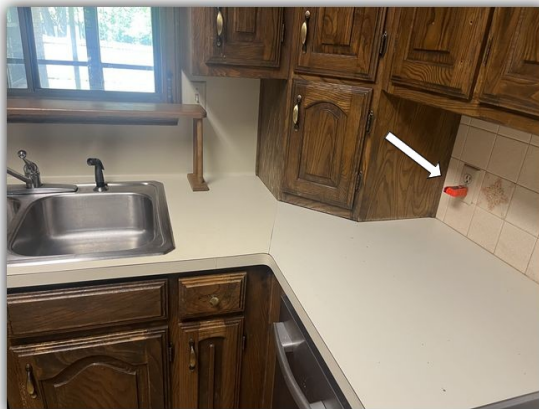
Missing GFCI protection in kitchen area

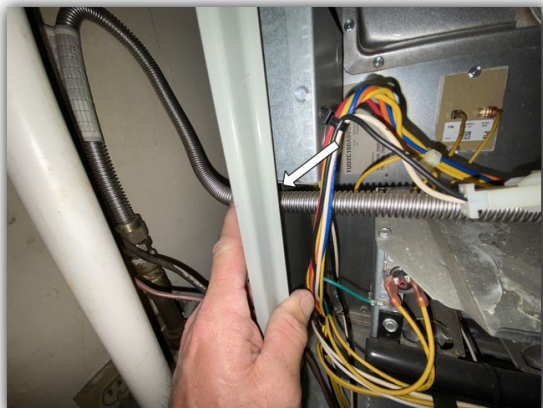
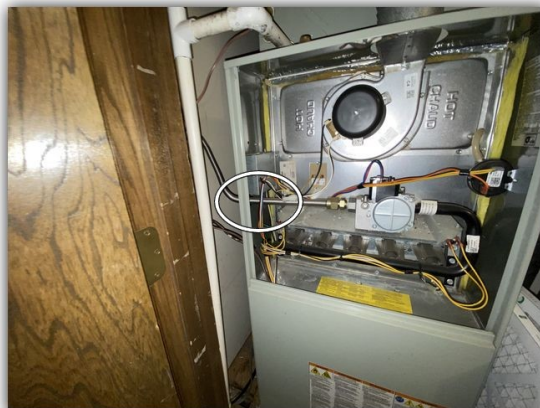
The gas supply flex connector was observed to be passing through the heating unit cabinet at time of inspection. Under

today's current mechanical installation standards, this may no longer be an accepted practice. The gas connector flex line is thin wall tubing and as such any vibration from the the air handler rubbing on the connector could eventually result in a leak. **Note: grommet placed on flex line for protection may be as per manufacturer specifications.** A Recommendation is rigid black gas pipe passing through the heating unit cabinet.

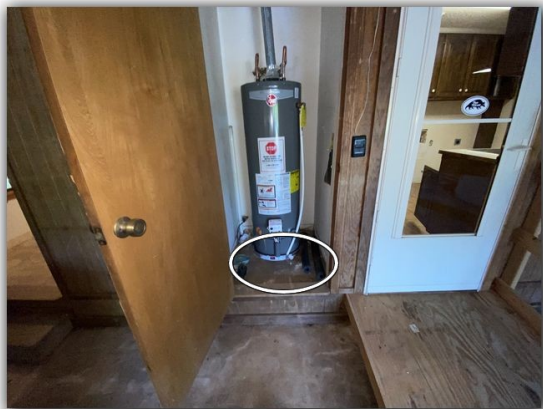
Comments: Performing as it should at time of inspection with deficiencies noted.

Note: water heater installed in garage area in utility closet. Technically speaking if heater were to fail for any reason water should terminate out of the garage with slope of garage floor. With that being said, the heater is elevated and shares a wall to living area so installation of pan that drains appropriately as well as Temperature Pressure relief drain line drained appropriately would be a consideration.

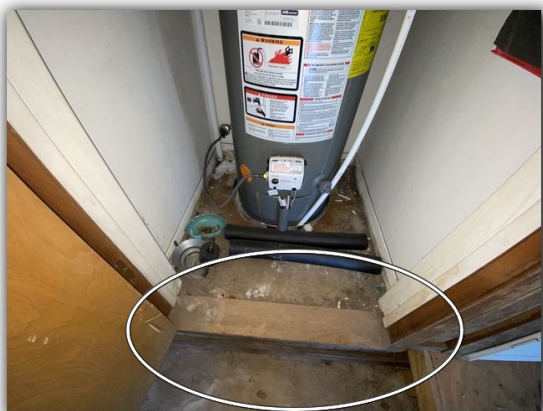
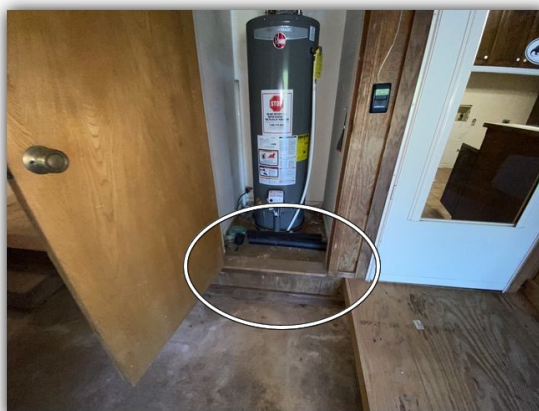
I observed where water heater located in closet installed with heater sitting on floor at time of inspection. Noted area with door that opens directly to garage area at time of assessment. Water heaters having an ignition source should be elevated so that the source of ignition is not less than 18" above the garage floor unless entry door to garage cannot be opened. This is not the case with this heater and location. Vapors from these liquids are heavier than air and may concentrate just above floor level posing a possible explosion hazard in garages with a water heater. Recommend evaluation from qualified contractor for appropriate repairs allowing for normal and safe function

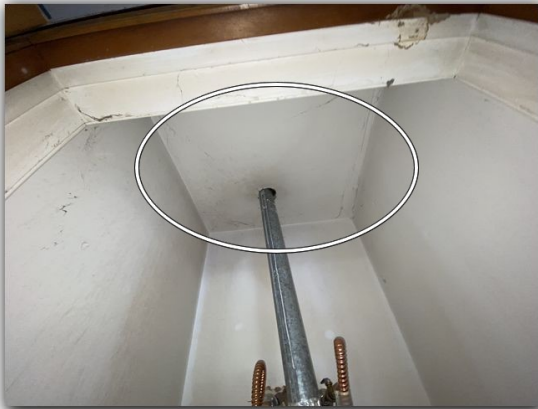
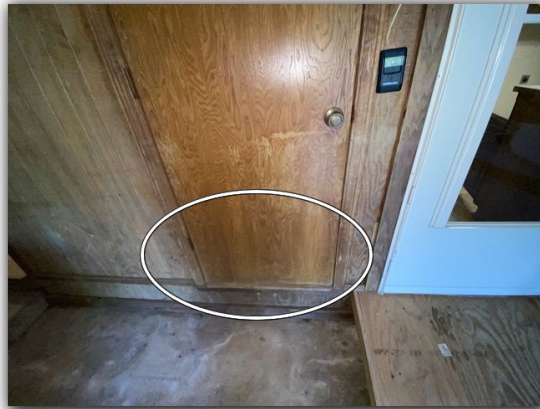
I observed where water heater located / installed inside interior closet at time of inspection. **Noted were no obvious openings for appropriate air movement. Typically confined space should be provided with at least two permanent openings communicating directly with on another allowing for sufficient air flow for normal combustion.** Enclosed area found creates conducive conditions for incomplete combustion creating possible elevated Carbon Monoxide numbers as well as allowing for possible down draft. Recommend evaluation for possible installation of some sort of vent system ( typically placed in door / ceiling ) allowing for at least 2 openings per manufacturer specification.

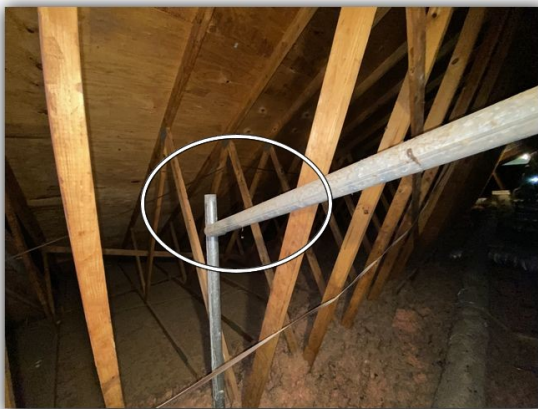
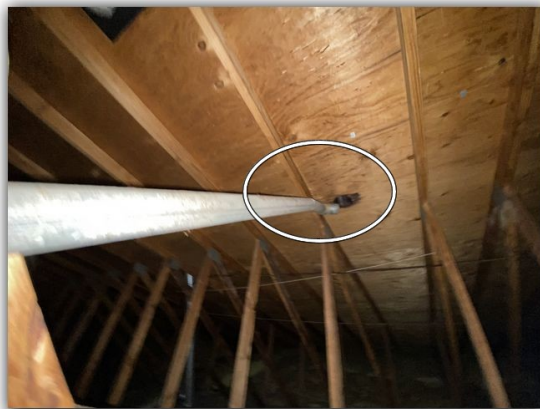
Note: this is common when home has new roof installed.

I observed where water heater exhaust flue appears to be displaced / separated / damaged in attic area at time of inspection. Noted area obviously allowing conducive conditions for water heater exhaust to discharge into attic area which could create possible fire hazard. Discharge into attic also creating conducive conditions for elevated carbon monoxide introduced creating unsafe and dangerous build up. Recommend evaluation for obvious repairs allowing water heater to perform as safely as possible.

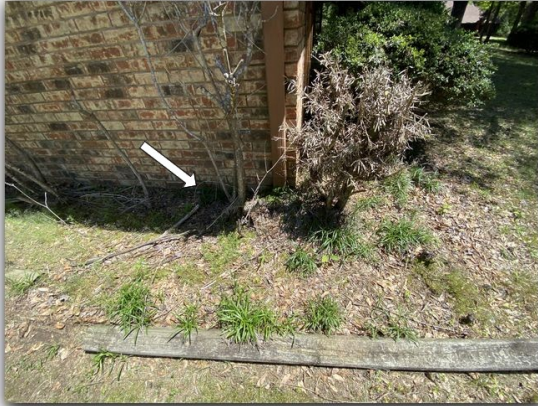
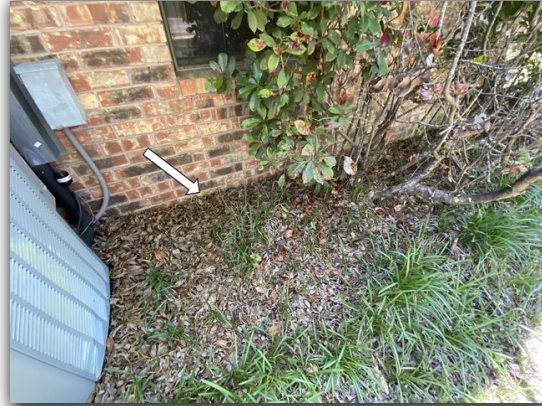
☑ Soil levels against the exterior grade are considered to be too high at the time of inspection. When soil levels are high against the face of the foundation it promotes water penetration of the structure and insect infestation. This item should be corrected so there is some exposure of the foundation face. It is generally accepted that a brick veneer house should have about 4 inches of clearance. Wood siding houses should have approximately 6 inches of clearance.

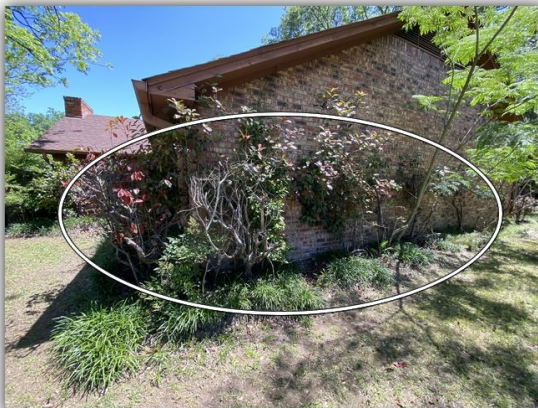
☑ I observed where foliage found to be too close to the structure at time of inspection. It is recommended that bushes and vegetation should be at least 12 inches from wall contact. Recommend cutting or trimming noted vegetation allowing for appropriate barrier.

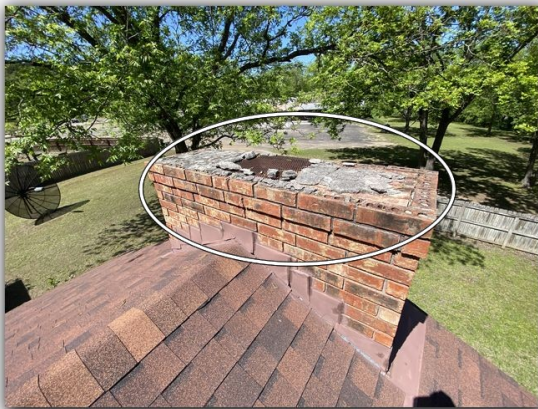
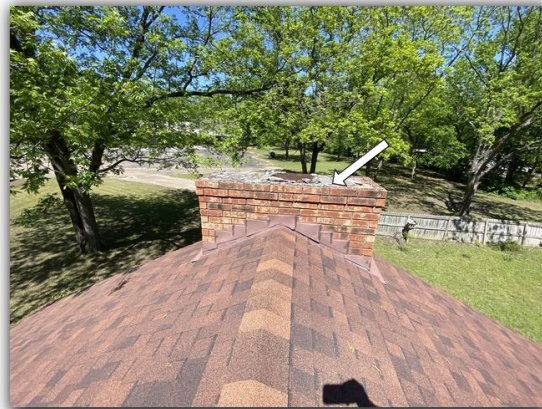
☑ I observed where the chimney was missing its chimney cap at the time of inspection. The cap is needed to obviously keep rain water from making entry into chimney which can lead to many components of damage to chimney as well as unpleasant odors. Cap also keeps animals out, reduces wind down drafts, and is also a spark arrestor. Recommend evaluation for possible repaired or replaced.

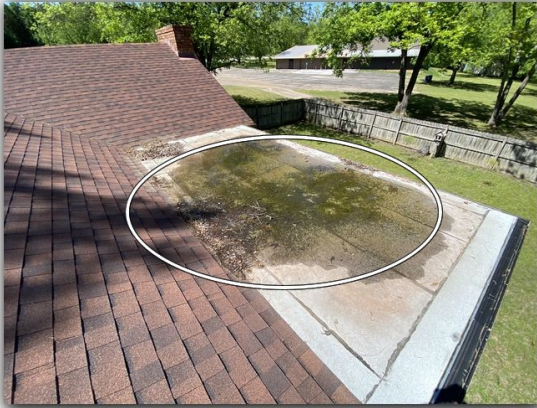
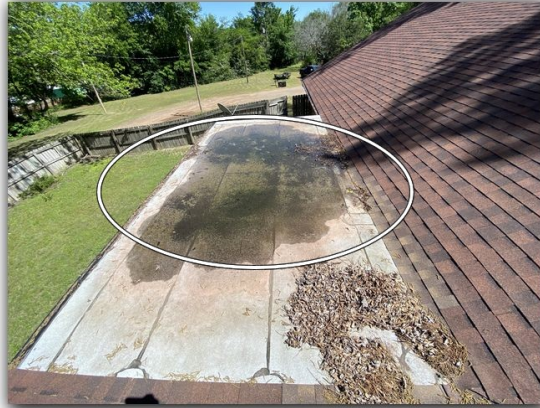
☑ I observed an area over back porch with obvious pooled water at time of inspection. Rolled / bitumen roofing normally used on any grade of roof less than 2 pitch as should. Area presenting with flat roof which has allowed for pooling water. Noted water could eventually work its way through seams allowing for moisture entry onto wood decking and supports below affected areas. Also noted is the mechanical weight associated with water and debris. Recommend evaluation for repairs allowing roof area to drain water off as should.

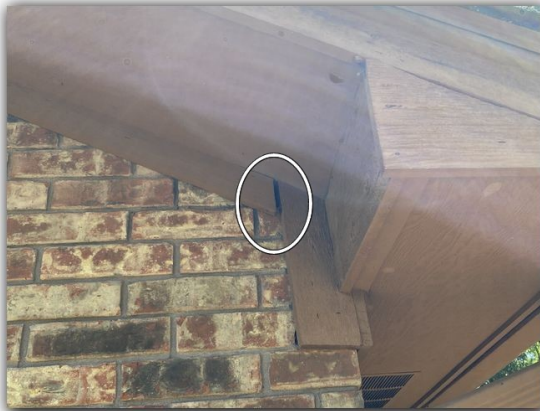
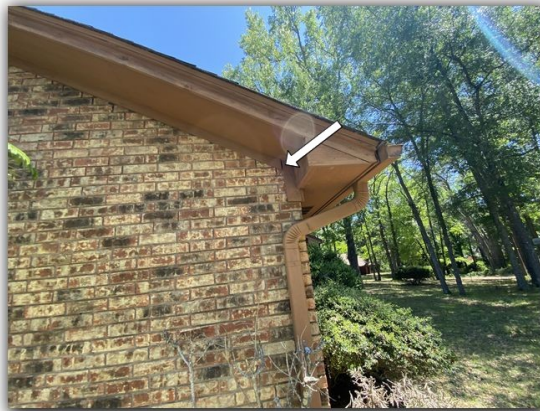
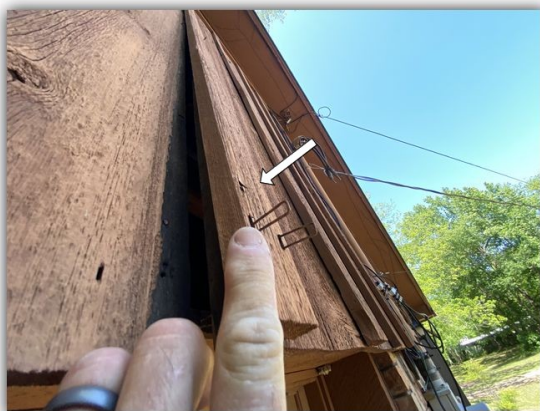
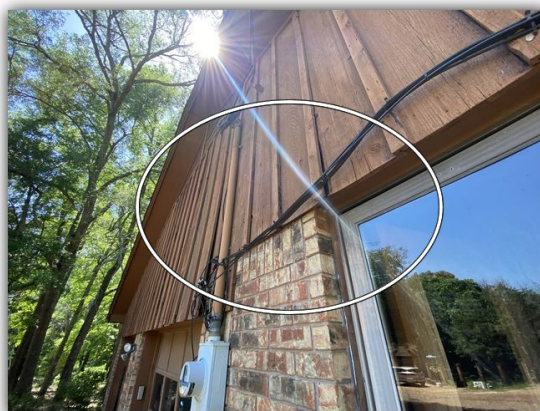
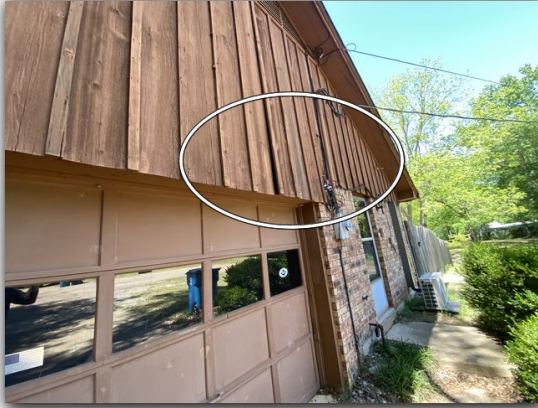
☑ I observed various areas on exterior wood siding with minor openings noted at time of inspection. Areas noted create possible conducive conditions for water entry under the right conditions. Recommend evaluation for sealing noted gaps / separations with some fashion of water proofing material allowing home to work as efficiently as possible.

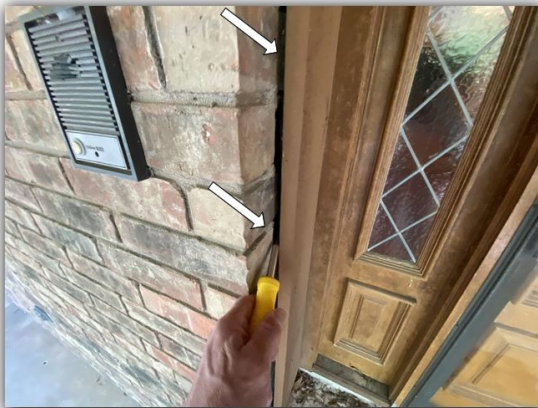
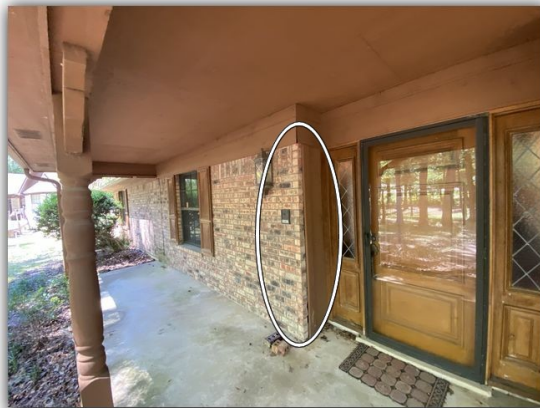
☑ I observed gaps / separations noted near front porch / door trim surround(s) at time of inspection. Appears that trim board has dried and turned a bit creating noted opening. Area possible that brick has settled allowing for minor separation as well. Recommend sealing gap with some fashion of weather proofing material ( silicone ) keeping water from possibly making entry in walls behind trim / veneer.
