**David K. Smith**  
Professional Home Inspector Lic #21666

## PROPERTY INSPECTION REPORT

**Concerning:** \_\_\_\_\_, TX 75755  
(Address or Other Identification of Inspected Property)

**By:** David Smith, Lic #21666 05/01/2023  
(Name and License Number of Inspector) (Date)

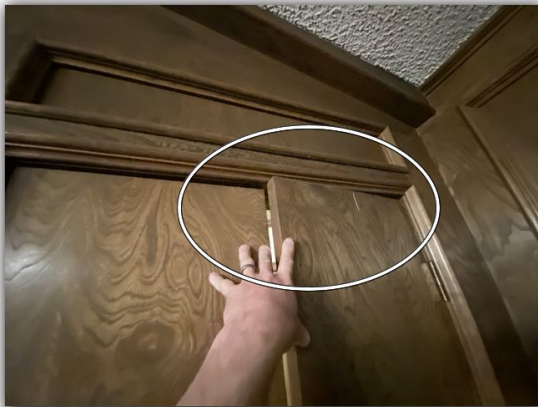
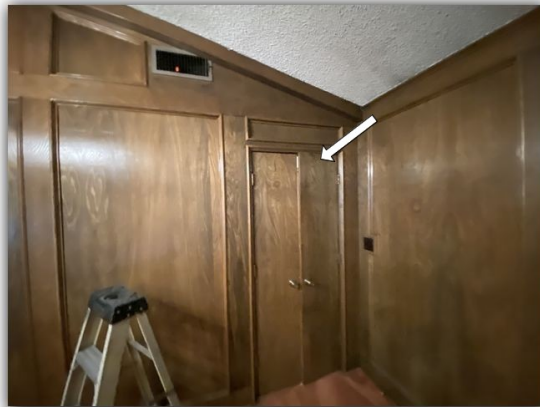
☑ I observed where various doors in home appear to 'stick' when attempting to open/close at time of inspection. Recommend evaluation for possibly adjusting door(s) allowing door to work as should.

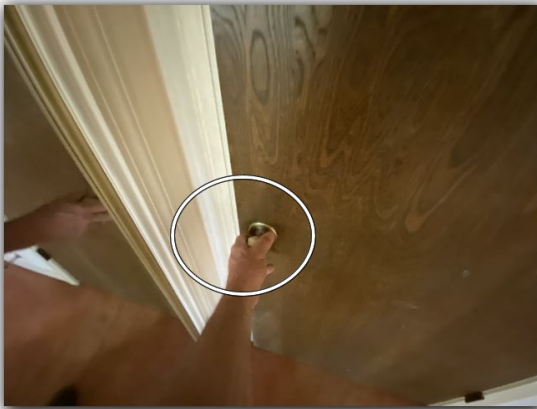
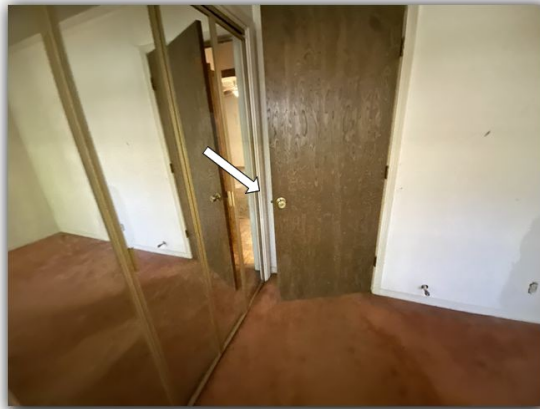
Master bedroom entry

I observed where ball assembly for double door found damaged at time of inspection. Typical when ball assembly loosens while in use. Note: inspector adjusted other door allowing ball assembly to work as should. Recommend evaluation for repairs allowing door(s) to work as should.

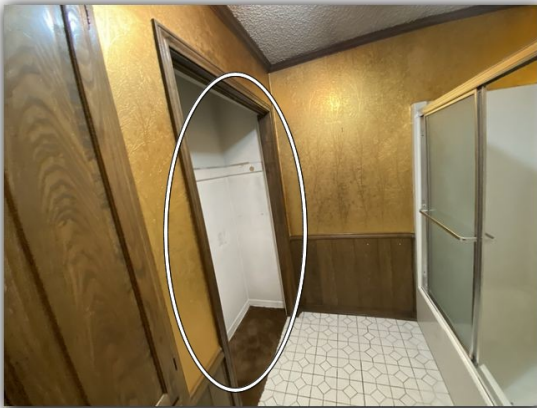
Hallway bathroom closet

I observed where various missing doors inside home at time of inspection.

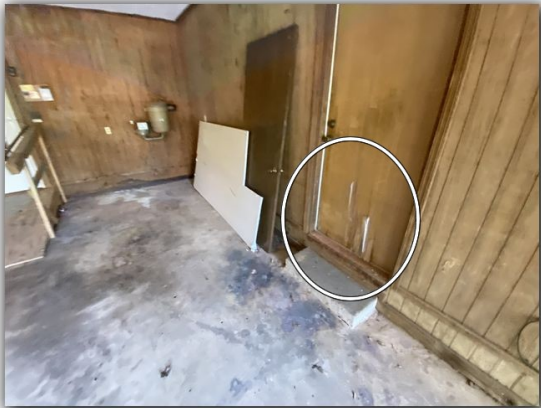
I observed various doors presenting with cosmetic damage at time of inspection.

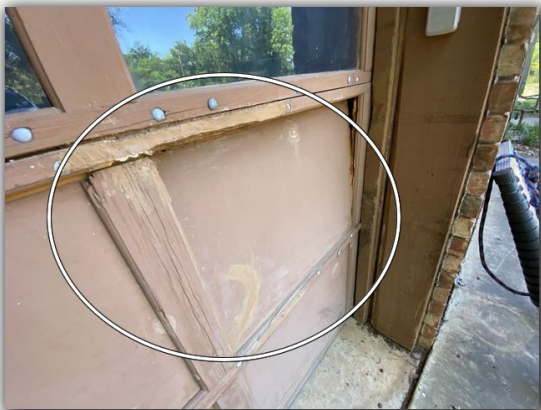
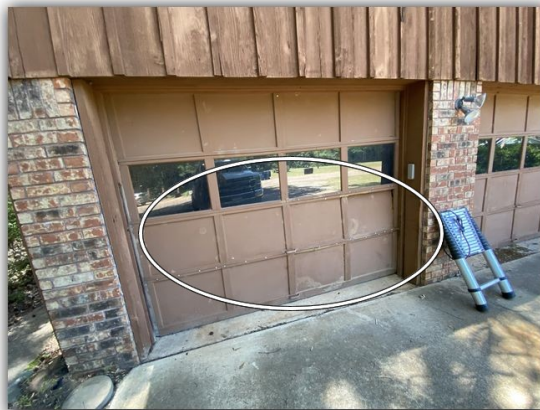
I observed areas of damage noted to at least 2 panels on outside garage door area at time of inspection. Damage appears to be cosmetic in nature. Note: garage door appears to perform as should with attempts. Recommend evaluation for repairs if desired monitoring for any noticeable changes.

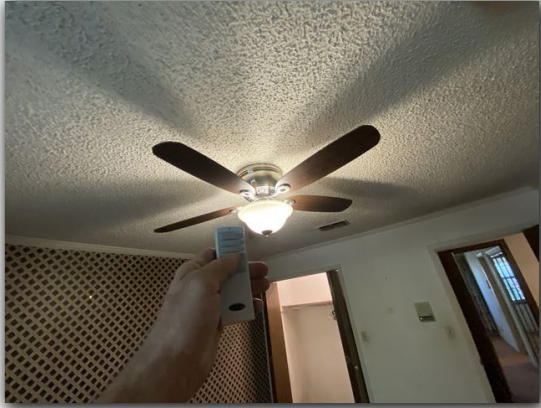
I observed where remote for front left bedroom ceiling fan did not have batteries at time of assessment. Inspector could not verify ceiling fan.

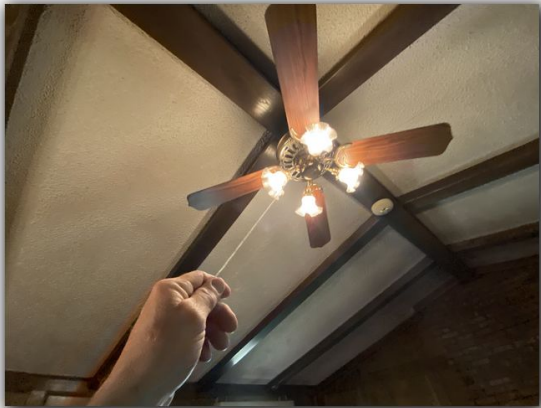
I observed where ceiling fan in living room was not working with attempts at time of inspection.

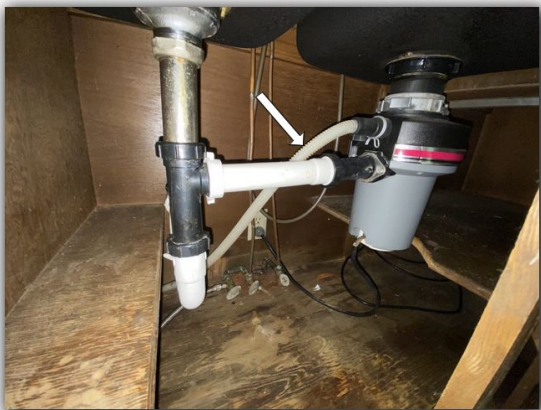
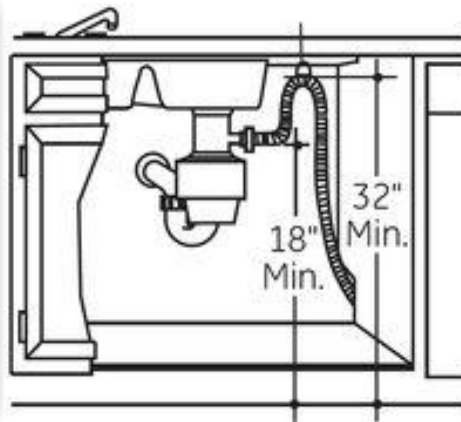
• Example of correct installation

I observed where dishwasher drain has been installed incorrectly. As it is now, wastewater from sink can be allowed to siphon into dishwasher. Recommend placing a high loop or air gap to prevent potential back flow contamination of the dishwasher.

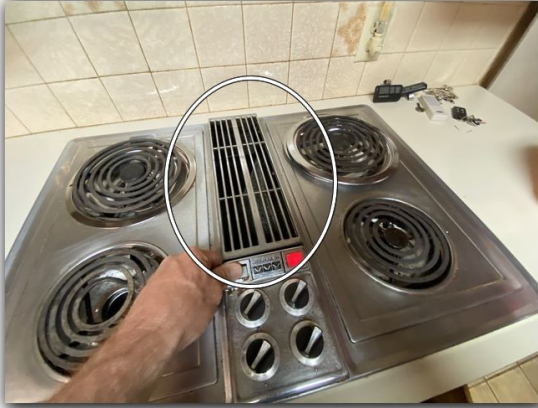
I observed where the range hood exhaust does not appear to be working with attempts at time of inspection.

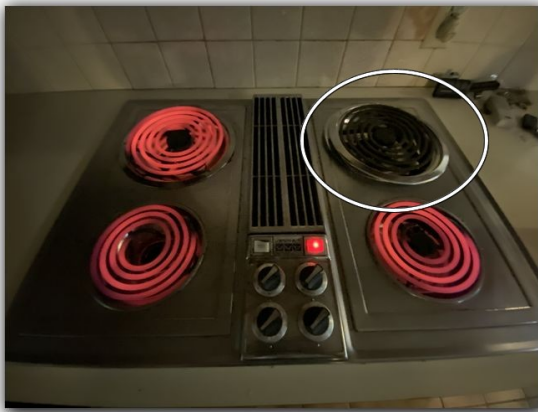
I observed where right rear burner may not be working appropriately at time of inspection.

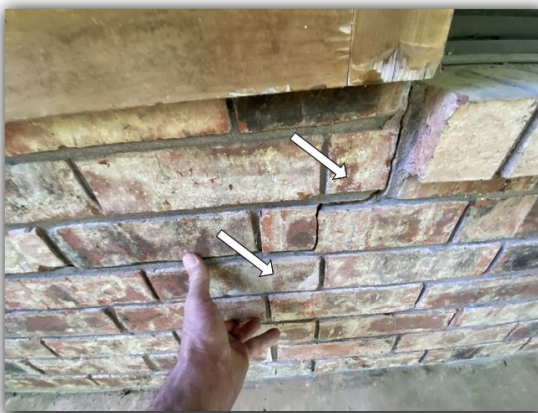
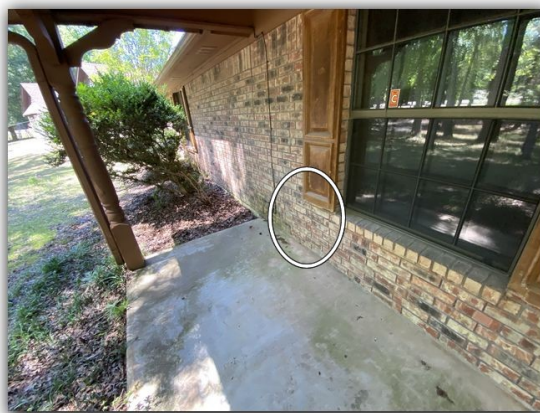
I observed various areas with mortar cracking in veneer siding at time of inspection. These cracks are typically due to thermal expansion and/or minor structural movement. Brick walls may expand (when heated) and contract (when cooled) and by doing so may do sufficiently enough to cause damage in mortar joints. These areas should be monitored for any noticeable changes that may occur.

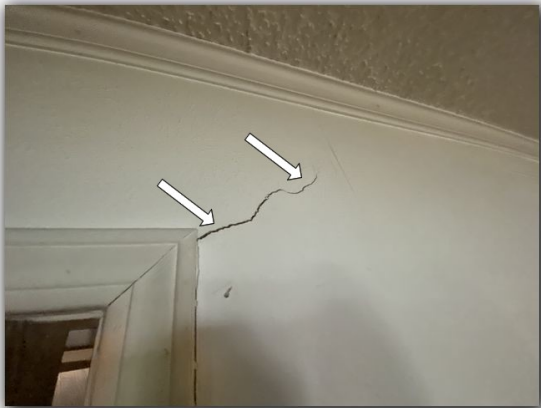
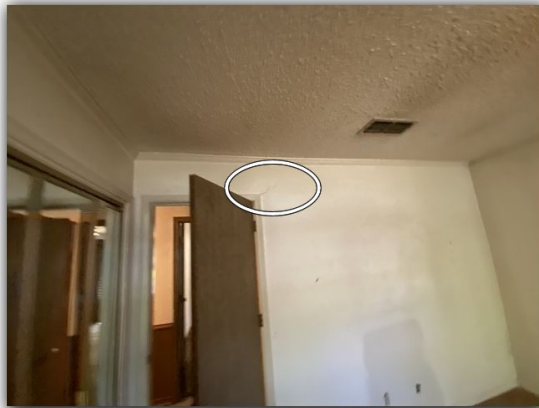
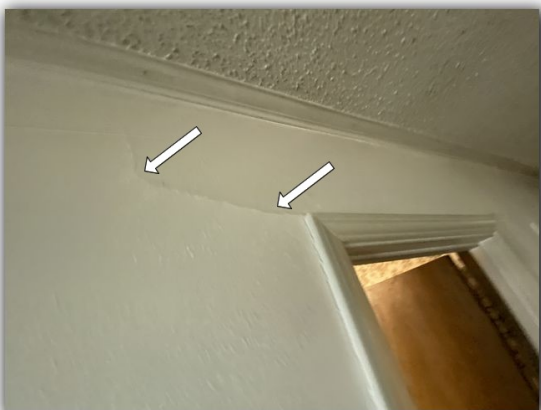
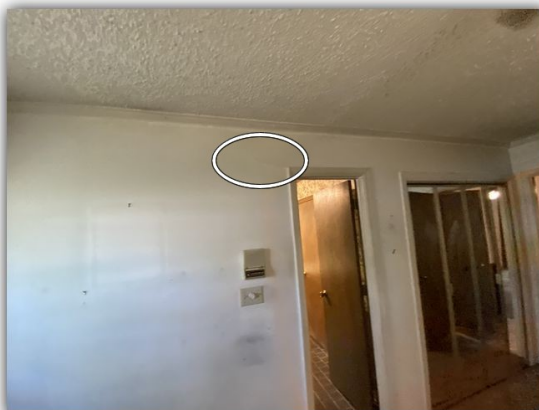
- Very common to see seam cracks near interior doors in home during assessment. All homes move but more so on pier homes. The headers over doors are where most cracks found due to areas being more load bearing with width. These would be the hinge points where movement would be found. All houses move again with pier and beam homes being the most prevalent.

I observed minor seam crack(s) in the interior sheet rock walls at time of inspection. Areas noted appear to have been cause from settlement of the homes foundation and/or thermal expansion. Recommend monitoring noted areas for any noticeable changes

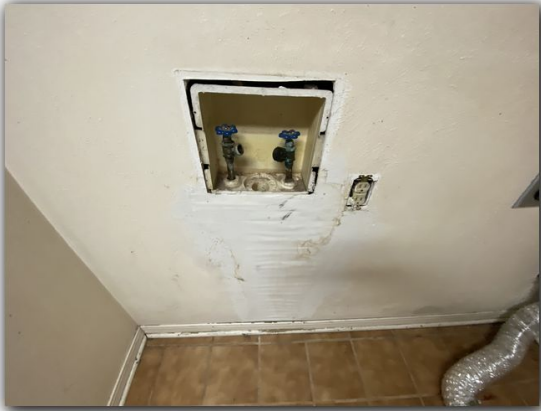
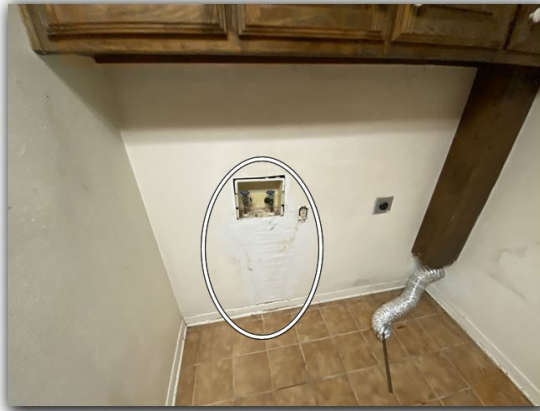
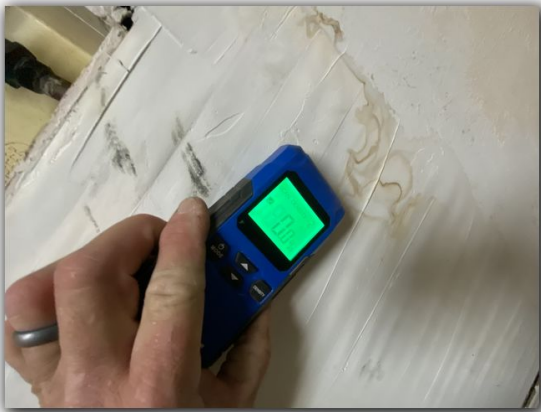
I observed an area of moisture staining noted in utility room at time of inspection. Further evaluation did not find any obvious evidence of moisture with moisture meter and thermal imager. Most likely leak with past washing machine connection that has since been removed. Recommend evaluation for repairs to damaged wall if desired monitoring noted areas for any noticeable changes.

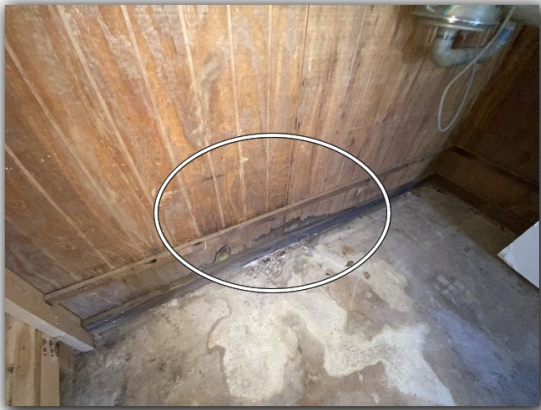
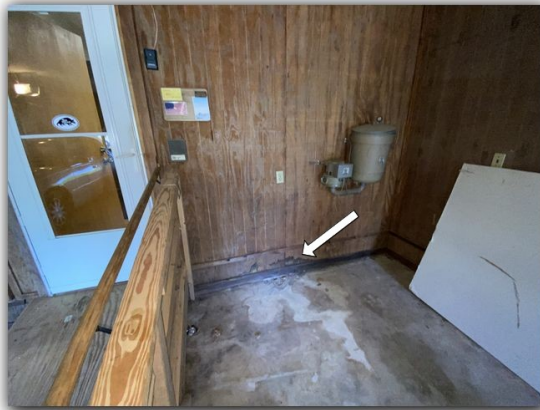
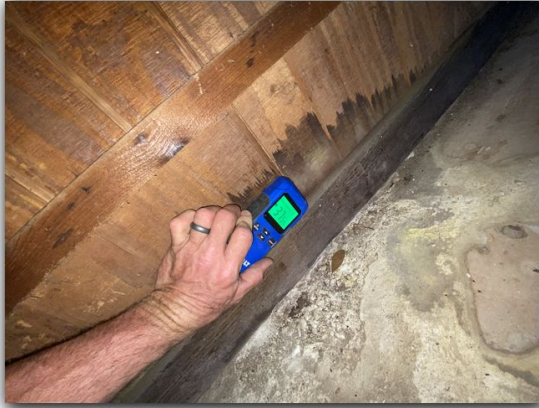
I observed an area of moisture staining noted in garage area at time of inspection. Further evaluation did not find any obvious evidence of moisture with moisture meter and thermal imager. No obvious areas for moisture from adjacent wall noted. Areas of damage to cement flooring most likely from some fashion of acid. Either from stored material or possibly batteries. Recommend evaluation for repairs to damaged wall if desired monitoring noted areas for any noticeable changes.

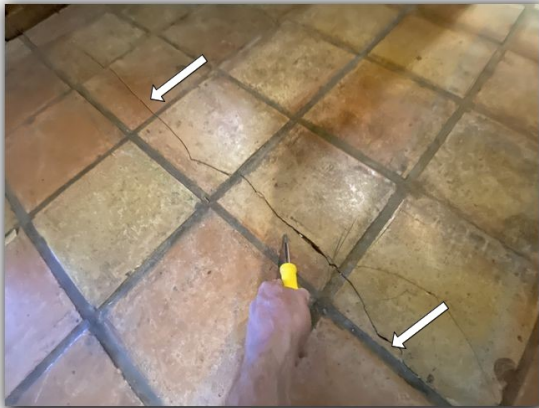
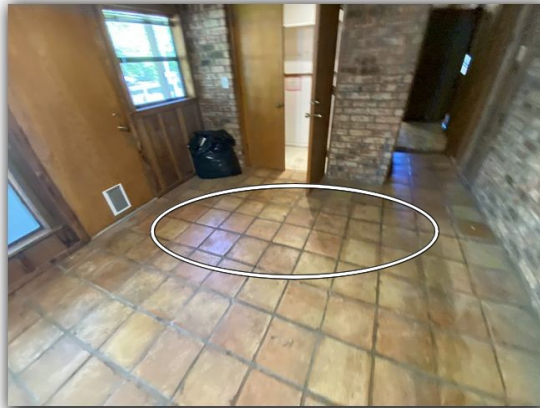
I observed minor tile cracks in various areas of home at time of inspection. Noted areas found with no obvious hollowed tiles during assessment. Area(s) appear to have been cause from normal settlement of the homes foundation, typical stress or shrinkage crack, and/or thermal expansion / shrinkage of cured concrete. Areas found do not exhibit horizontal movement (normal) found on all slabs without the proper control joints. Cracks should be monitored for any noticeable changes.
