PROPERTY INSPECTION REPORT

Concerning: 1234, Somewhere, TX 75601
(Address or Other Identification of Inspected Property)

By: David Smith, Lic #21666 05/05/2023
(Name and License Number of Inspector) (Date)

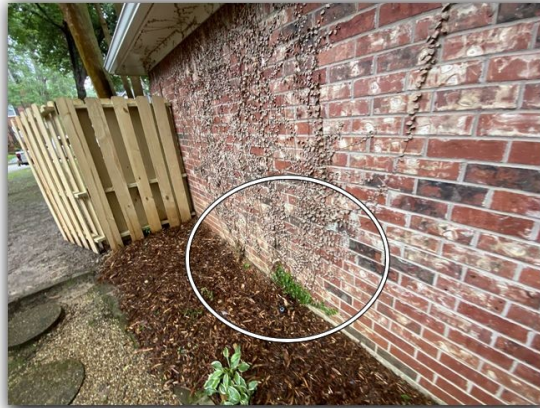
I observed where foliage found to be too close to the structure at time of inspection. It is recommended that bushes and vegetation should be at least 12 inches from wall contact. Recommend cutting or trimming noted vegetation allowing for appropriate barrier.

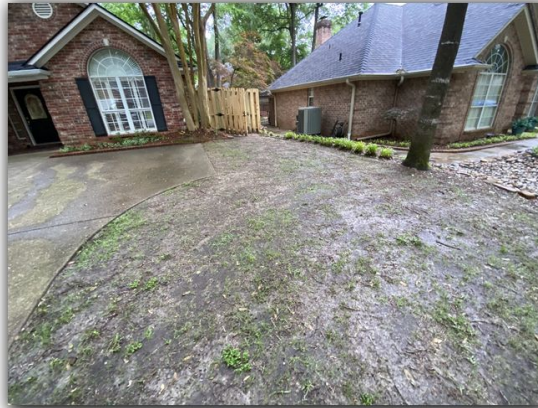
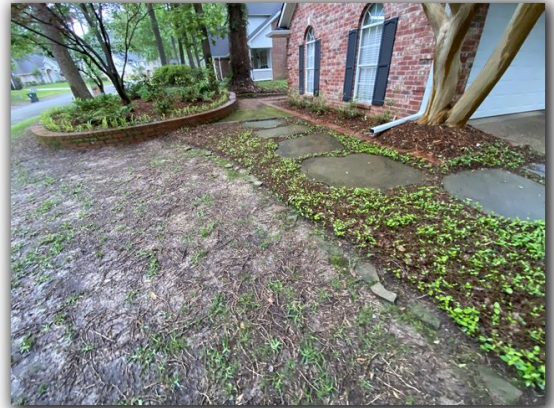
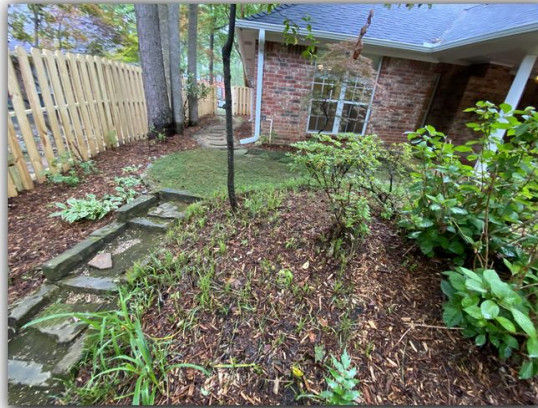
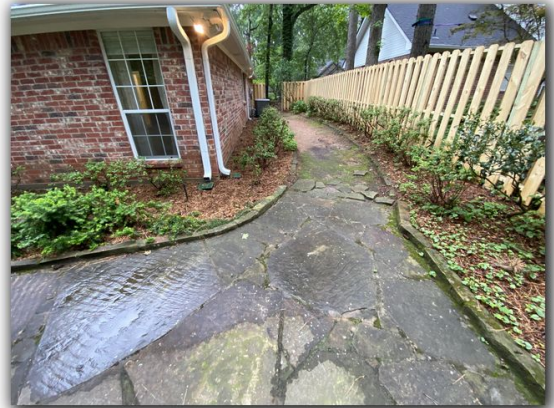
Monitor areas around perimeter of home after heavy rain to make sure water is draining away from structure.

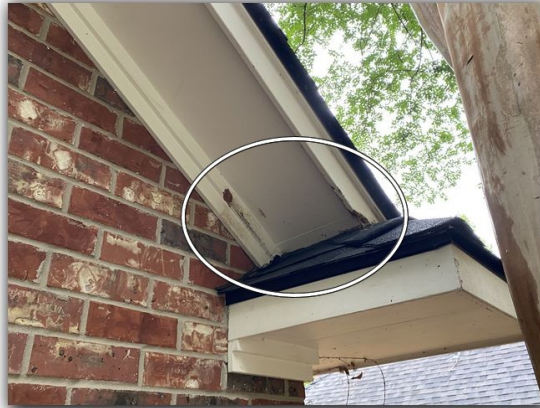
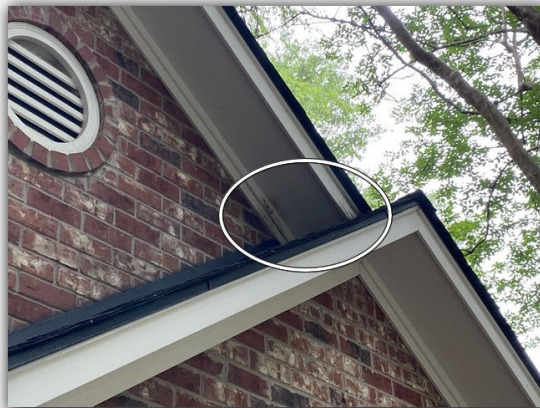
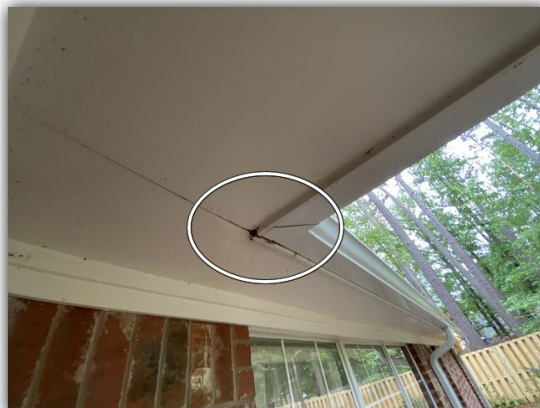
I observed various area with minor cosmetic damage noted to wood fascia / frieze boards under soffit areas at time of inspection. Noted damage appears to be from possible squirrels and/or birds. Recommend evaluation for keeping areas painted allowing for appropriate weather protection monitoring noted areas for any noticeable changes.

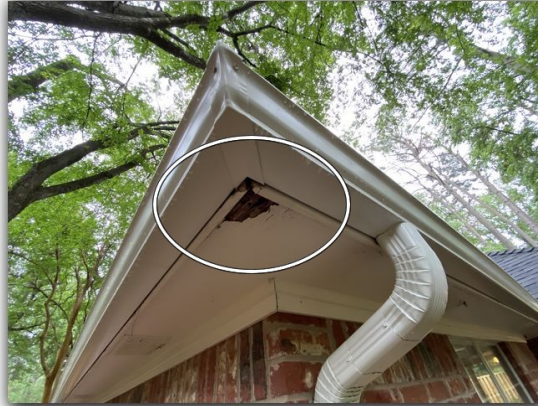
I observed various areas found with moisture damage near home soffit and fascia boards at time of inspection. Noted areas are common with debris filled gutters which can allow water to spill over allowing moisture contact or in this case could be from silicone that has worn away from seamed gutters. Area is painted which is added protection. Recommend evaluation for possible repairs if desired.

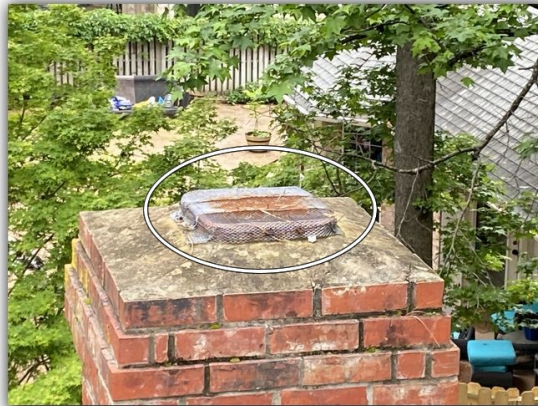
I observed where the chimney was missing its chimney cap at the time of inspection. The cap is needed to obviously keep rain water from making entry into chimney which can lead to many components of damage to chimney as well as unpleasant odors. Cap also Keeps animals out, reduces wind down drafts, and is also a spark arrestor. Recommend evaluation for possible repaired or replaced.

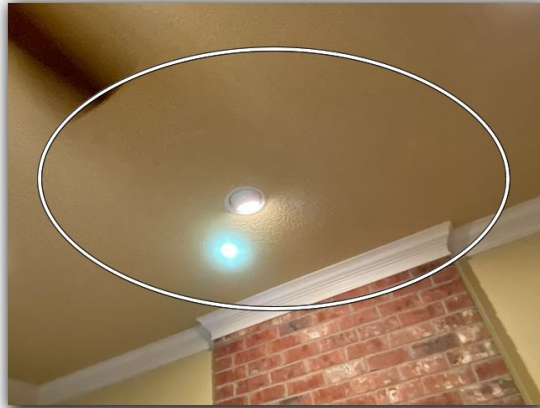
No evidence of damage noted in living room below affected areas

I observed an area in attic over living room near chimney where it appears that a leak might have occurred at some point in roof area at time of inspection. Further evaluation did not find any obvious evidence of moisture entry with hands on dry wood supports. Note: heavy rain night before inspection which would have allowed for water entry if active leak. Home presenting with new roof which most likely remedied any past moisture entry concerns. Recommend monitoring noted areas for any noticeable changes.

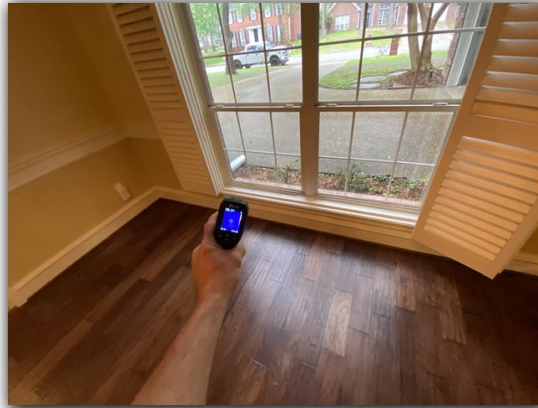
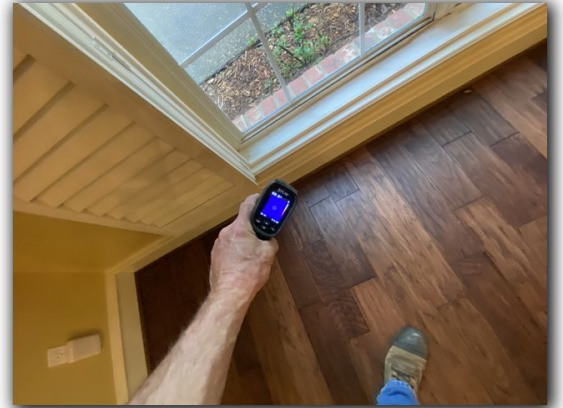
Dining room

I observed areas with possible moisture damage noted in front dining room area at time of inspection. Further evaluation did not find obvious evidence of moisture when assessed with moisture meter and thermal camera. Attic area did not find any obvious evidence of moisture with roof area finding where newer roof has been installed. Noted areas of damage near large window which may be the reason for areas of moisture. Inside roof valleys could have allowed water to flow off roof striking brick ledge near windows allowing water entry at some point. Silicone noted near bottom corners of windows at time of assessment. Roof valleys terminate into vertical walls above affected areas with no obvious evidence of moisture noted in attic area. Taller flashing added to inside valleys which would keep water from pooling and making entry into home as well. Noted areas of moisture damage appear to be on trim made of MDF which swells with very limited amounts of water contact. All indications show that every possible entry point for water has been remedied. Heavy rain night before inspection with no obvious evidence of moisture entry. Recommend repairs to trim if desired monitoring noted areas for any noticeable changes.

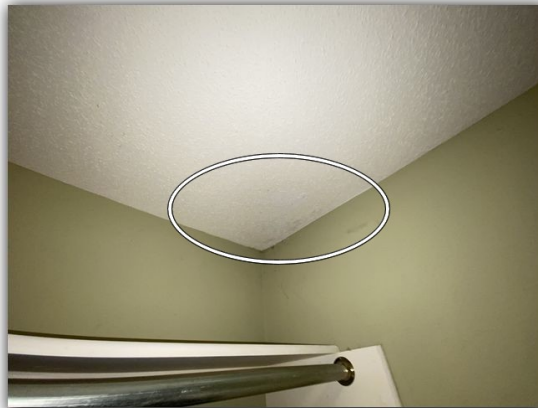
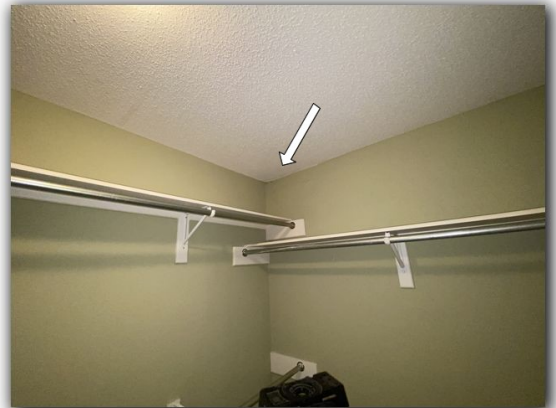
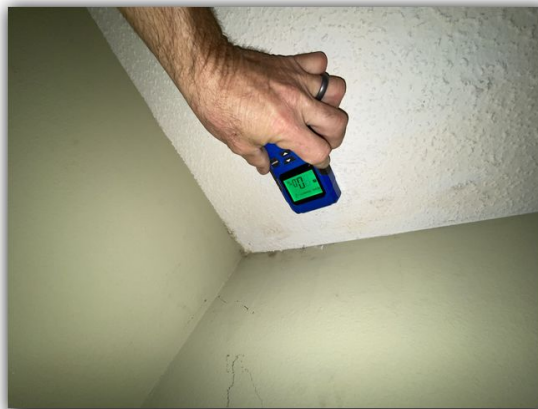
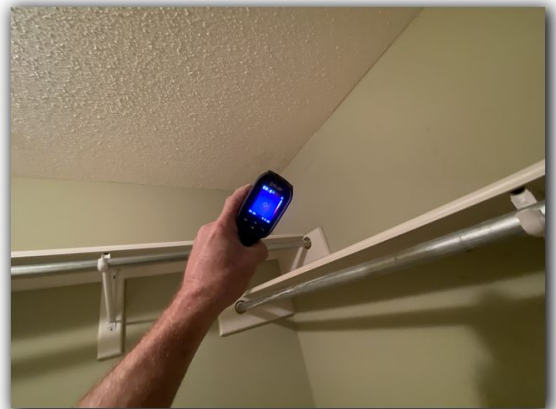
Master closet corner

I observed an area an possible moisture staining / moisture damage noted near outside corner of master closet at time of inspection. Further evaluation did not find obvious evidence of moisture when assessed with moisture meter and thermal camera. Attic area found where AC suction line found to make entry into attic through exterior wall over affected areas. Heating and AC unit appears to be newer with outside unit showing 2022. Area of damage most likely from deficient insulation over suction line for AC which will allow for condensation in hot attic allowing for moisture on insulation and eventually onto sheet rock. Noted area does not present with evidence of damage liquid or suction lines for AC at time of assessment. Recommend monitoring area for any noticeable changes.

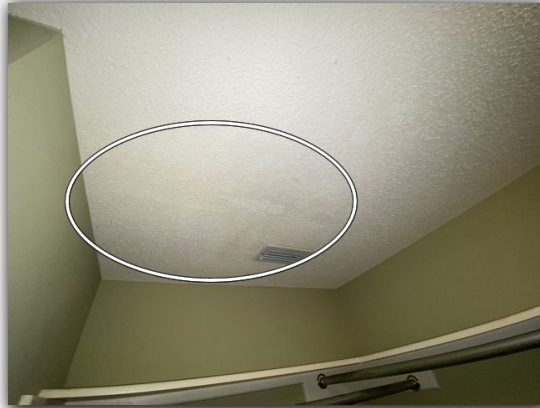
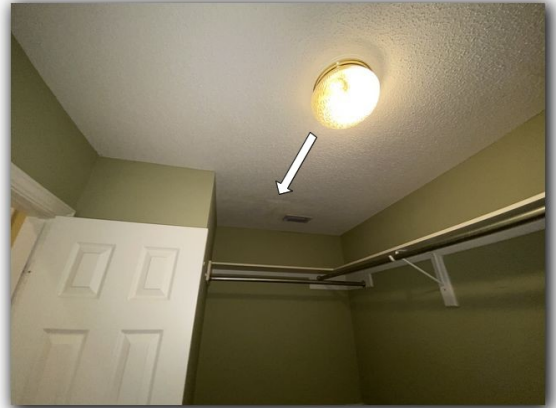
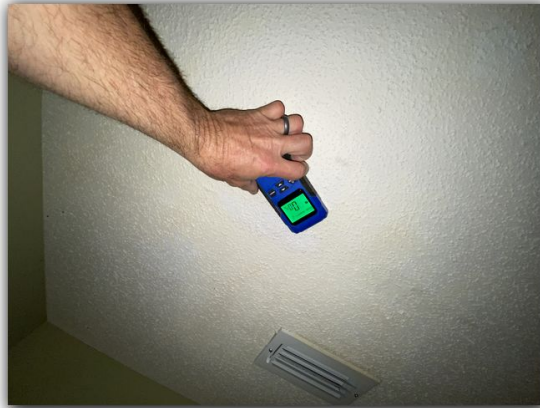
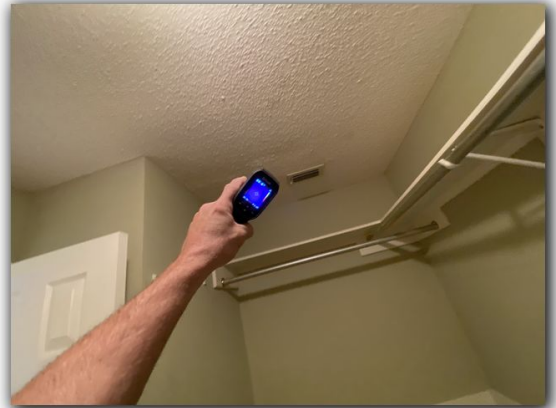
Master closet area

I observed an area an possible moisture staining / moisture damage noted in master closet area at time of inspection. Further evaluation did not find obvious evidence of moisture when assessed with moisture meter and thermal camera. Attic area found evidence of moisture on insulation below water heater roof termination. Home presenting with new roof with no obvious evidence of water entry at time of inspection with heavy rain night before inspection. Most likely newer roof as remedied any past moisture entry issues. (Note: inspector can not verify this at time of inspection.) Recommend repairs to ceiling if desired monitoring noted areas for any noticeable changes.

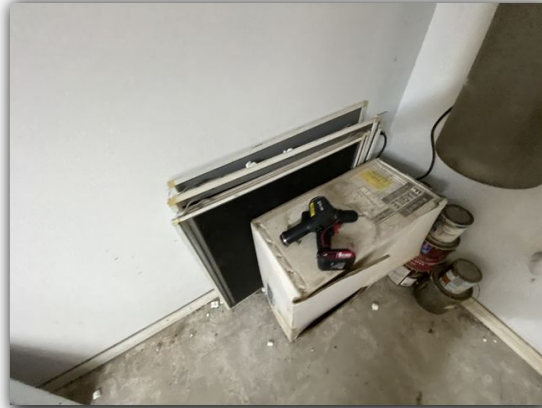
- Various screens missing on home at time of inspection. Screens found in garage area.

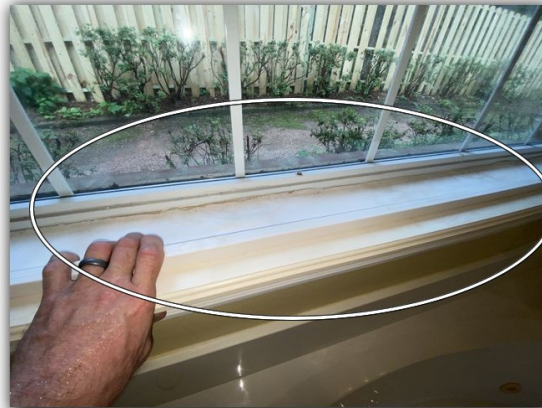
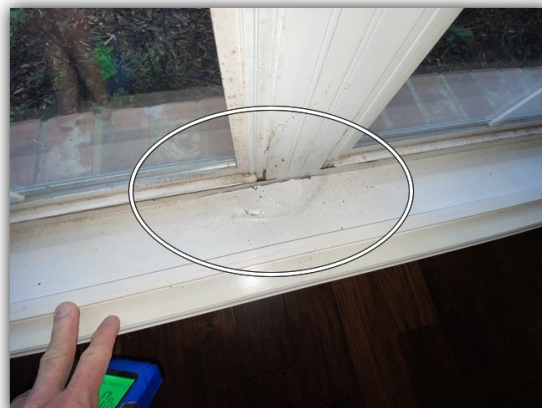
Master bathroom area

I observed various areas of moisture damage noted to window sills in home at time of inspection. This is common and can be caused by several different factors. Damage found in various locations in home which could be possible water entry around windows but does not appear likely. Damage is isolated to areas near actual window itself. Damage appears to be from condensation buildup near windows in combination with window sills having been made out of

MDF material. (Note: MDF and water do not mix.) Higher humidity levels in home (with various damaged window seals) allow moisture to form on windows which in turn make contact with found window sills. Recommend evaluation for possible repairs to sills if desired.

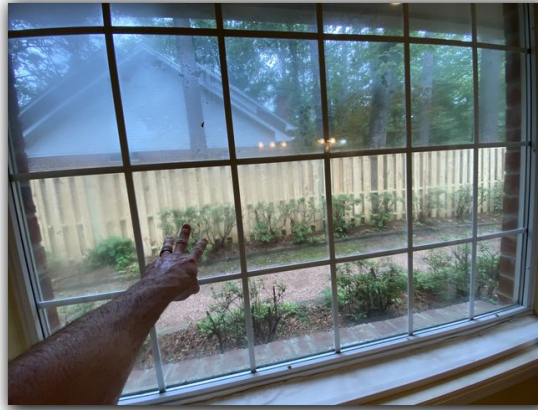
Master bathroom window

I observed areas of damage noted to double pane insulated windows in home at time of inspection. Typically seen on south and west facing homes, the seals on noted windows fail allowing moist air between the glass panes at time of inspection. When this happens the air condenses allowing for fogging appearance. This will generally appear in cooler months of the year. Recommend monitoring conditions and / or making repairs if desired.

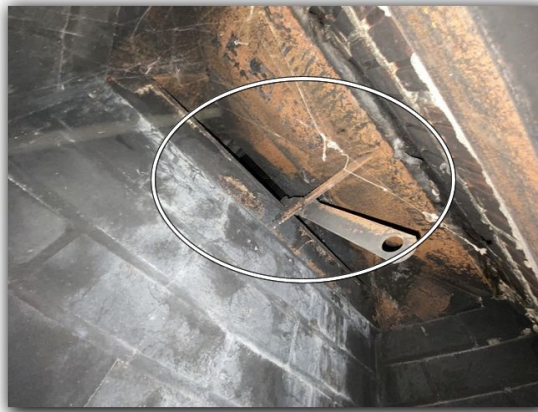
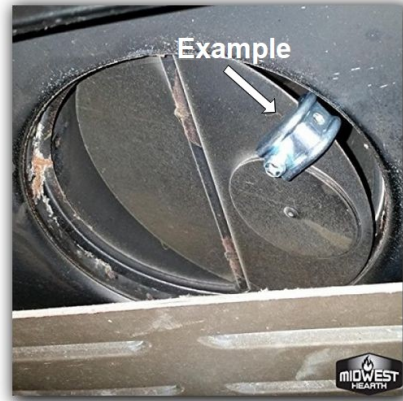
Example of damper clamp

- I observed where gas log / insert fire place missing damper clamp at time of inspection. A damper clamp is recommended by code when artificial gas logs or a log lighter are present in an open fireplace. Damper clamps keep the chimney's damper from closing allowing dangerous gases to escape the firebox in the case of a gas leak.

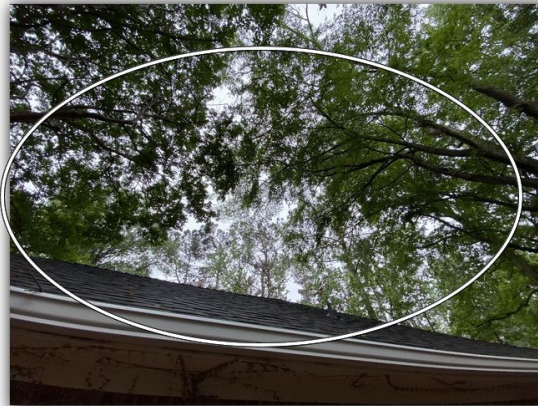
I observed where larger tree in front / back yard with obvious large limbs over home at time of inspection. Various lower limbs appear to be damaged possibly dead. Possible that falling limbs could come in contact with home / roof structure. Recommend possible evaluation from tree specialist / arborist to assess for possible removal of unsafe limbs if needed.

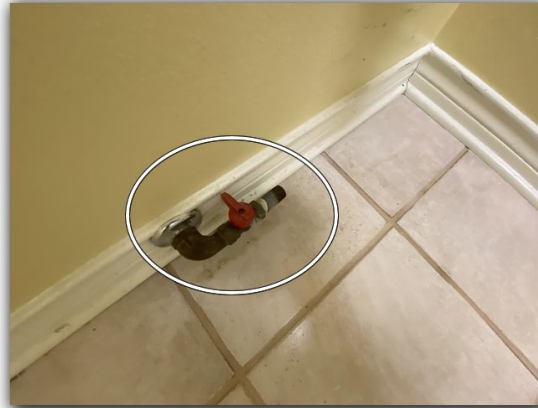
Open gas line in home

I observed an area found with open gas lines in home at time of inspection. Areas such as these could create conducive conditions for accidental openings allowing gas to flow freely into home. Recommend evaluation for covering noted gas valves with appropriate caps keeping home as safe as possible.

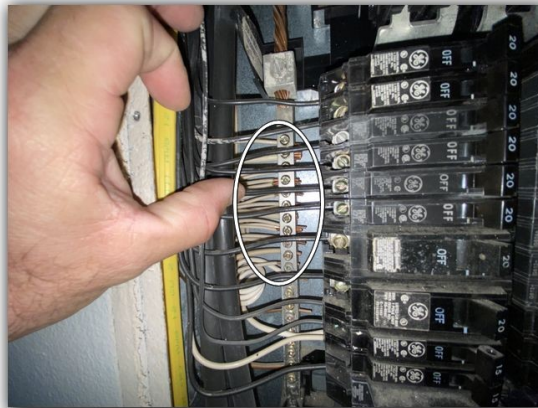
- I observed multiple neutral conductors in a single termination (double tap) create a possible problem when the circuit needs to be isolated. If the terminal is shared with another circuit, the connection on the other (still energized) circuit will be loosened as well. Loosening of the second neutral (loss of neutral) under load is a safety hazard, and may establish an overvoltage condition on lighting and appliances.

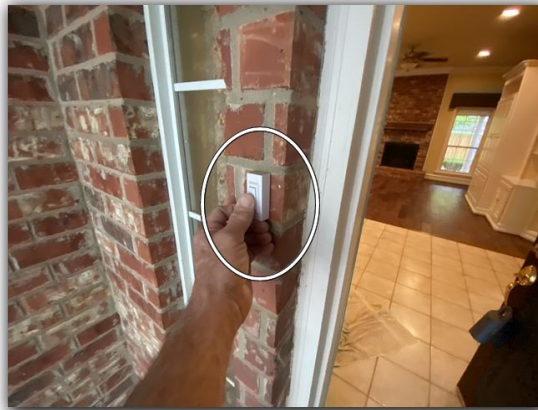
I observed where door bell button does not appear to work with attempts at time of inspection.

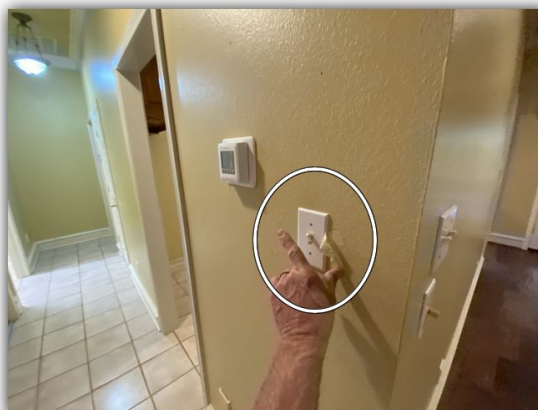
I observed where 3 way switch for hallway off kitchen was found to be deficient at time of inspection. If switch in hallway was in up position then switch near living room then hallway light could be turned on and off with switch near master bedroom. If switch in down position near living room then switch would not turn light on or off in hallway. Note: tape was placed over switch to keep from being used. This is typically a wiring issue that may have occurred during installation / rough in work with construction of home. Recommend evaluation for possible repairs if needed

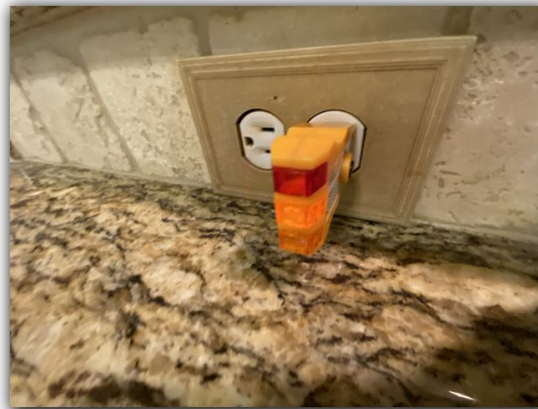
Missing GFCI protection in kitchen area. Noted receptacle presenting with an open ground. Receptacle does not appear to have been wired correctly allowing receptacle to trip as should.

No GFCI/ARC Fault protection at one or more location. This is considered a recognized safety hazard. GFCI protection was not provided in the home at locations where it now deemed necessary. GFCI protection may not have been required at the time the home was built, but for safety reasons it is recommended that GFCI protection be installed at all the following locations: • Bathrooms • Exterior • Garages • Crawlspace (at or below grade) • Unfinished basements • Kitchens • Laundry rooms • Within 6 feet of all plumbing fixtures. Recommend evaluation for possible repairs and / or replacement of deficient receptacles for added safety.

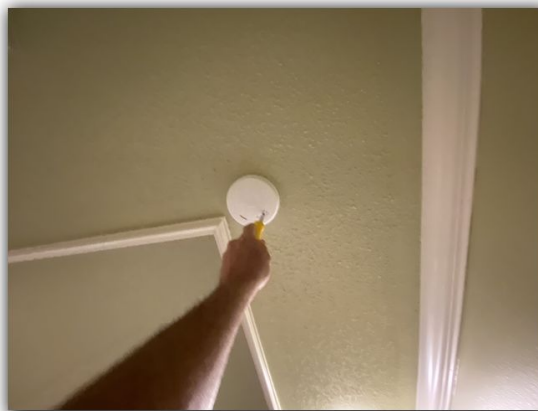
Smoke and Fire Alarms

- Smoke alarms present and working properly at time of inspection

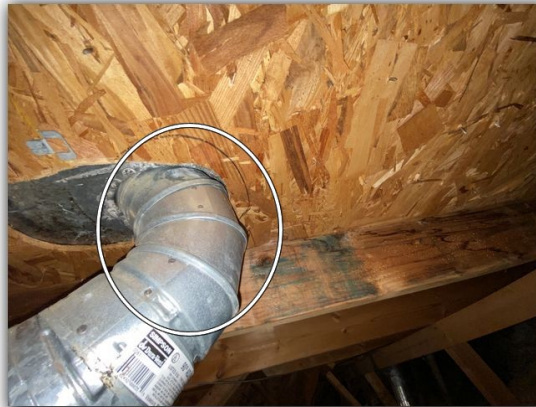
I observed where furnace flue in contact with wood roof decking in attic area at time of inspection. Note: temperatures of the vent pipe could transferred to the surrounding area (wood) and all the materials that are in the vent pipe vicinity. Noted rise in temperature could be conducive for possible fire under the right conditions. Inspector unable to verify whether flue pipe is insulated at time of assessment. Double walled flues typically may need 1 - 3 inch clearance. Recommend evaluation for possible repairs allowing appropriate buffer per manufacturer specifications.

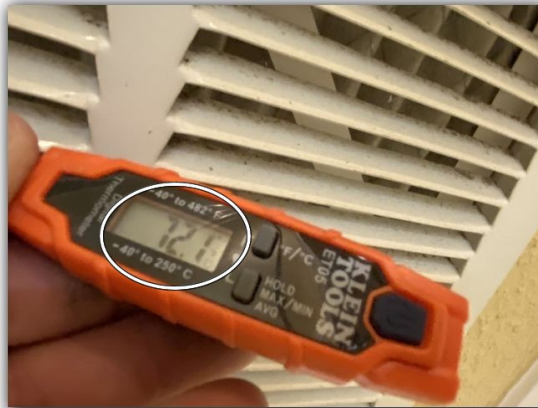
Return / room air temperature

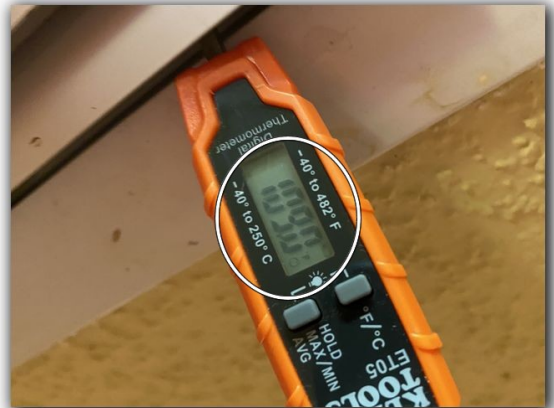
Supply air / differential

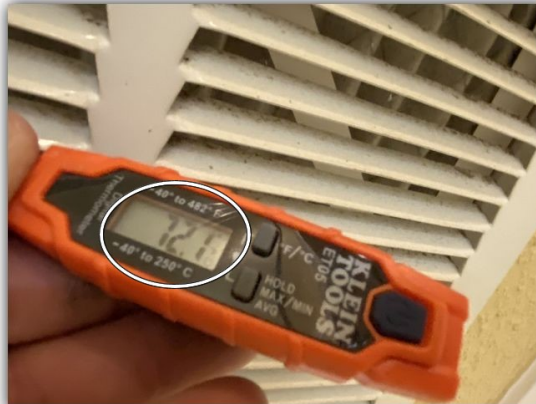
Return / room air temperature

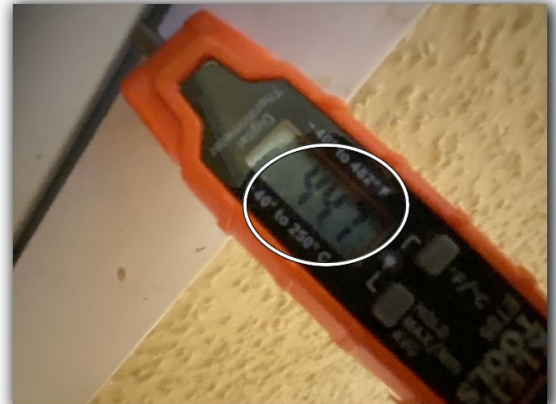
Supply air / differential

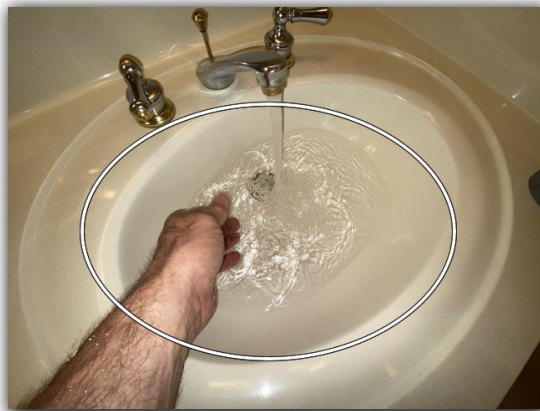
Master Bathroom

I observed where right side master bathroom sink found to drain slowly at time of inspection. Area of concern appears to be isolated to noted fixture with volume test in home with other plumbing fixtures allowing for drainage as should. Recommend evaluation for possible repairs allowing possible debris / blockage to be removed allowing for normal function.

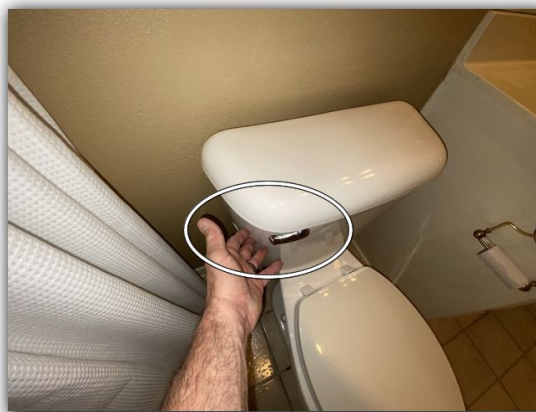
I observed where hallway bathroom commode found to keep 'running' at time of inspection. Recommend evaluation for possible adjustment of tank float if needed allowing commode to work

as should.

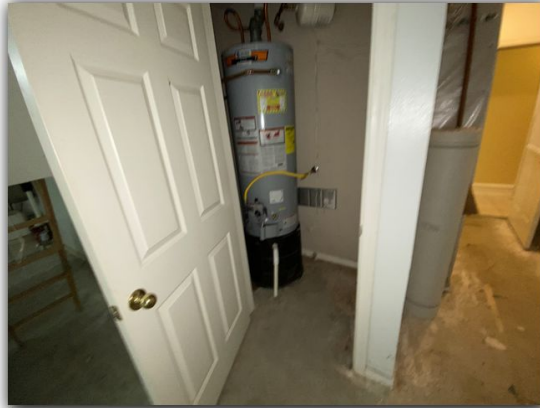
Note: water heater installed in garage area in utility closet. Technically speaking if heater were to fail for any reason water should terminate out of the garage with slope of garage floor. With that being said, the heater is elevated and shares a wall to living area so installation of pan that drains appropriately as well as Temperature Pressure relief drain line drained appropriately would be a consideration.

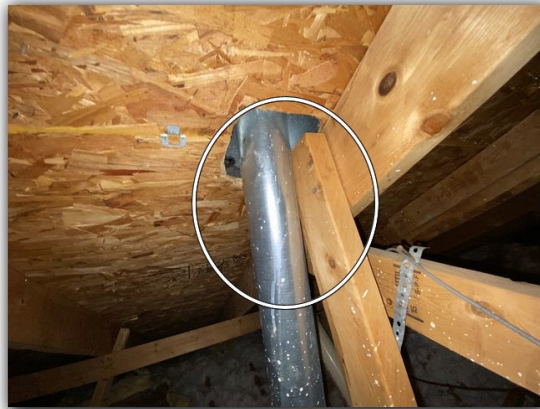
I observed where water heater flue in contact with wood roof purlin support in attic area at time of inspection. Note: temperatures of the vent pipe could transferred to the surrounding area (wood) and all the materials that are in the vent pipe vicinity. Noted rise in temperature could be conducive for possible fire under the right conditions. Inspector unable to verify whether flue pipe is insulated at time of assessment. Double walled flues typically may need 1 - 3 inch clearance. Recommend evaluation for possible repairs allowing appropriate buffer per manufacturer specifications.

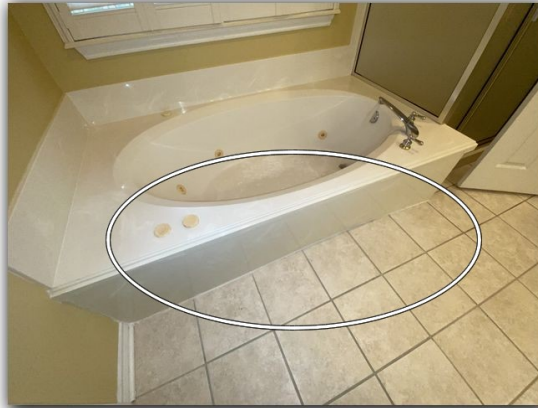
Access panel in inaccessible / missing at time of inspection. This is commonly seen with the cosmetic appeal more apparent than ease for possible repairs to unit if ever needed. Mind set is that it would be better to remove noted surround(s) on spa tub for access if needed than having a possible unattractive opening under / near tub. Recommend evaluation for repairs if desired and/or monitor area in case ever needed.

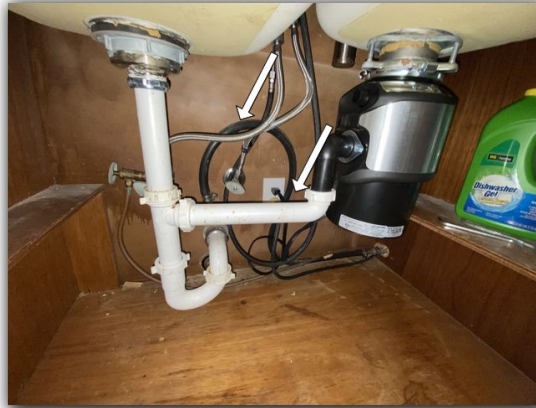
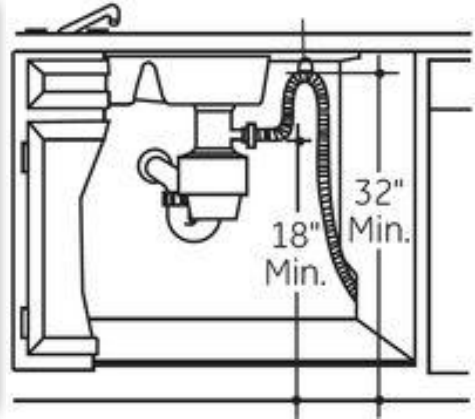
I observed where dishwasher drain has been installed incorrectly. As it is now, wastewater from sink can be allowed to siphon into dishwasher. Recommend placing a high loop or air gap to prevent potential back flow contamination of the dishwasher.

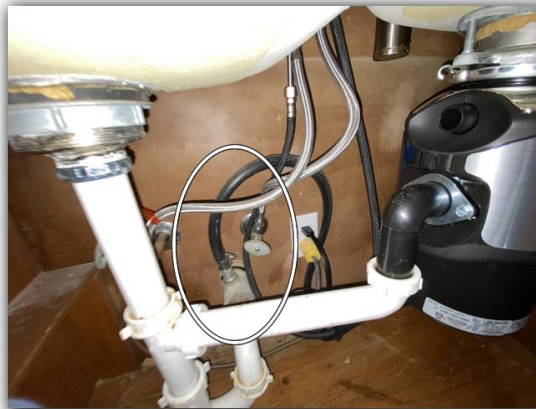
I observed where dishwasher drain is connected to the sewer side of the trap at time of inspection. The dishwasher drain hose is recommended be connected before the P trap, not on the sewer side of the trap. The water "held" in the P trap prevents gases coming back into the dishwasher from the sewer. At time of inspection unpleasant odors could back flow from dishwasher. Recommend evaluation for repairs allowing dishwasher to drain as should.

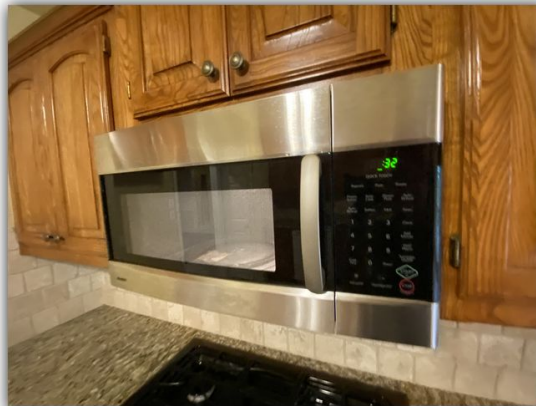
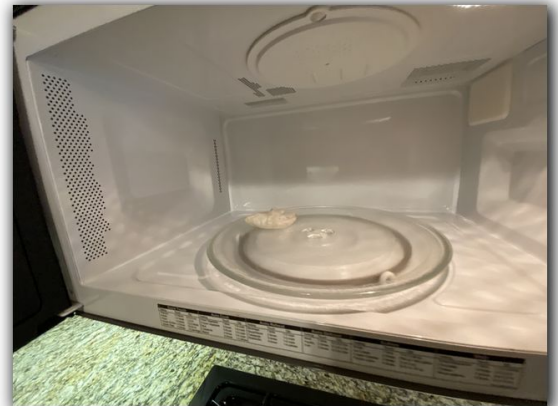
E. Microwave Ovens

Comments: This appliance was inspected and/or operated in its normal mode of operation and appeared to be performing properly at the time of this inspection

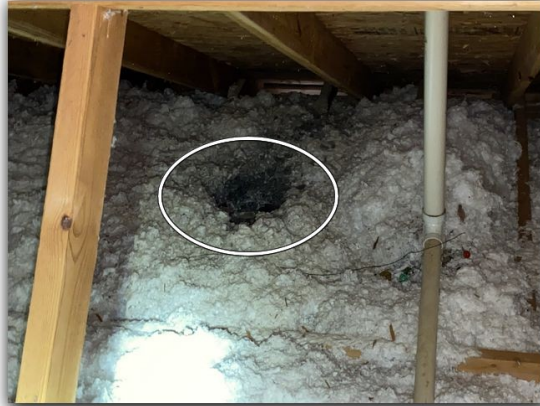
I observed where the bathroom vents for home appeared to terminate in the attic area. It is not typical to vent directly into an attic even if the attic itself is vented. The excessive moisture could cause condensation on the roof members, insulation, and could eventually cause mold. Would recommend terminating vents to outside.

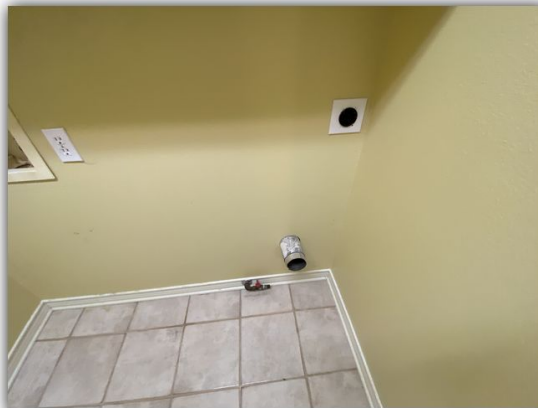
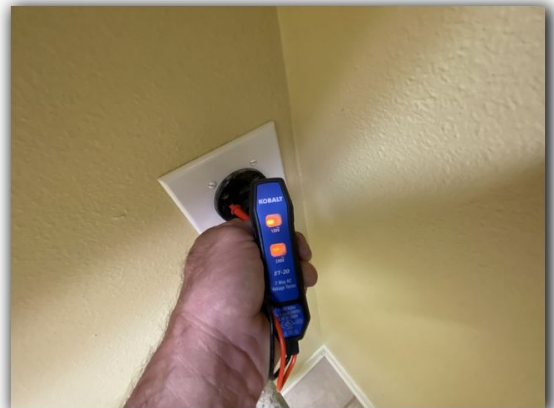
H. Dryer Exhaust Systems

Comments: This fixture was inspected and appeared to be in functional condition at the time of this inspection.

Dryer not connected at time of inspection.

Dryer receptacle working as should.

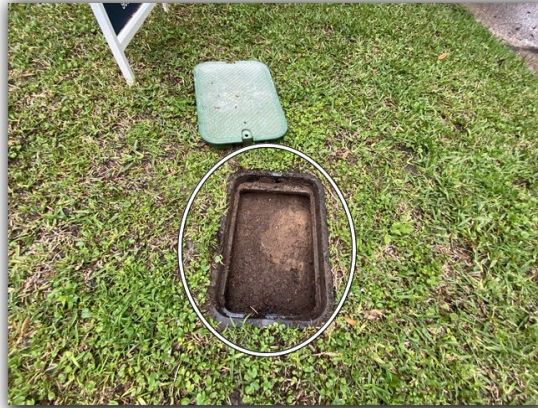
I observed back flow preventer found completely covered with dirt at time of inspection. While unit may work properly when covered the moist dirt could eventually rust away shut off valves on back flow keeping one from shutting down irrigation system if needed or desired. Recommend evaluation for possible repairs if needed removing noted areas of dirt of unit

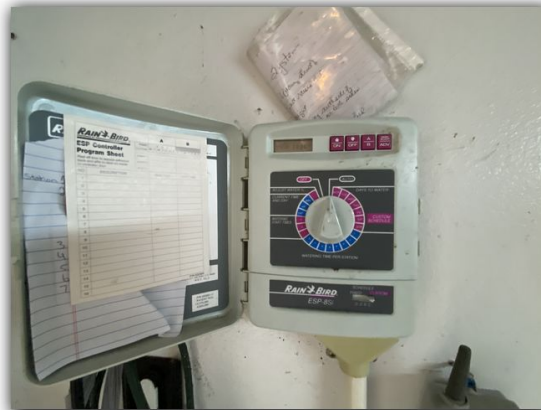
Rain Bird system

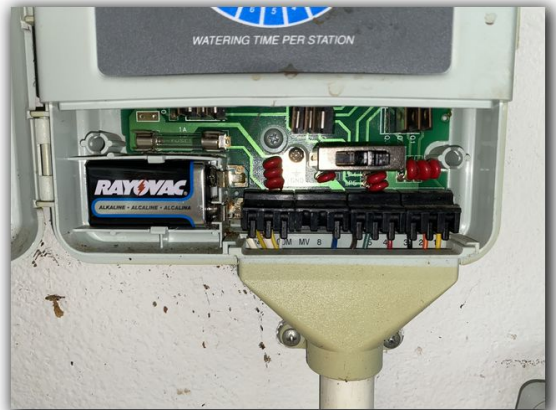
7 Active zones

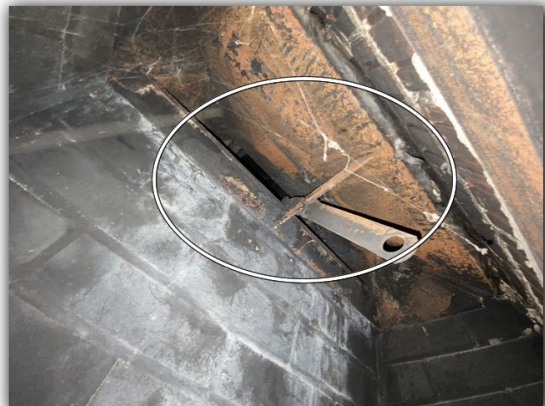
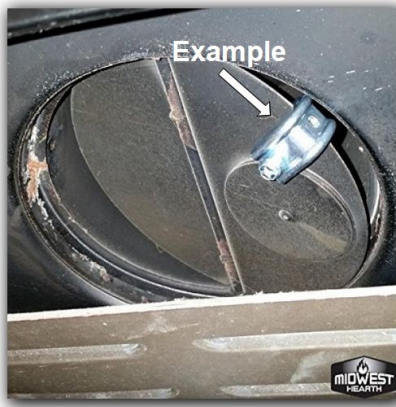
Example of damper clamp

- I observed where gas log / insert fire place missing damper clamp at time of inspection. A damper clamp is recommended by code when artificial gas logs or a log lighter are present in an open fireplace. Damper clamps keep the chimney's damper from closing allowing dangerous gases to escape the firebox in the case of a gas leak.
Open gas line in home

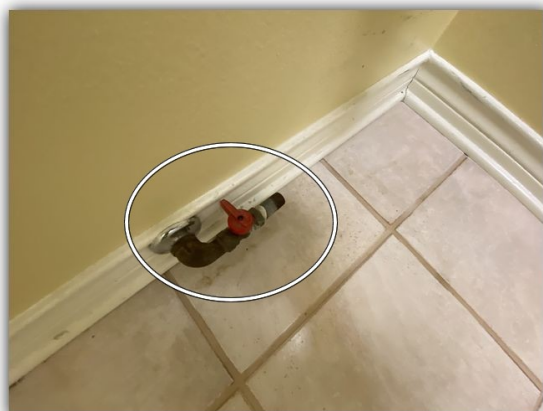
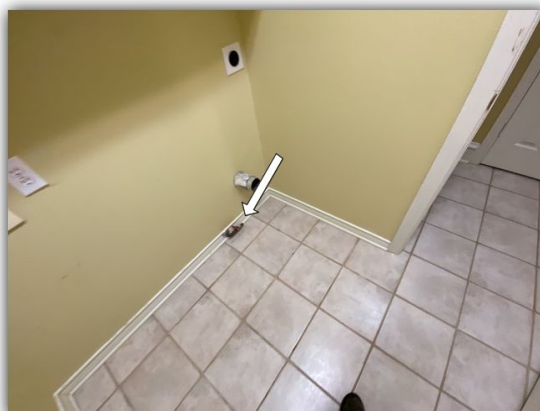
- I observed an area found with open gas lines in home at time of inspection. Areas such as these could create conducive conditions for accidental openings allowing gas to flow freely into home. Recommend evaluation for covering noted gas valves with appropriate caps keeping home as safe as possible.

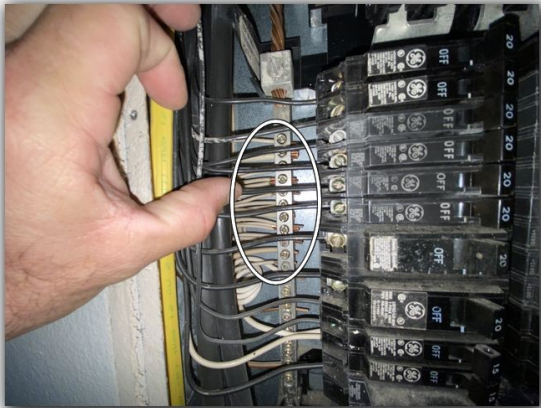
- Lack of AFCI breakers servicing the bedrooms, living room, dining room, and any other similar rooms in the home at time of inspection. This may not have been available at the time this house was constructed and is considered a safety upgrade. Under the new TREC inspection standards, it is considered a deficiency if AFCI protection is not in kitchens, family rooms, dining rooms, living rooms, parlors, libraries, dens, bedrooms, sunrooms, recreation rooms, closets, hallways, and laundry areas. Recommend evaluation for upgrade to today's standard allowing for safe use.

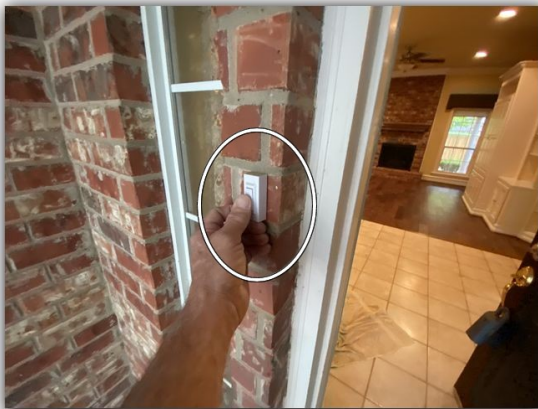
☑ I observed where door bell button does not appear to work with attempts at time of inspection.

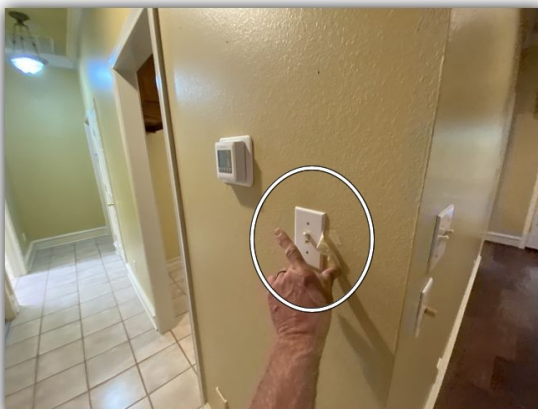
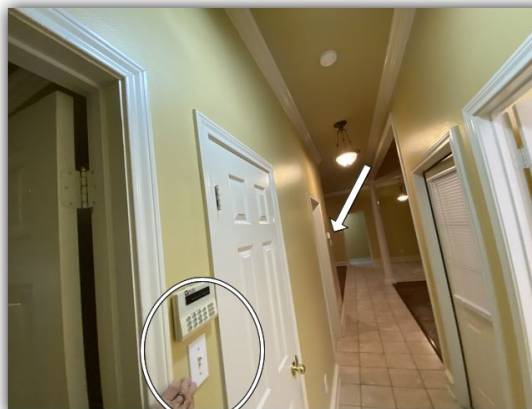
☑ I observed where 3 way switch for hallway off kitchen was found to be deficient at time of inspection. If switch in hallway was in up position then switch near living room then hallway light could be turned on and off with switch near master bedroom. If switch in down position near living room then switch would not turn light on or off in hallway. Note:

tape was placed over switch to keep from being used. This is typically a wiring issue that may have occurred during installation / rough in work with construction of home. Recommend evaluation for possible repairs if needed allowing lights / 3 way to work as should.

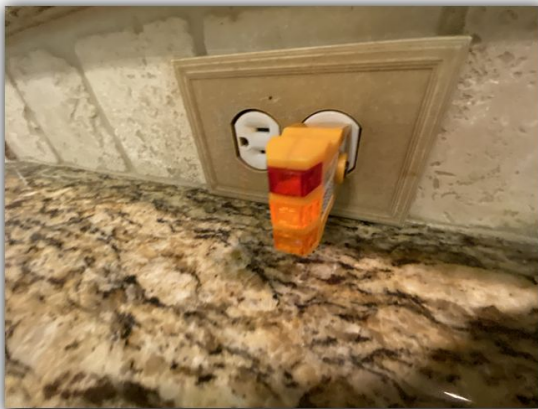
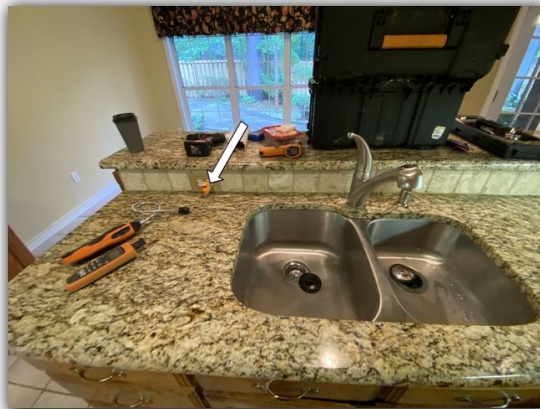
Missing GFCI protection in kitchen area. Noted receptacle presenting with an open ground. Receptacle does not appear to have been wired correctly allowing receptacle to trip as should.

No GFCI/ARC Fault protection at one or more location. This is considered a recognized safety hazard. GFCI protection was not provided in the home at locations where it is now deemed necessary. GFCI protection may not have been required at the time the home was built, but for safety reasons it is recommended that GFCI protection be installed at all the following locations: • Bathrooms • Exterior • Garages • Crawlspace (at or below grade) • Unfinished basements • Kitchens • Laundry rooms • Within 6 feet of all plumbing fixtures. Recommend evaluation for possible repairs and / or replacement of deficient receptacles for added safety.

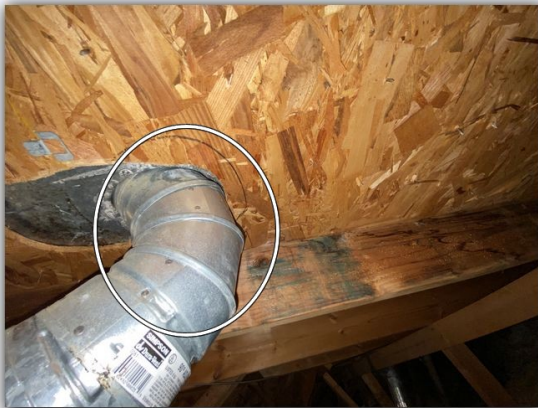
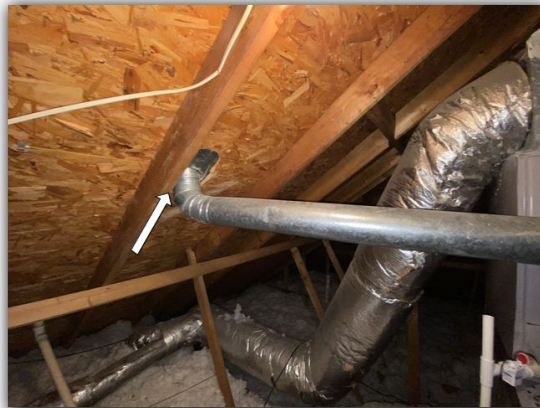
I observed where furnace flue in contact with wood roof decking in attic area at time of inspection. Note: temperatures of the vent pipe could be transferred to the surrounding area (wood) and all the materials that are in the vent pipe vicinity.

Noted rise in temperature could be conducive for possible fire under the right conditions. Inspector unable to verify whether flue pipe is insulated at time of assessment. Double walled flues typically may need 1 - 3 inch clearance. Recommend evaluation for possible repairs allowing appropriate buffer per manufacturer specifications.

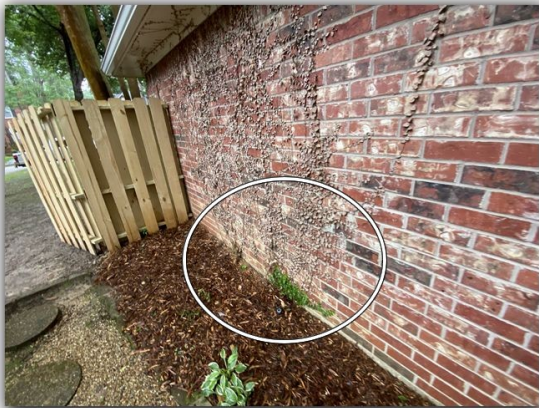
I observed where foliage found to be to close to the structure at time of inspection. It is recommended that bushes and vegetation should be at least 12 inches from wall contact. Recommend cutting or trimming noted vegetation allowing for appropriate barrier.

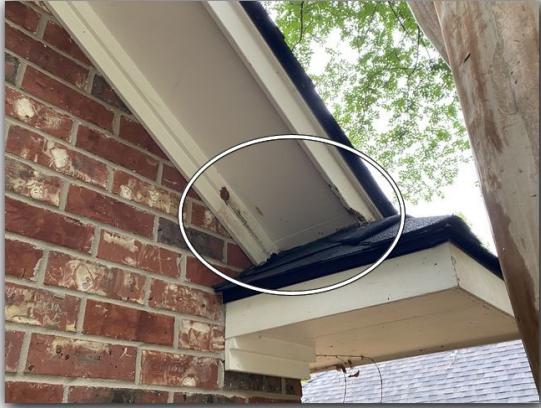
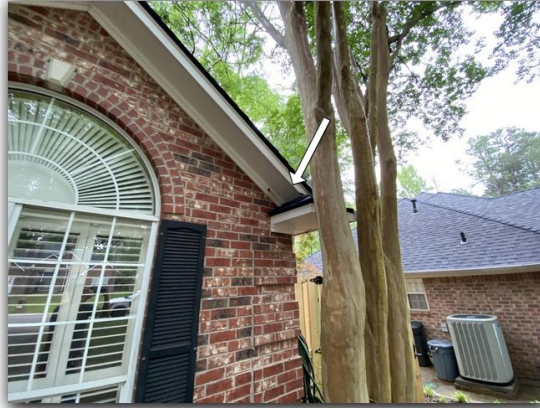
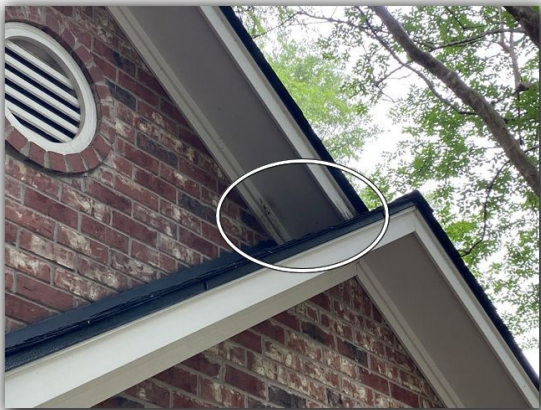
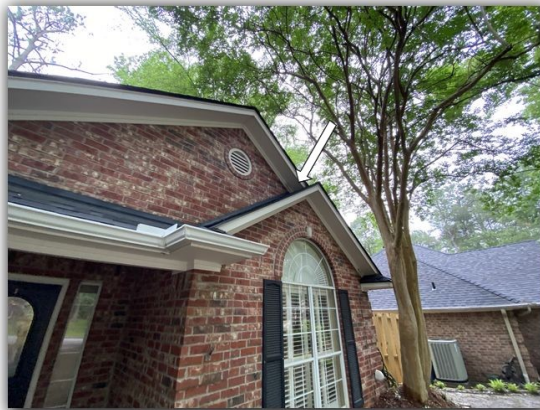
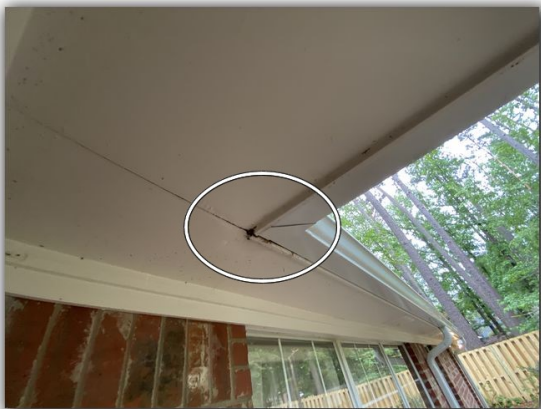
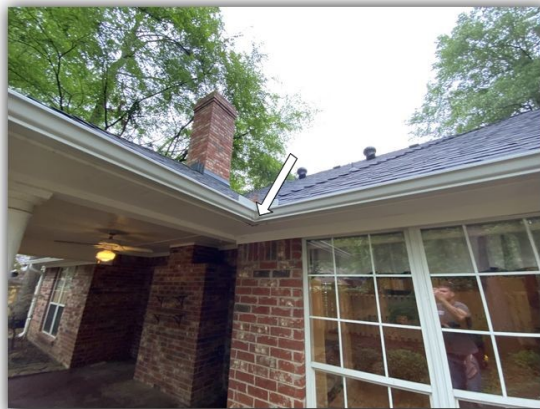
I observed various area with minor cosmetic damage noted to wood fascia / frieze boards under soffit areas at time of inspection. Noted damage appears to be from possible squirrels and/or birds. Recommend evaluation for keeping areas painted allowing for appropriate weather protection monitoring noted areas for any noticeable changes.

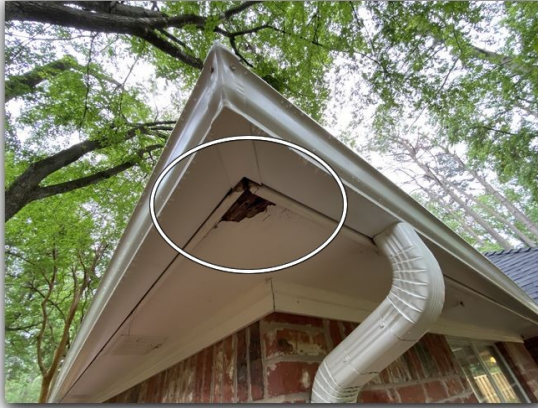
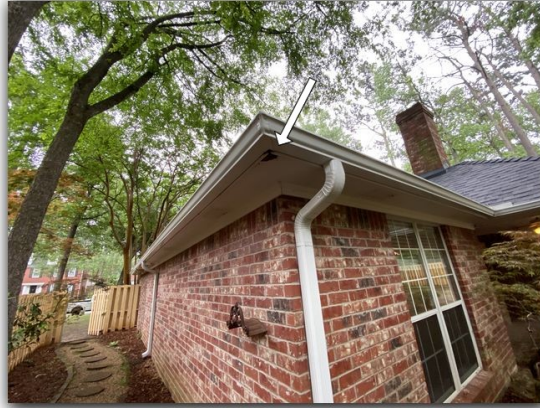
☑ I observed various areas found with moisture damage near home soffit and fascia boards at time of inspection. Noted areas are common with debris filled gutters which can allow water to spill over allowing moisture contact or in this case could be from silicone that has worn away from seamed gutters. Area is painted which is added protection. Recommend evaluation for possible repairs if desired.
