PROPERTY INSPECTION REPORT

Concerning: 1234, Somewhere, TX 75601
(Address or Other Identification of Inspected Property)

By: David Smith, Lic #21666 05/05/2023
(Name and License Number of Inspector) (Date)

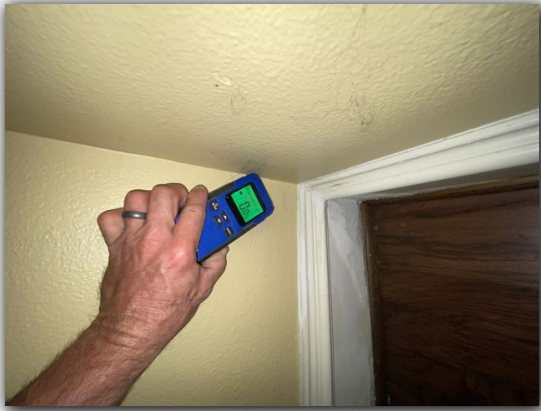
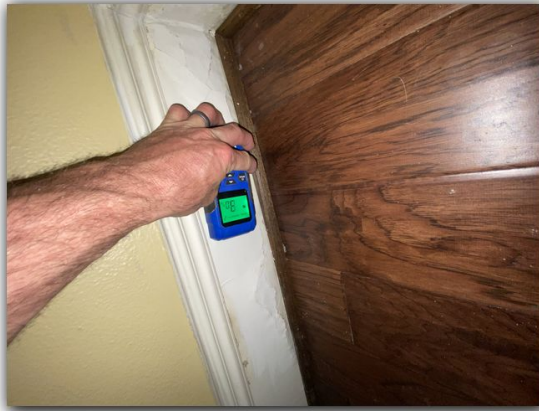
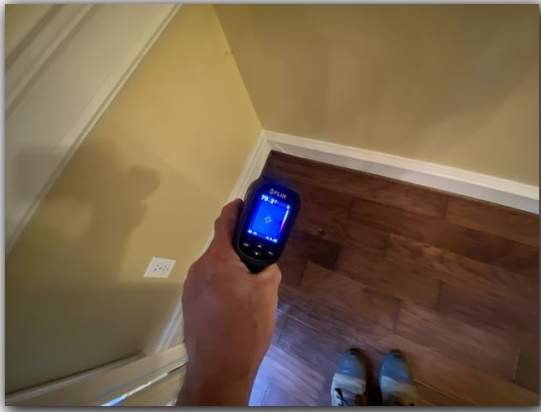
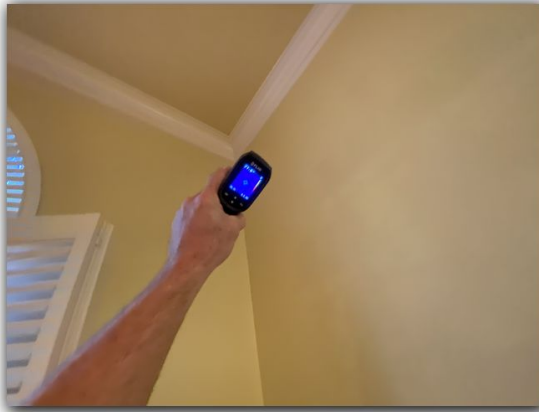
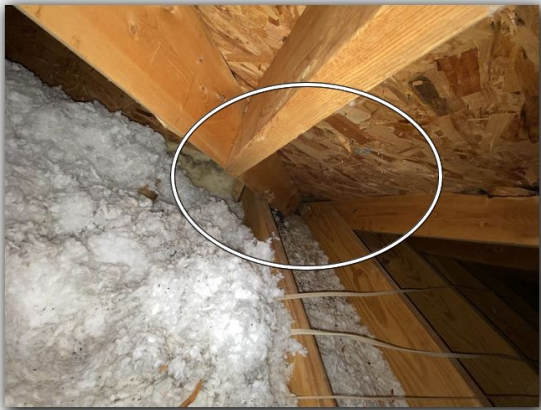
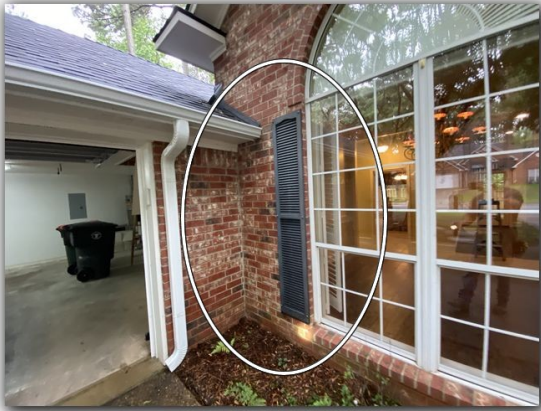
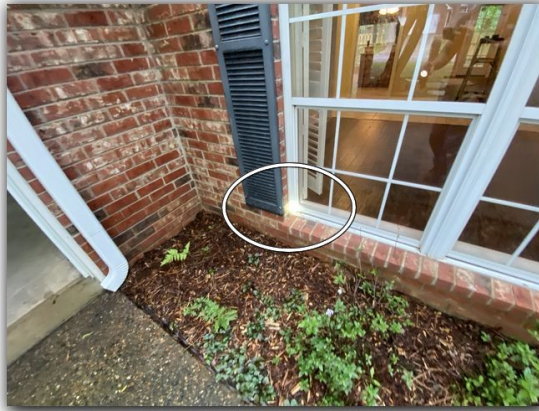
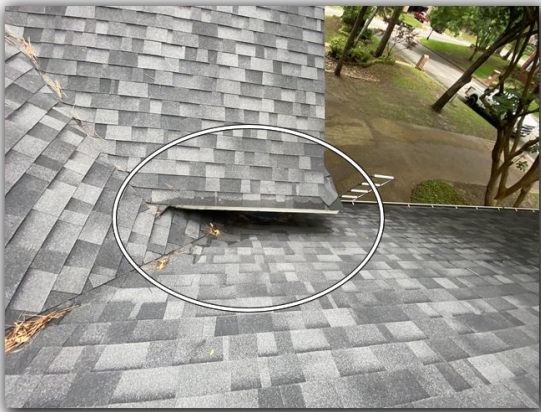
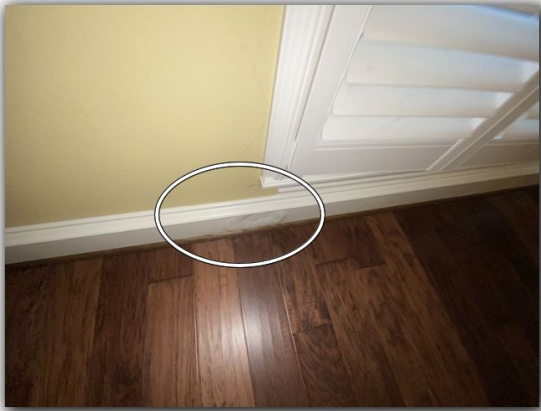
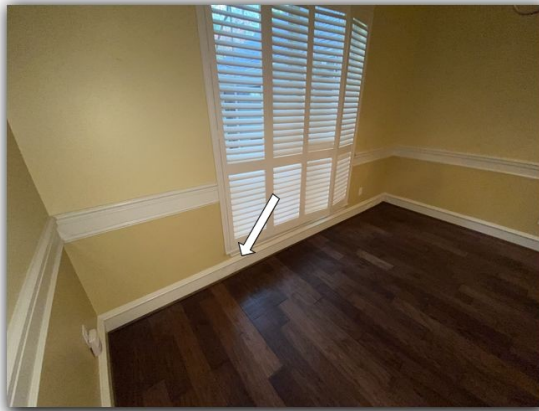
I observed areas with possible moisture damage noted in front dining room area at time of inspection. Further evaluation did not find obvious evidence of moisture when assessed with moisture meter and thermal camera. Attic area did not find any obvious evidence of moisture with roof area finding where newer roof has been installed. Noted areas of damage near large window which may be the reason for areas of moisture. Inside roof valleys could have allowed water to flow off roof striking brick ledge near windows allowing water entry at some point. Silicone noted near bottom corners of windows at time of assessment. Roof valleys terminate into vertical walls above affected areas with no obvious evidence of moisture noted in attic area. Taller flashing added to inside valleys which would keep water from pooling and making entry into home as well. Noted areas of moisture damage appear to be on trim made of MDF which swells with very limited amounts of water contact. All indications show that every possible entry point for water has been remedied. Heavy rain night before inspection with no obvious evidence of moisture entry. Recommend repairs to trim if desired monitoring noted areas for any noticeable changes.

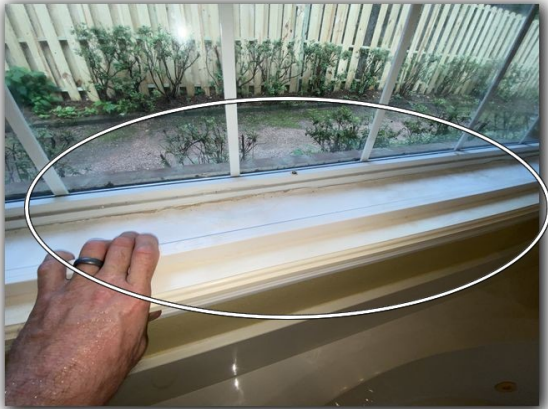
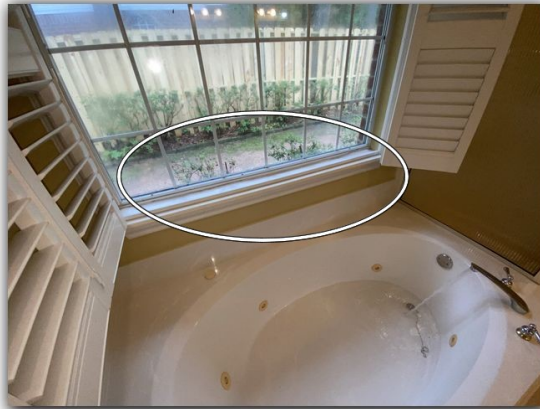
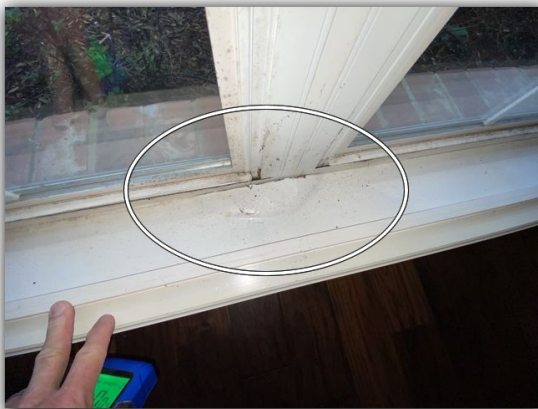
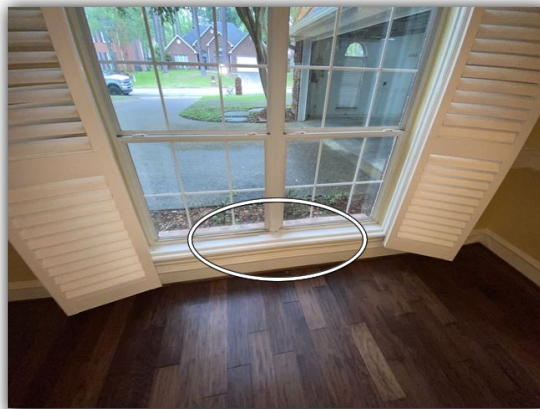
Master bathroom area

I observed various areas of moisture damage noted to window sills in home at time of inspection. This is common and can be caused by several different factors. Damage found in various locations in home which could be possible water entry around windows but does not appear likely. Damage is isolated to areas near actual window itself. Damage appears to be from condensation buildup near windows in combination with window sills having been made out of MDF material. (Note: MDF and water do not mix.) Higher humidity levels in home (with various damaged window seals) allow moisture to form on windows which in turn make contact with found window sills. Recommend evaluation for possible repairs to sills if desired.

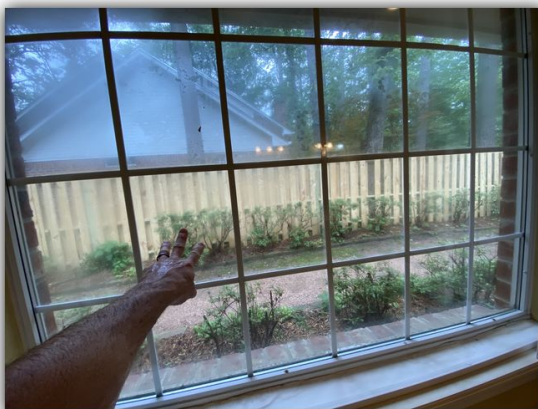
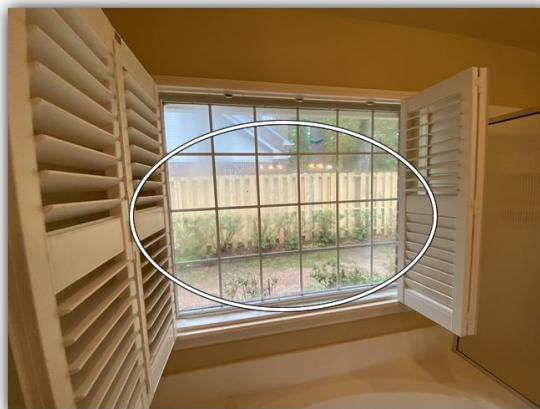
Master bathroom window

I observed areas of damage noted to double pane insulated windows in home at time of inspection. Typically seen on south and west facing homes, the seals on noted windows fail allowing moist air between the glass panes at time of

inspection. When this happens the air condenses allowing for fogging appearance. This will generally appear in cooler months of the year. Recommend monitoring conditions and / or making repairs if desired.

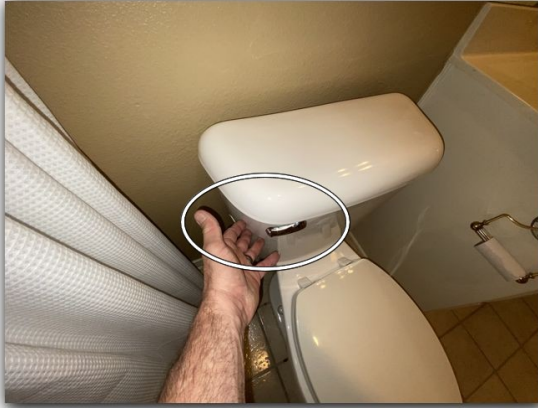
I observed where hallway bathroom commode found to keep 'running' at time of inspection. Recommend evaluation for possible adjustment of tank float if needed allowing commode to work as should.

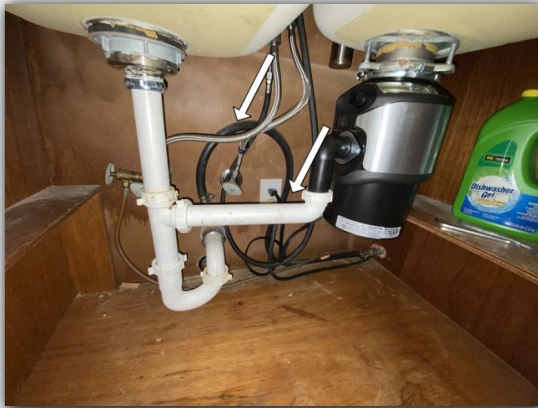
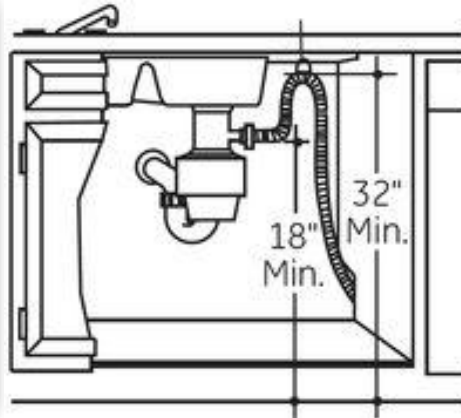
I observed where dishwasher drain has been installed incorrectly. As it is now, wastewater from sink can be allowed to siphon into dishwasher. Recommend placing a high loop or air gap to prevent potential back flow contamination of the dishwasher.

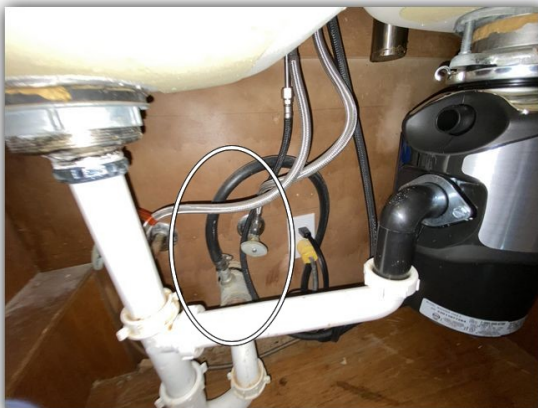
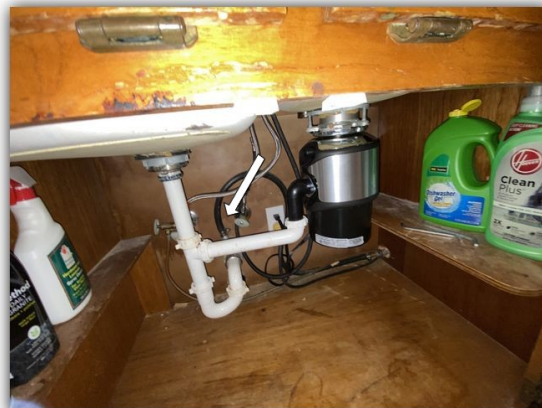
I observed where dishwasher drain is connected to the sewer side of the trap at time of inspection. The dishwasher drain hose is recommended be connected before the P trap, not on the sewer side of the trap. The water "held" in the P trap prevents gases coming back into the dishwasher from the sewer. At time of inspection unpleasant odors could back flow from dishwasher. Recommend evaluation for repairs allowing dishwasher to drain as should.

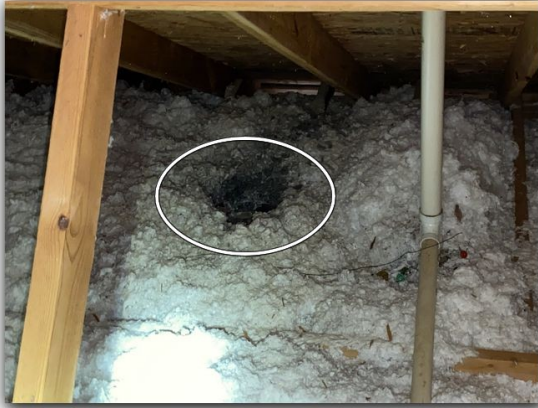
I observed where the bathroom vents for home appeared to terminate in the attic area. It is not typical to vent directly into an attic even if the attic itself is vented. The excessive moisture could cause condensation on the roof members, insulation, and could eventually cause mold. Would recommend terminating vents to outside.

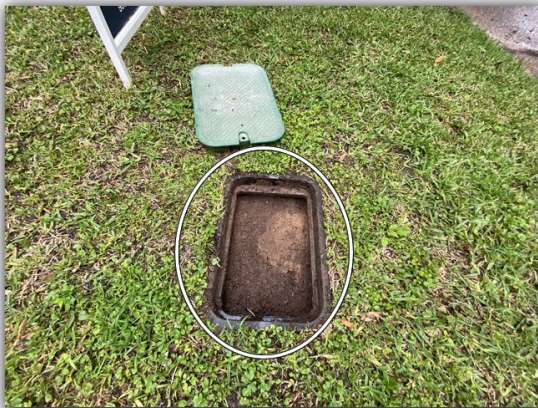
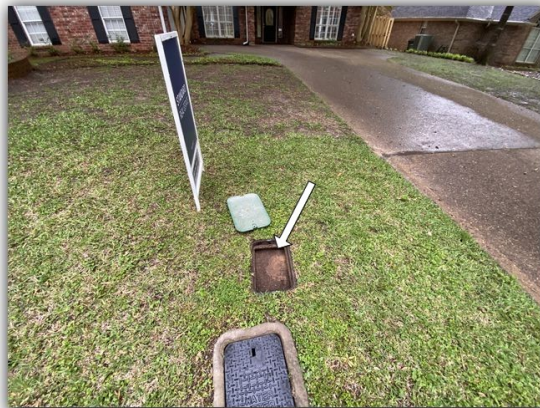
I observed back flow preventer found completely covered with dirt at time of inspection. While unit may work properly when covered the moist dirt could eventually rust away shut off valves on back flow keeping one from shutting down irrigation system if needed or desired. Recommend evaluation for possible repairs if needed removing noted areas of dirt of unit

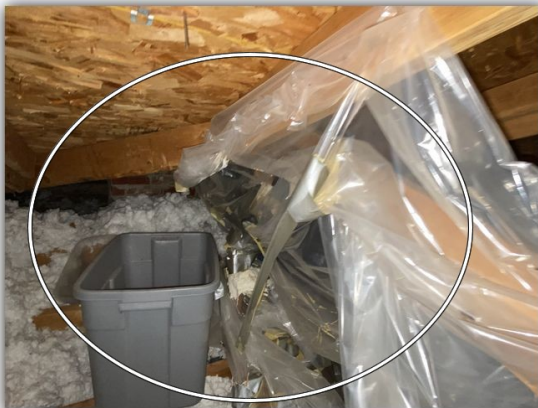
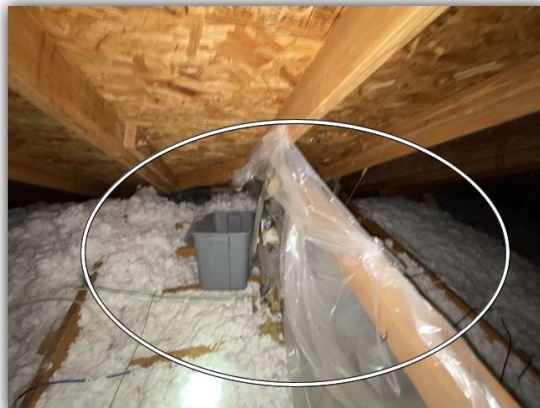
Attic area

No evidence of damage noted in living room below affected areas

I observed an area in attic over living room near chimney where it appears that a leak might have occurred at some point in roof area at time of inspection. Further evaluation did not find any obvious evidence of moisture entry with hands on dry wood supports. Note: heavy rain night before inspection which would have allowed for water entry if active leak. Home presenting with new roof which most likely remedied any past moisture entry concerns. Recommend monitoring noted areas for any noticeable changes.

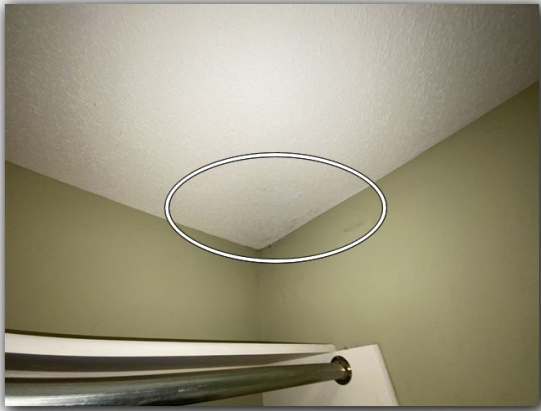
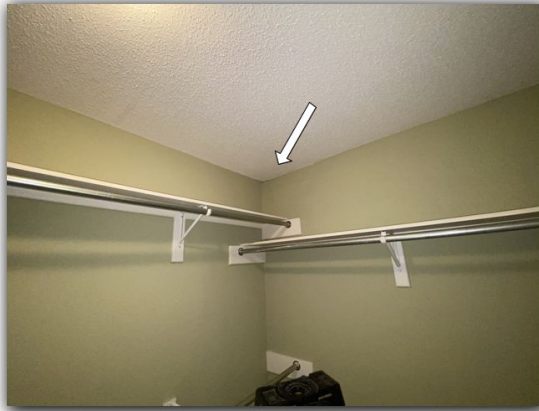
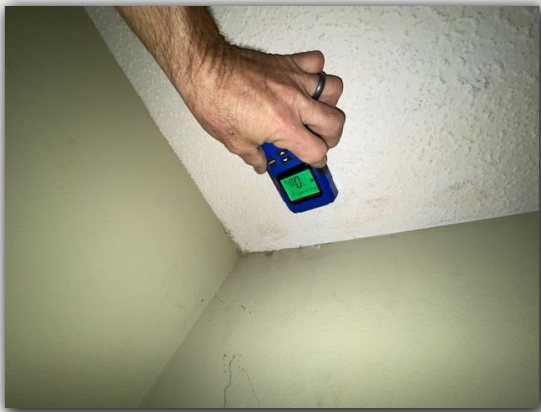
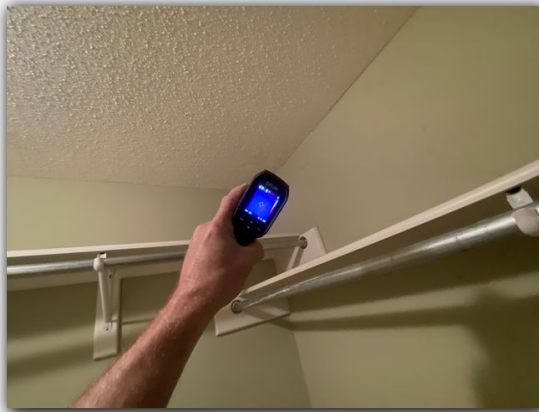
Master closet corner

I observed an area an possible moisture staining / moisture damage noted near outside corner of master closet at time of inspection. Further evaluation did not find obvious evidence of moisture when assessed with moisture meter and thermal camera. Attic area found where AC suction line found to make entry into attic through exterior wall over affected areas. Heating and AC unit appears to be newer with outside unit showing 2022. Area of damage most likely from deficient insulation over suction line for AC which will allow for condensation in hot attic allowing for moisture on insulation and eventually onto sheet rock. Noted area does not present with evidence of damage liquid or suction lines for AC at time of assessment. Recommend monitoring area for any noticeable changes.

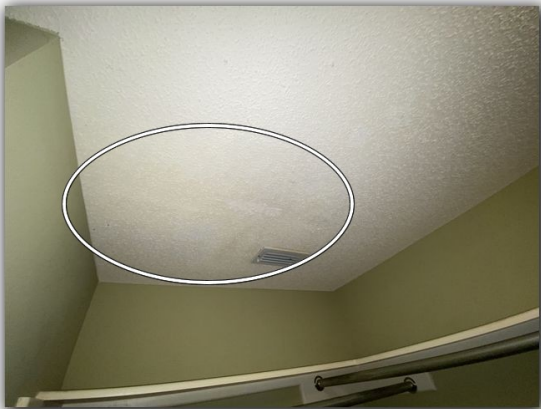
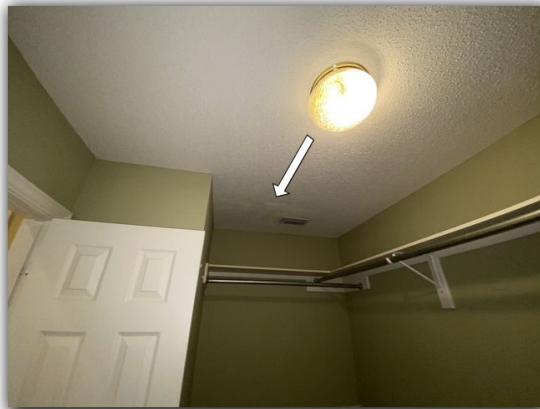
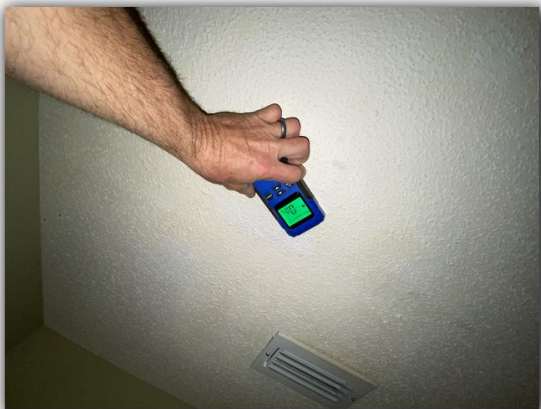
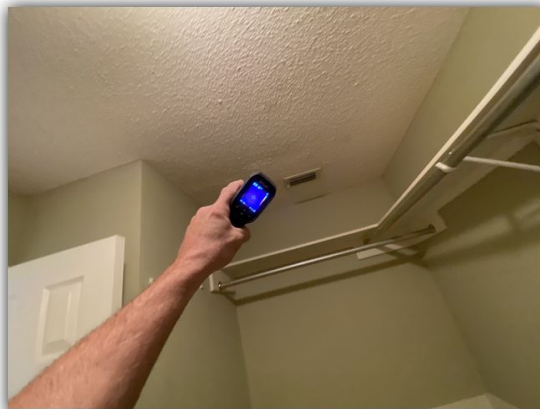
Master closet area

I observed an area an possible moisture staining / moisture damage noted in master closet area at time of inspection. Further evaluation did not find obvious evidence of moisture when assessed with moisture meter and thermal camera. Attic area found evidence of moisture on insulation below water heater roof termination. Home presenting with new roof with no obvious evidence of water entry at time of inspection with heavy rain night before inspection. Most likely newer roof as remedied any past moisture entry issues. (Note: inspector can not verify this at time of inspection.) Recommend repairs to ceiling if desired monitoring noted areas for any noticeable changes.

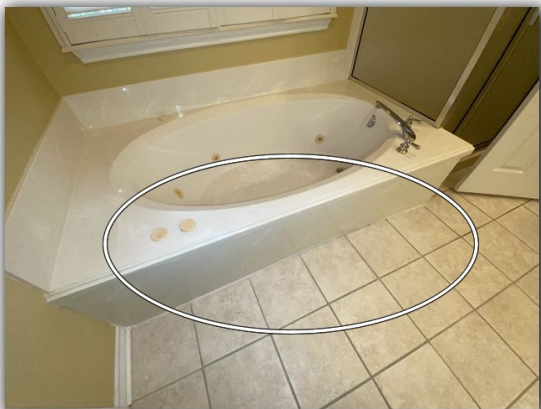
Access panel in inaccessible / missing at time of inspection. This is commonly seen with the cosmetic appeal more apparent than ease for possible repairs to unit if ever needed. Mind set is that it would be better to remove noted surround(s) on spa tub for access if needed than having a possible unattractive opening under / near tub. Recommend evaluation for repairs if desired and/or monitor area in case ever needed.
