David K. Smith
Professional Home Inspector Lic #21666

PROPERTY INSPECTION REPORT

Concerning: 1234 Drive, Somewhere, TX 75605
(Address or Other Identification of Inspected Property)

By: David Smith, Lic #21666 04/07/2023
(Name and License Number of Inspector) (Date)

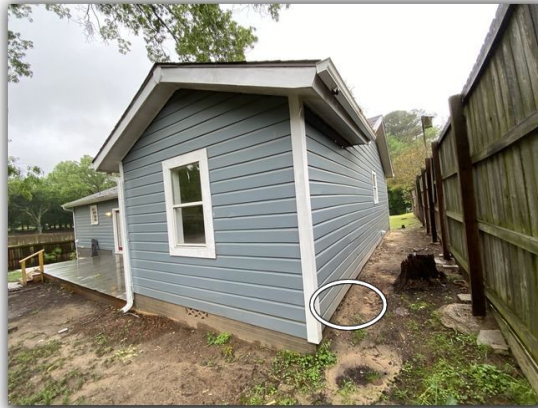
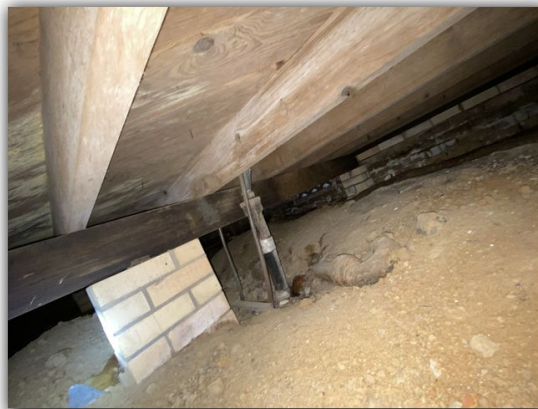
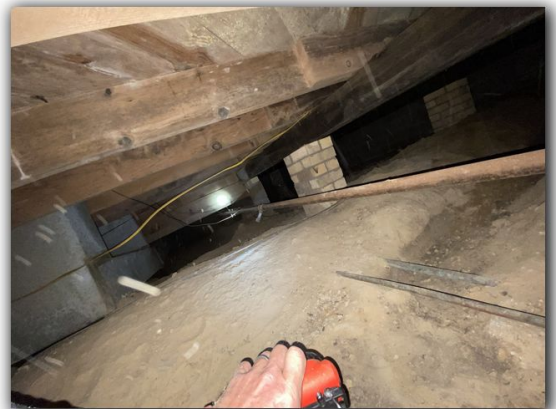
- Crawlspace vent noted near grade level.
- I observed an area of pooled water under master bedroom area at time of inspection. It appears that water can make entry near left rear corner of home through crawl space vent that is ground / grade level. Recommend evaluations for repairs allowing water to move away from home as should.

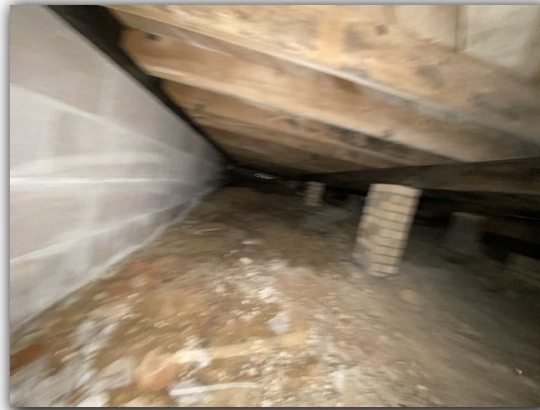
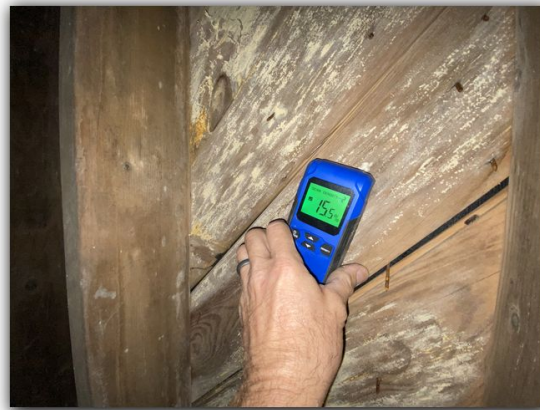
15-25 percent moisture found under home. Less than 27 percent found within normal limits.

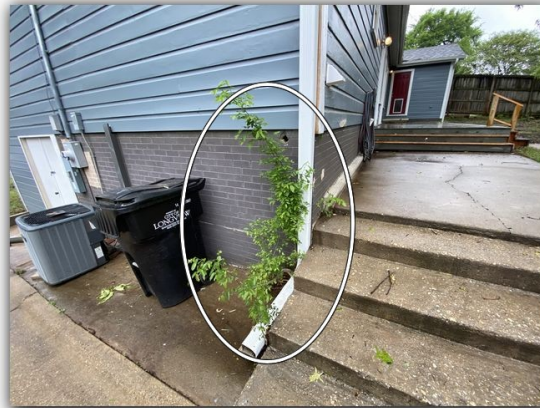
- I observed where foliage found to be too close to the structure at time of inspection. It is recommended that bushes and vegetation should be at least 12 inches from wall contact. Recommend cutting or trimming noted vegetation allowing for appropriate barrier.

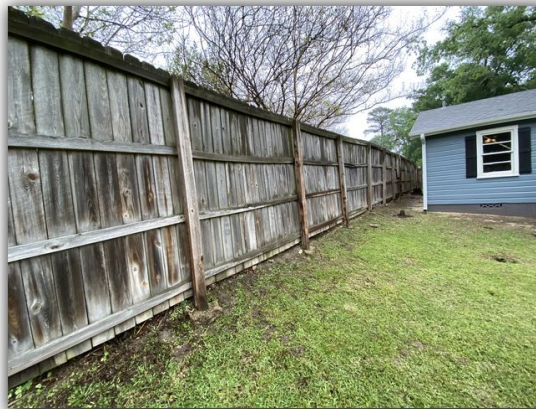
Various areas of privacy fence near property boundary appears to be damaged at time of inspection. Inspector can not verify who may own fence.

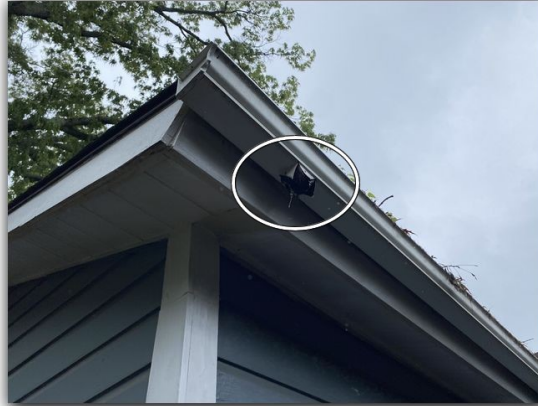
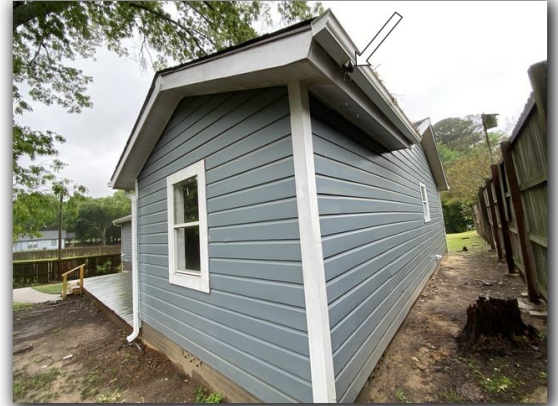
I observed an area near back left corner of home where down spout for home gutter appears to be missing at time of inspection. Recommend evaluation for repairs allowing water to run away from home as should.

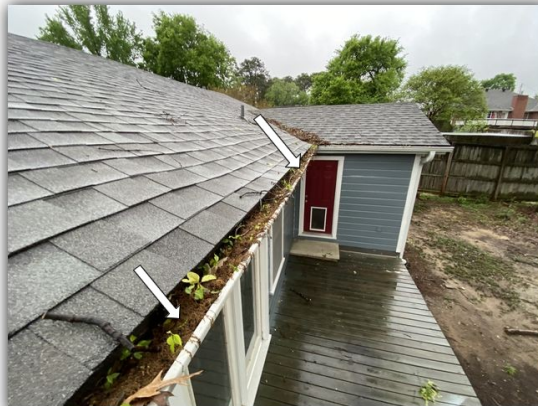
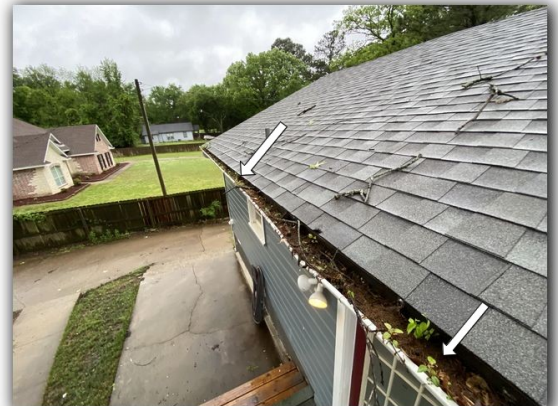
I observed an area of roof with damage from past limb strike at time of inspection. Noted area of damage to gutter as well.

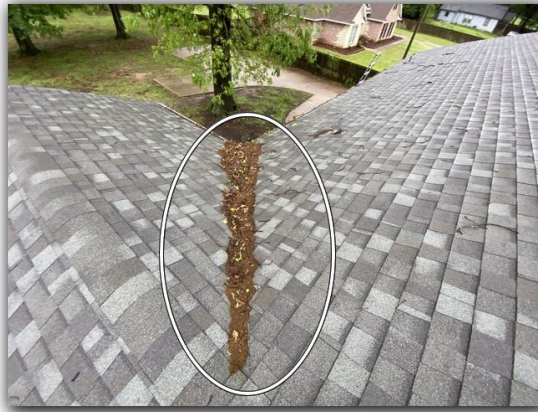
I observed roof area with moderate amounts of debris buildup at time of inspection. Debris buildup on roof area is conducive for water penetrations. Recommend cleaning roof area.

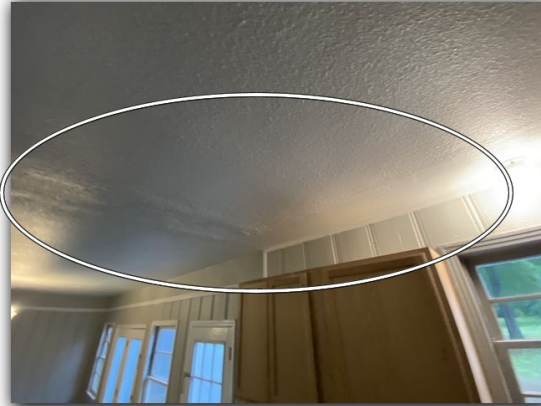
Note: areas on ceiling in kitchen appears to be where upper cabinets pulled at some point. This is not considered to be any issues.

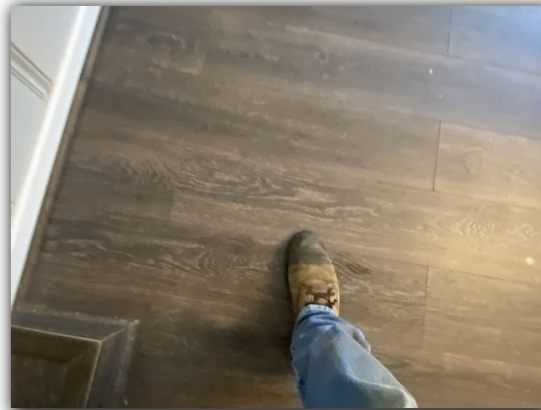
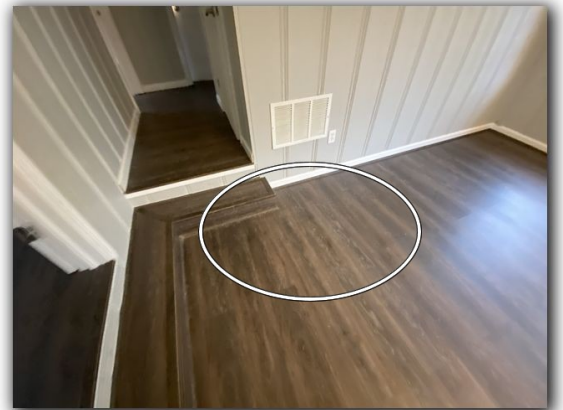
Dining room area

I observed where various areas in home presented with floors that appear to buckle or cup at time of inspection. This can be caused by any number of potential issues. Humidity, possible water leaks, installation prior to allowing floors to adjust and/or acclimate to environment, or possibly installed without allowing room for expansion. In this case it appears that thermal expansion is the culprit. The fix might be to pull quarter round or trim around the edge and see if there is adequate expansion / gap allowing for possible movement making adjustments if needed. Recommend evaluation for repairs if desired monitoring noted areas for any noticeable changes.

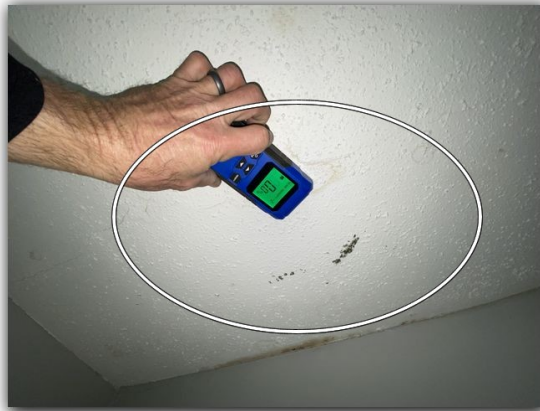
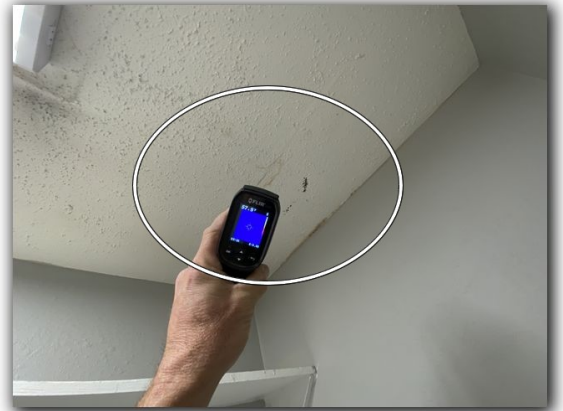
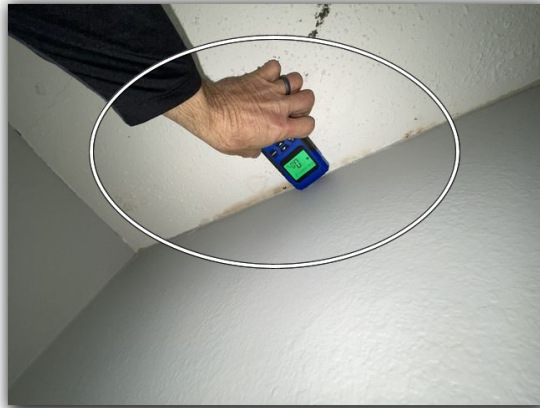
Laundry room

I observed an area an possible moisture staining / moisture damage noted over laundry area at time of inspection. Further evaluation did not find obvious evidence of moisture when assessed with moisture meter and thermal camera. Attic area found evidence of moisture with roof area finding where newer roof has been installed. Appears that roof has received possible limb strike from tree above. Most likely newer roof as remedied any past moisture entry issues. (Note: inspector can not verify this at time of inspection.) Recommend repairs to ceiling if desired monitoring noted areas for any noticeable changes.

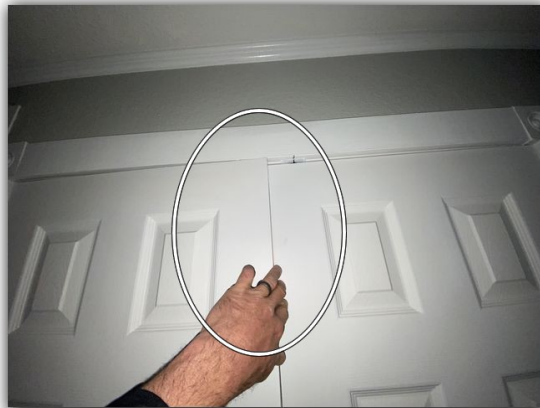
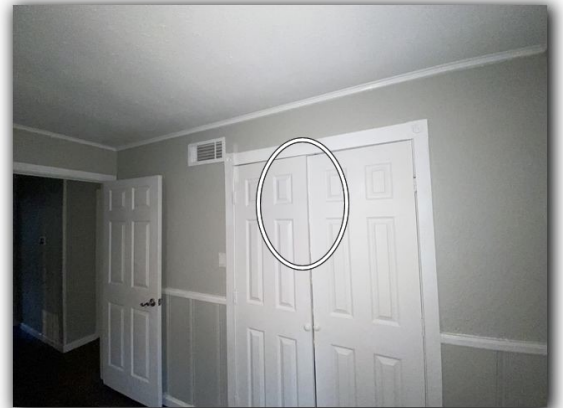
- Front left bedroom double closet doors

I observed where various doors in home appear to 'stick' when attempting to open/close at time of inspection. Recommend evaluation for possibly adjusting door(s) allowing door to work as should.

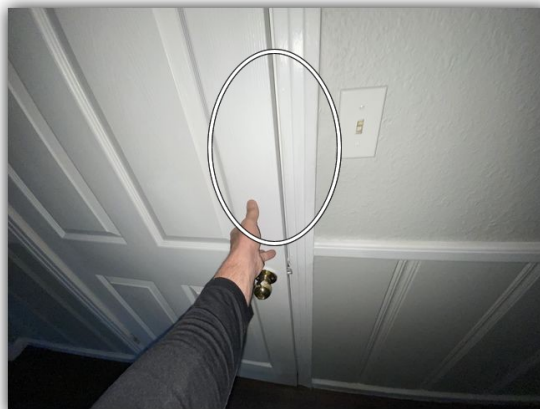
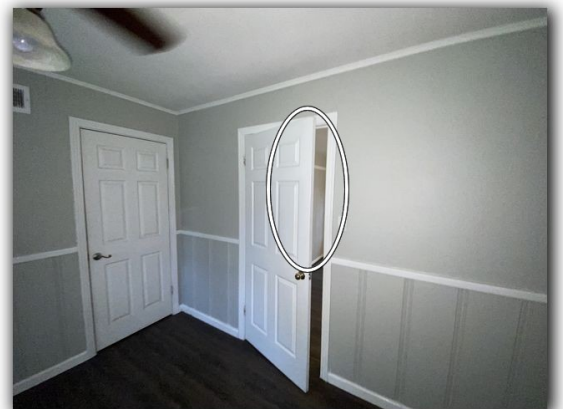
- Front middle bedroom entry door

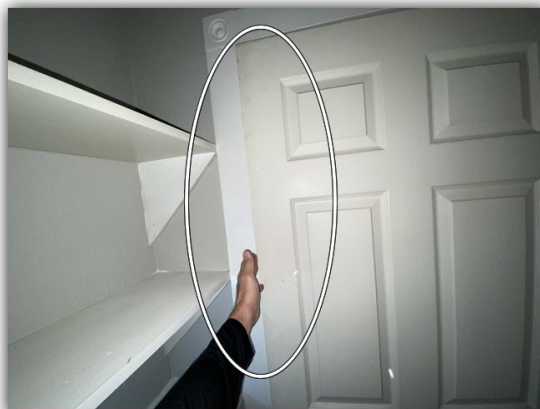
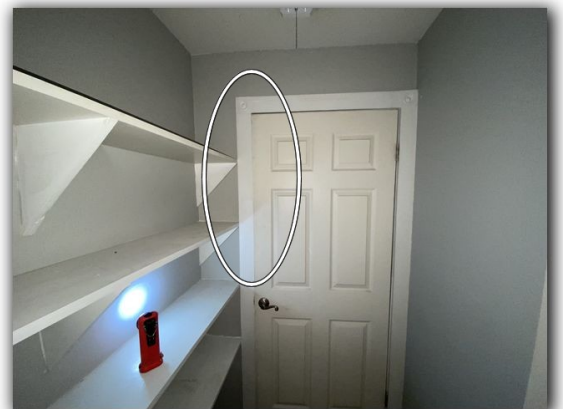
- Utility / laundry room door

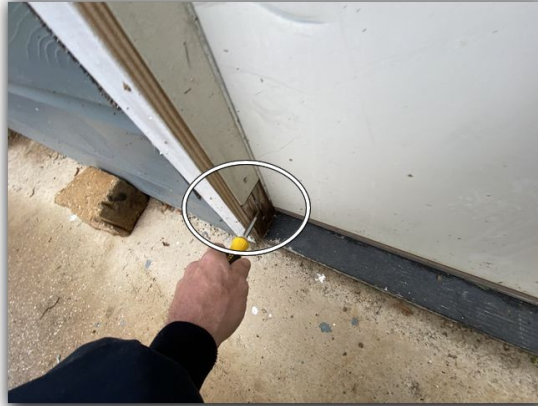
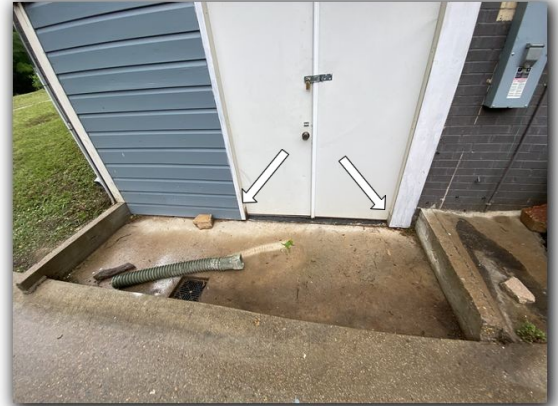
- Basement double doors have had door jams cut and replaced leaving areas of exposed wood.

I observed an areas on exterior of home found with exposed wood / door surround at time of inspection. Doors appear to be in good working condition with exposed wood / trim noted at time of assessment. Recommend evaluation for painted noted exposed wood keeping areas protected from possible moisture exposure / damage.

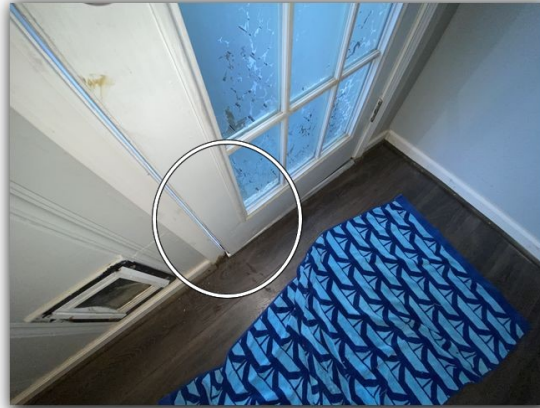
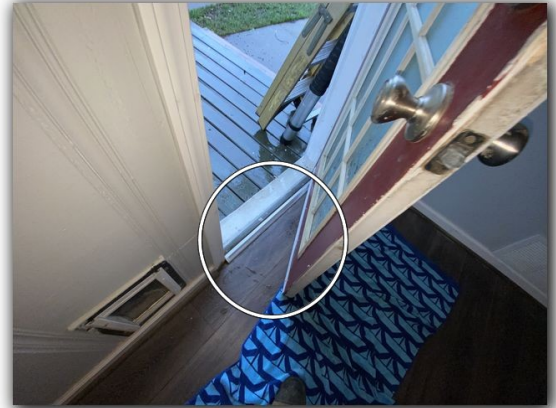
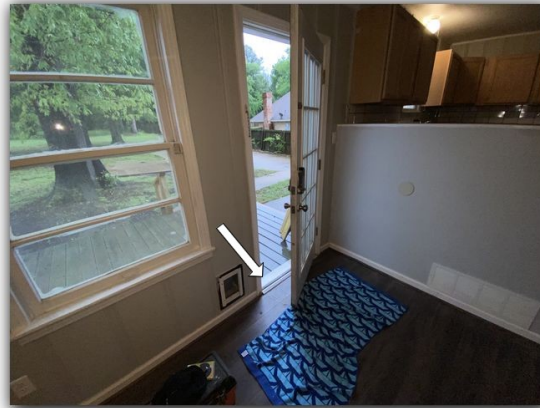
I observed where rear single entry / exit door near back of home found with door that appears to 'stick' when attempting to open/close at time of inspection. Recommend evaluation for possibly adjusting door(s) allowing door to work as should. Note: weather stripping near bottom of door may not be appropriate at time of inspection. Areas of weather stripping in place but inspector could still see day light near bottom of door when door closed.

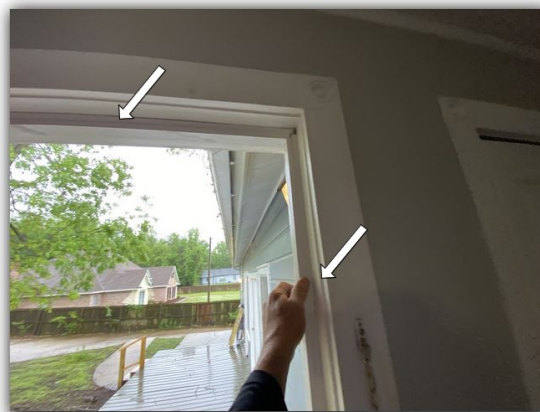
I observed areas of damaged weather stripping near master bedroom exterior door area at time of inspection. Missing weather stripping may allow conducive conditions for unconditioned

air to make entry into home as well as conditioned air to escape. Recommend evaluation for repairs allowing home to work as efficiently as possible.

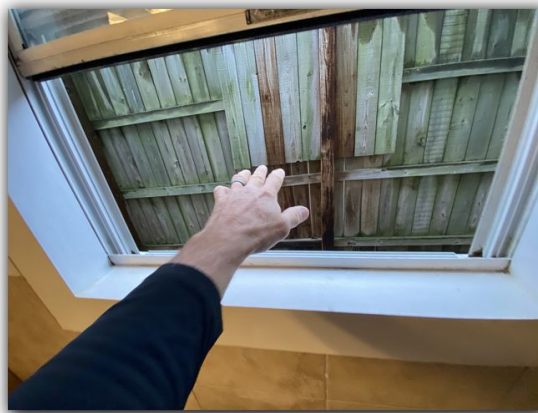
Various screens missing on home at time of inspection.

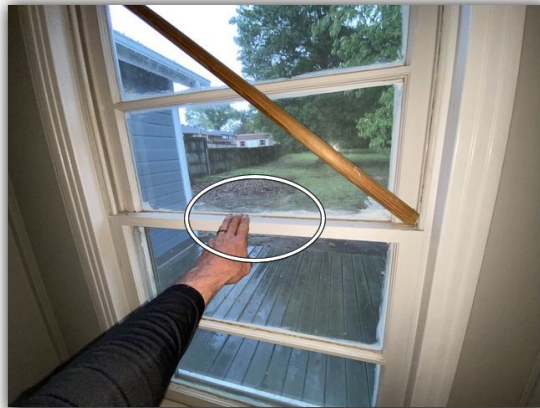
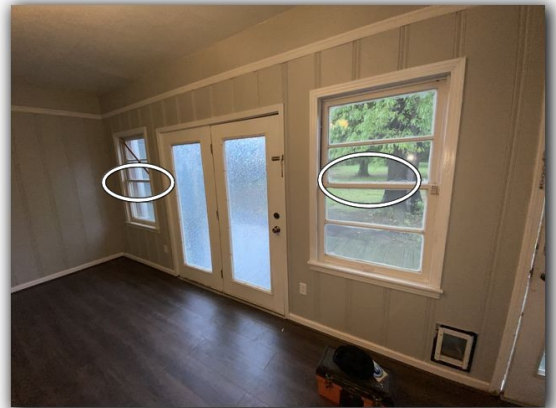
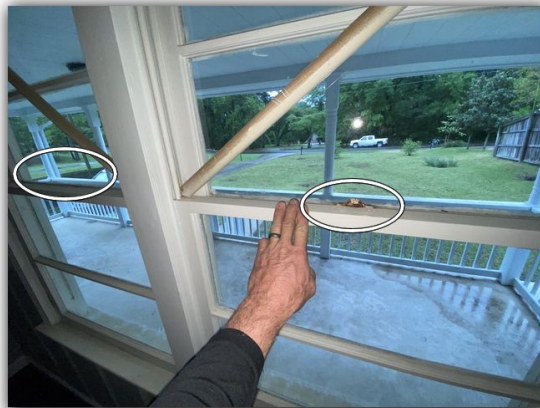
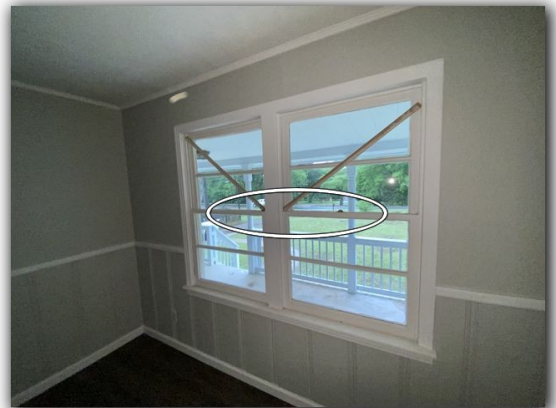
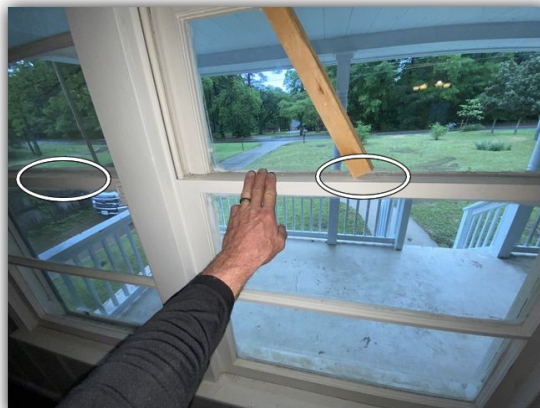
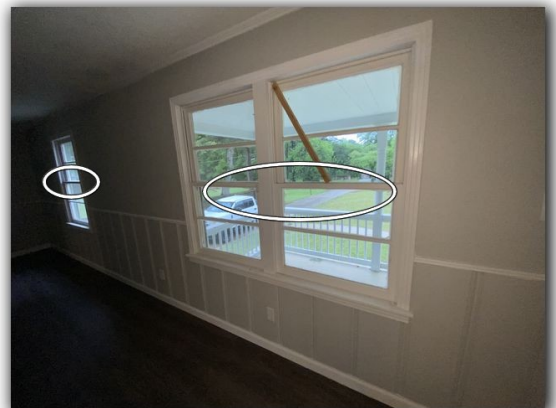
I observed various windows in home with damaged / missing window locks at time of inspection. Noted 'stick' placed in window for lock. Recommend evaluation for repairs allowing windows to lock securely as should.

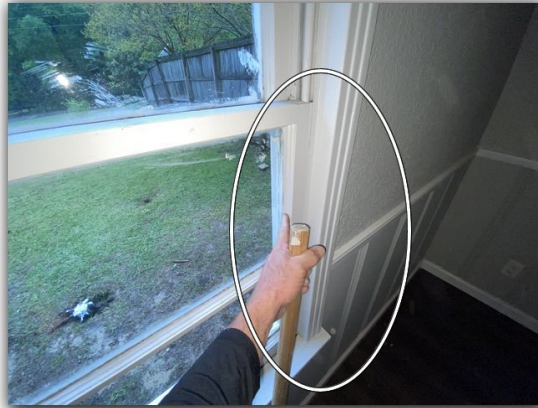
I observed where wood pane cased windows found to be painted shut at time of assessment. Windows in bedrooms / sleeping rooms should open allowing for functional emergency escape and rescue openings. Recommend evaluation for possible repairs if needed allowing for normal / safe function.

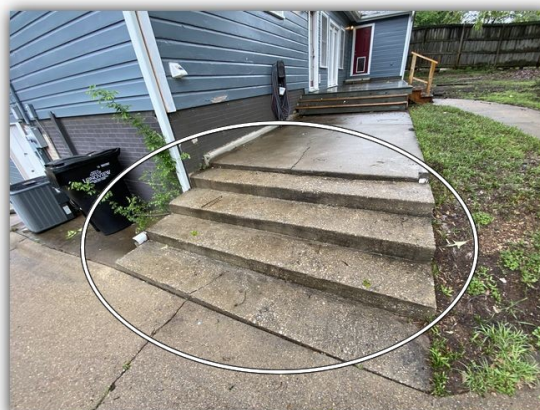
I observed where some of the exterior stairs do not have a hand rail on either side at time of inspection. Typically on any interior or exterior flight of stairs having more than 4 risers they should have a hand rail on one side of the stair. Would consider adding appropriate hand rail for safety purposes.

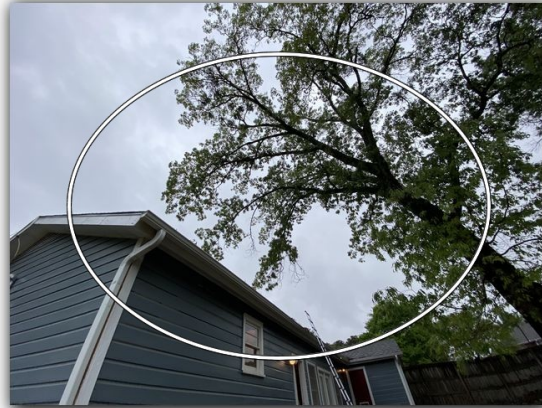
I observed where larger tree in back yard with obvious large limbs over home at time of inspection. Possible that falling limbs could come in contact with home / roof structure. Recommend possible evaluation from tree specialist / arborist to assess for possible removal of unsafe limbs if needed.

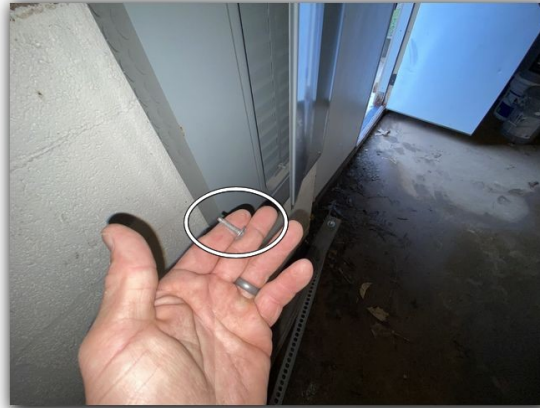
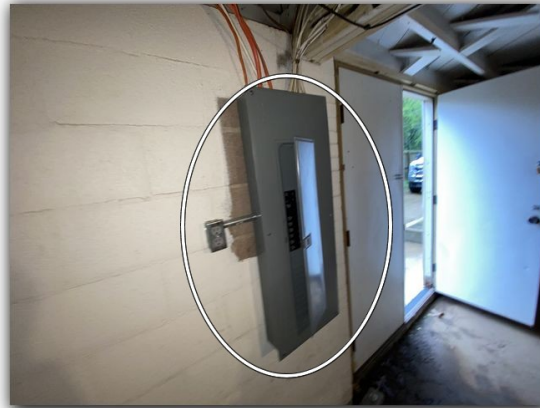
I observed where panel cover screws do not hold panel cover in place as should. It appears that securing screws are too small for cover. Attempts to screw in allowed screws to 'pop out' when installed. Recommend evaluation for repairs allowing load center panel cover to be covered as should.

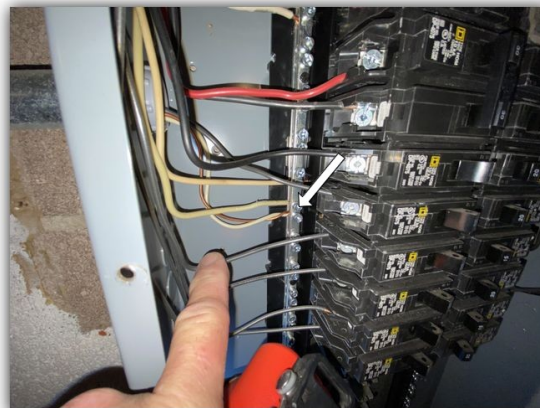
- Only 1 double tapped neutral / ground noted.
- I observed where ground bar has neutral and grounds double tapped at the time of inspection. Under today's code each grounded conductor should terminate within the panel board in an individual terminal that is not also used for another conductor. When the neutral is disconnected,

the objective is to still have the equipment ground solidly connected to the grounding electrode. If both the neutral and grounded conductor is under the same terminal, this cannot be accomplished.

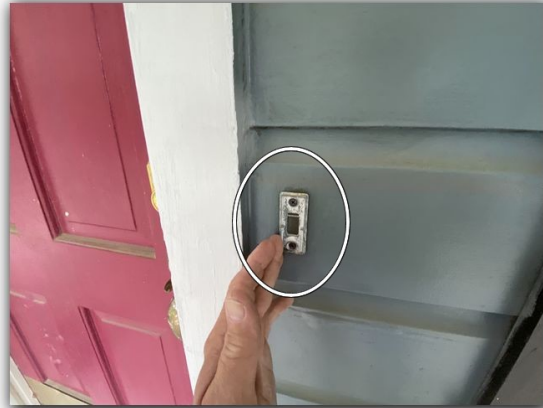
I observed where door bell button missing on home at time of inspection.

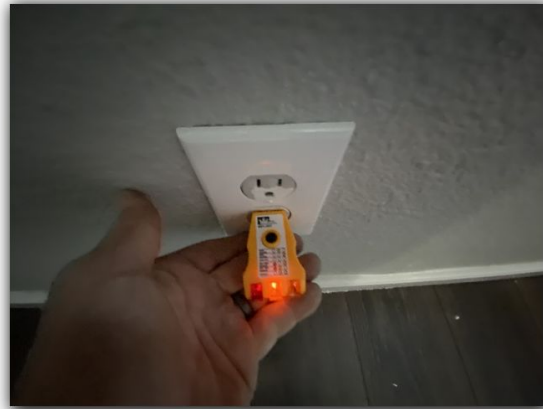
I observed where house has 2 and 3 prong ungrounded receptacles at time of inspection. Ungrounded 2/3 -prong electrical outlets do not provide an effective pathway for equipment grounding procedures. While acceptable, this older wiring method may limit the use of some modern appliances such as refrigerators, washing machines, computers, etc., that require a grounding conductor. Surge protector(s) may be recommendation for various applications.

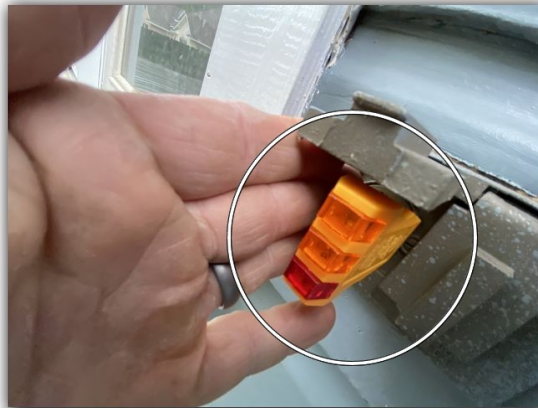
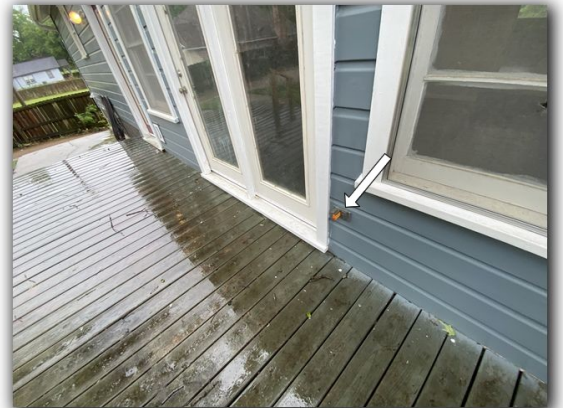
Exterior of home

I observed where exterior receptacle on back porch area did not present with power at time of inspection. Note: receptacle on interior wall adjacent to exterior receptacle found without power as well. Recommend evaluation for repairs allowing home receptacles to work as should.

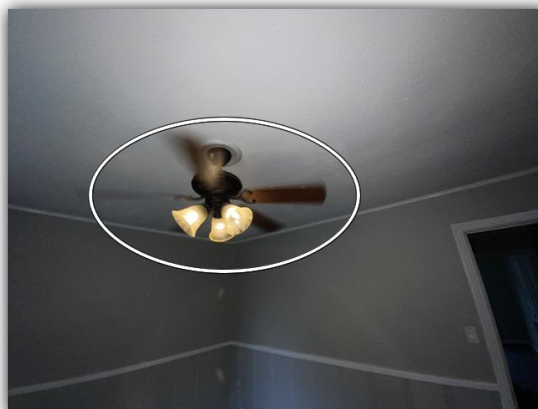
I observed where ceiling fan in front left bedroom out of balance with operating at time of inspection. Noted 'wobble' very obvious. Possible that fan blades may need to be tightened or adjusted to allow for normal use.

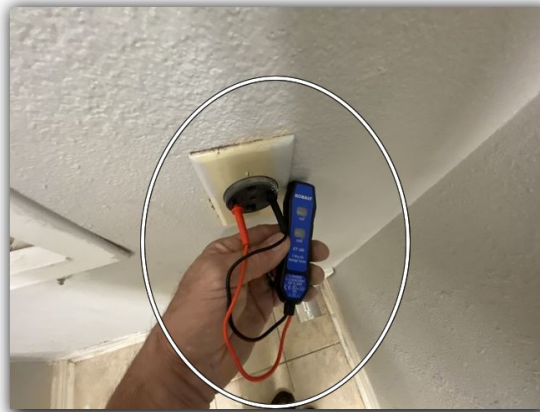
I observed where dryer receptacle does not appear to be working at time of inspection. Note: power on to dryer receptacle on panel. Recommend evaluation for repairs allowing receptacle to work as should.

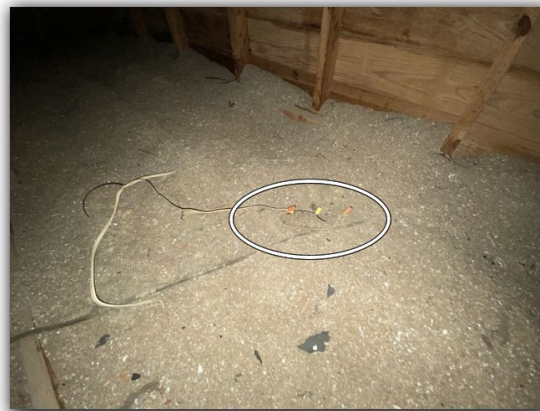
I observed various areas in attic presenting with open junction boxes and/or inappropriate splices made to wiring at time of inspection. Areas noted should be made up in approved or appropriate junction boxes. Recommend evaluation for repairs.

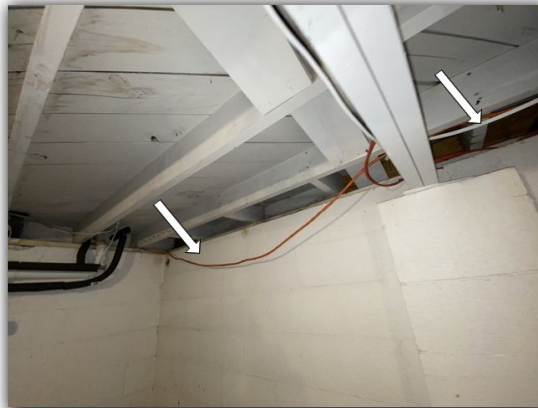
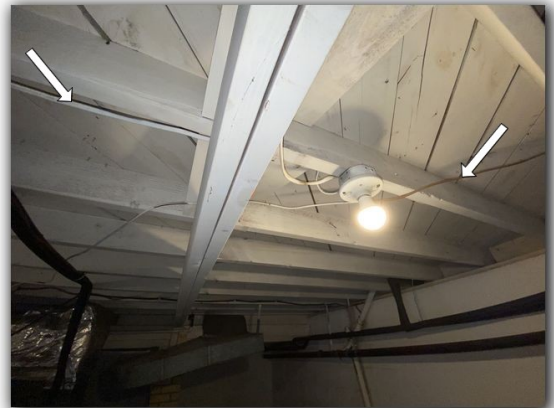
- Wires are "exposed" in basement and should be protected. Romex is fine when it is inside a wall/ceiling/floor because it is protected from puncture/cuts/etc.

I observed various areas with exposed electrical wiring at time of inspection. Romex is designed to be used inside walls, attics, and/or in conduit. Exposed wiring is subject to physical damage and should be protected. Recommend evaluation for enclosing noted wires in some fashion of conduit for added safety.

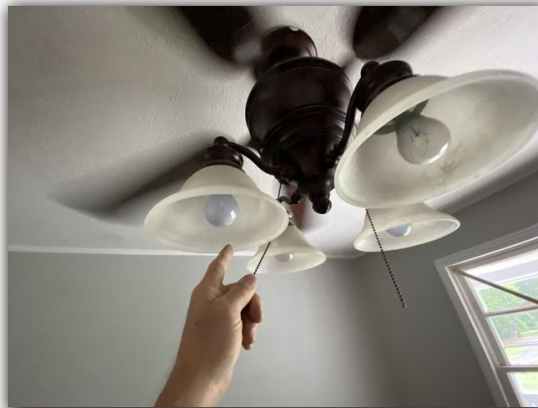
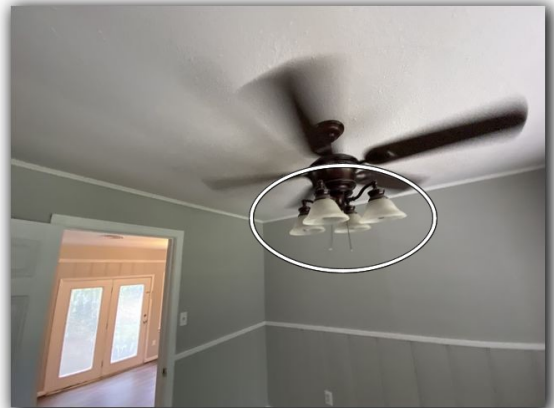
Front middle bedroom light kit would not turn on with 4 bulbs in place

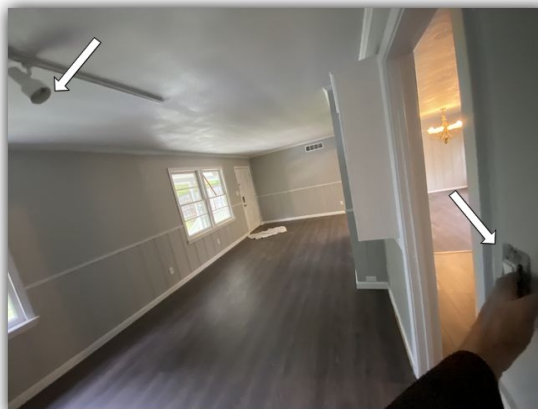
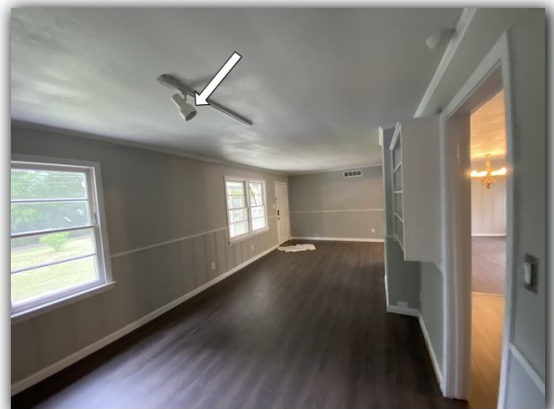
Track light in dining room would not turn on with attempts

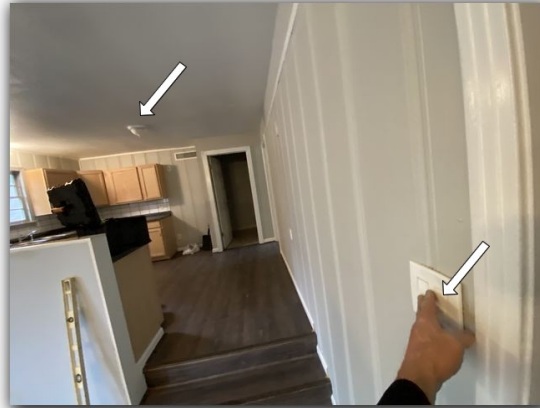
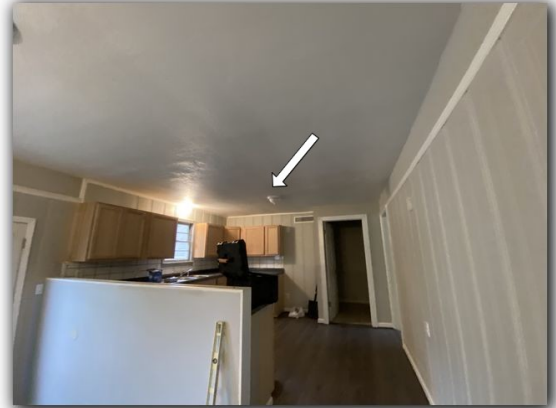
Kitchen light would not turn on with attempts

I observed where various light fixtures / light kits would not turn on with attempts at time of inspection. Possible that bulbs / lamps may be burnt out but the number of fixtures not working may allow for reasons to think issues could be electrical.

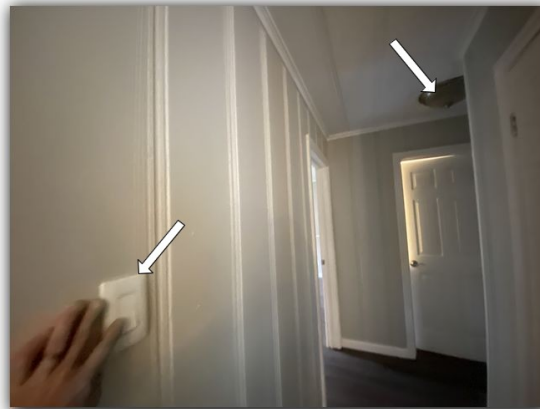
Hallway light would not turn on with attempts

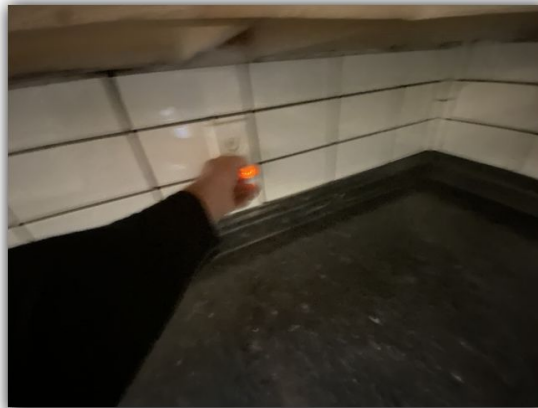
Missing GFCI protection in kitchen area

No GFCI/ARC Fault protection at one or more location. This is considered a recognized safety hazard. GFCI protection was not provided in the home at locations where it now deemed necessary. GFCI protection may not have been required at the time the home was built, but for safety reasons it is recommended that GFCI protection be installed at all the following locations: • Bathrooms • Exterior • Garages • Crawlspc (at or below grade) • Unfinished basements • Kitchens • Laundry rooms • Within 6 feet of all plumbing fixtures. Recommend evaluation for possible repairs and / or replacement of deficient receptacles for added safety.

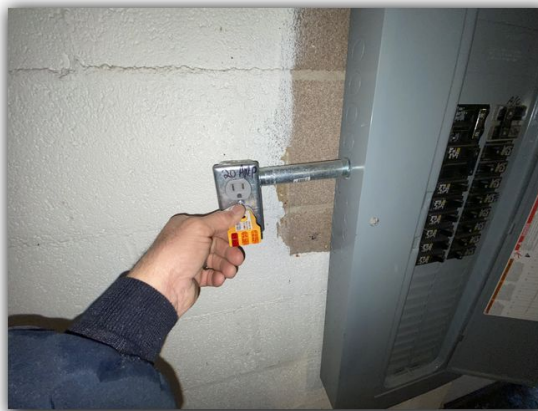
Missing GFCI protection in basement area

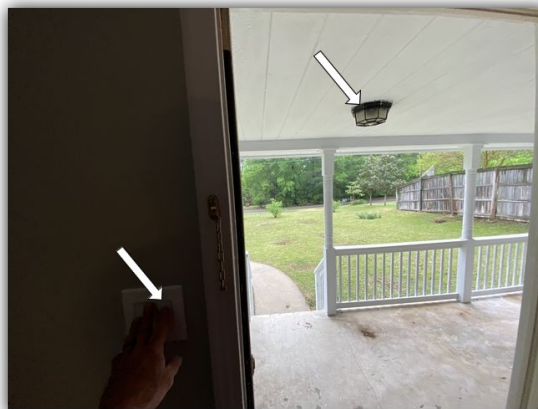
Front porch light would not turn on with attempts

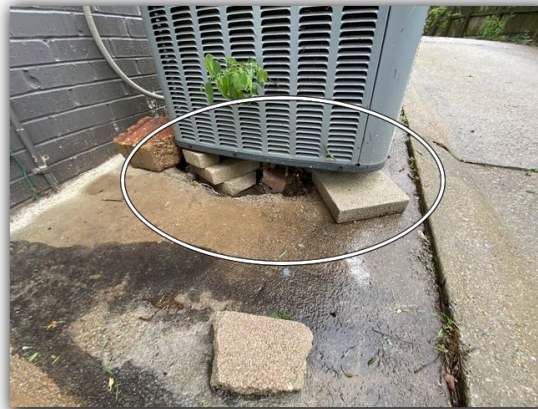
I observed where outside unit sitting on pieces of cement block(s) at time of inspection. Noted condition could allow for movement over time which could cause harm to outside unit. Typically outside condenser unit placed on solid flat surface or pad.

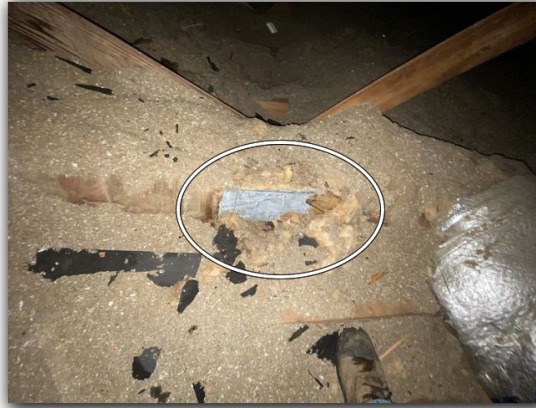
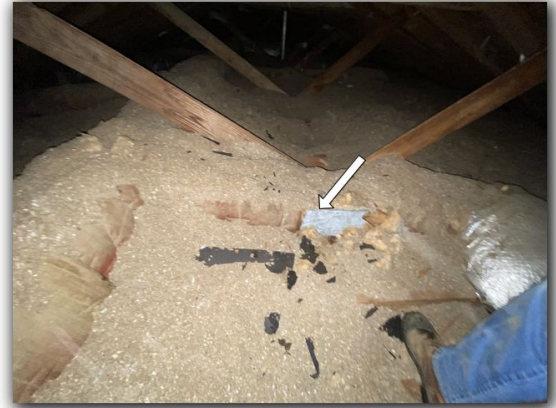
I observed an area in attic where it appears that outer shell of covering insulation has separated from metal ductwork at time of inspection. Areas such as this allow hot / cold duct in an unconditioned attic to possible create moisture / condensation. Recommend evaluation for repairs allowing home to work as efficiently as possible.

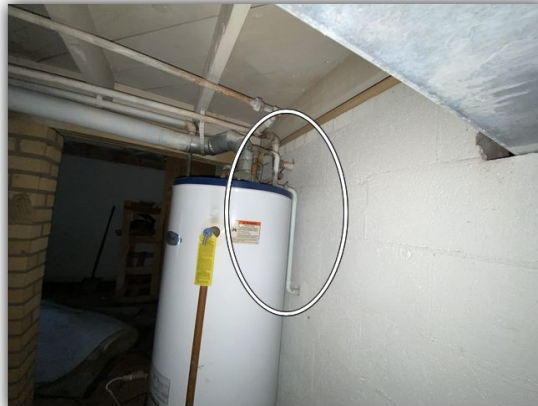
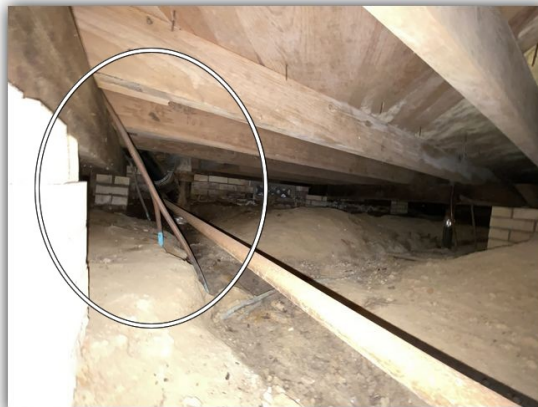
I observed where water lines under home were without adequate insulation at time of inspection. Areas such as this crawlspace could be exposed to freezing temperatures creating conducive conditions for possible pipes to burst. Recommend evaluation for appropriate

installation of insulation over noted exposed main water lines keeping home working as efficiently as possible.

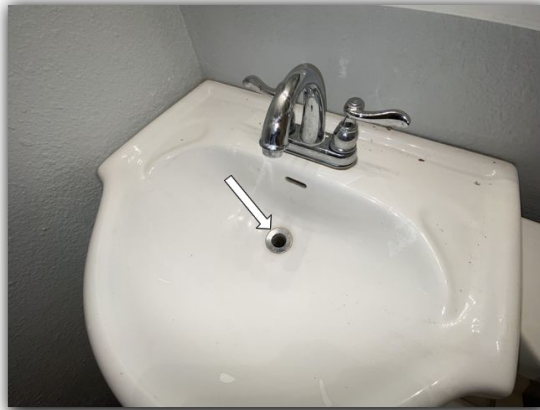
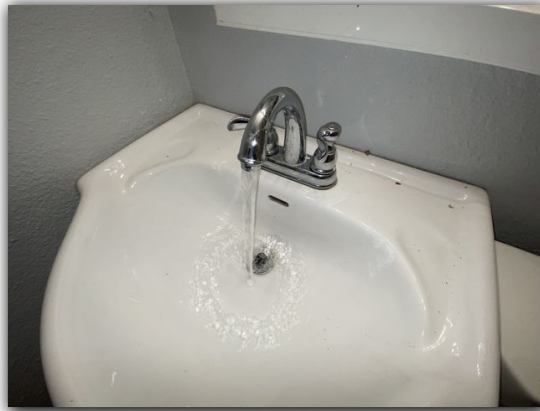
Master Bathroom

I observed where master bathroom sink drain stop was not installed appropriately at time of inspection. Recommend evaluation for installing drain stop per manufacturer specifications allowing drain stop to work as should.

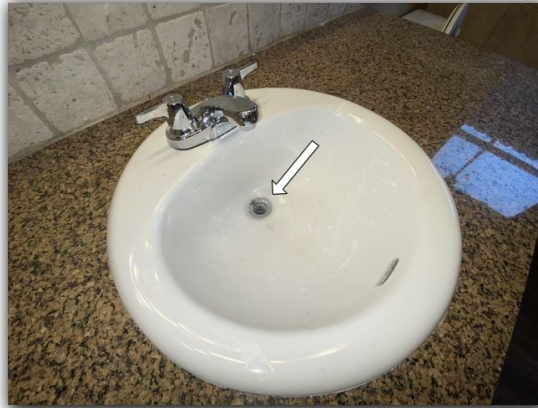
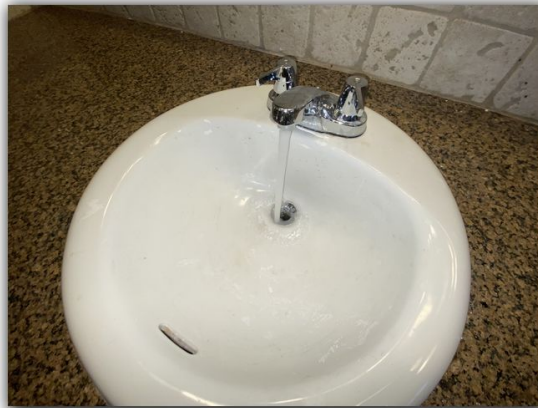
Hallway Bathroom

I observed where hallway bathroom sink drain stop was not installed appropriately at time of inspection. Recommend evaluation for installing drain stop per manufacturer specifications allowing drain stop to work as should.

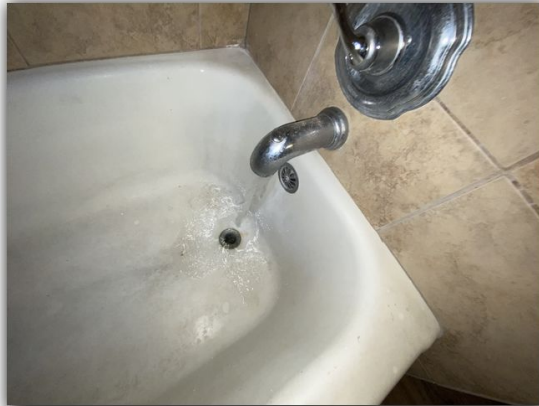
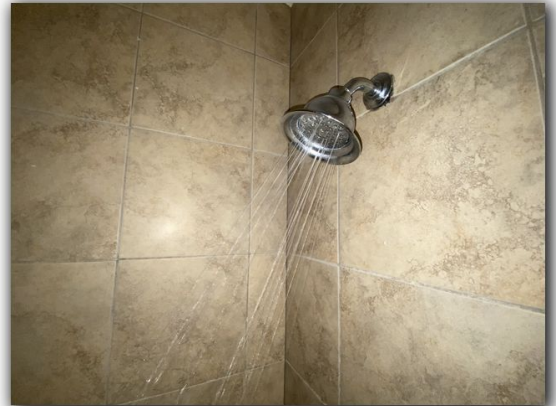
I observed areas of minor separation between shower / tub fixtures and surround. Noted areas allowing for conducive conditions for water entry under the right conditions. Recommend evaluation for sealing noted separations allowing shower / tub to work as efficiently as possible.

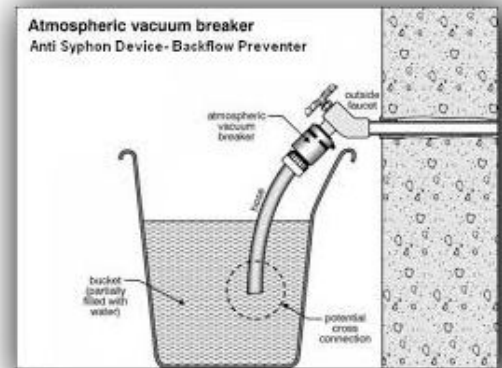
Example back flow preventer

- Missing back flow preventer. The back flow preventer keeps contaminated water from entering potable (drinking) water.

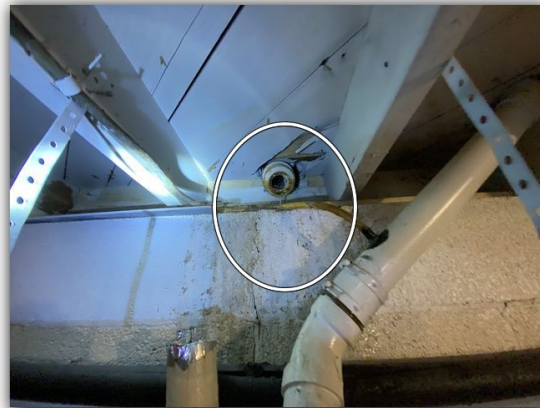
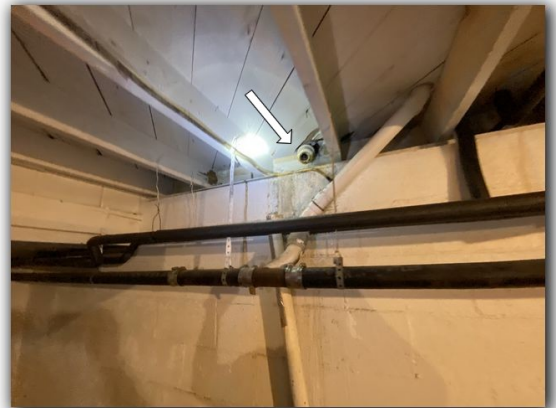
I observed an obvious leak under master bathroom shower drain line at time of inspection. Inspector performs volume test in home running water for approximately 30 minutes. Obvious water under master bathroom shower and on ground. Recommend evaluation for repairs allowing shower drain to work as should.

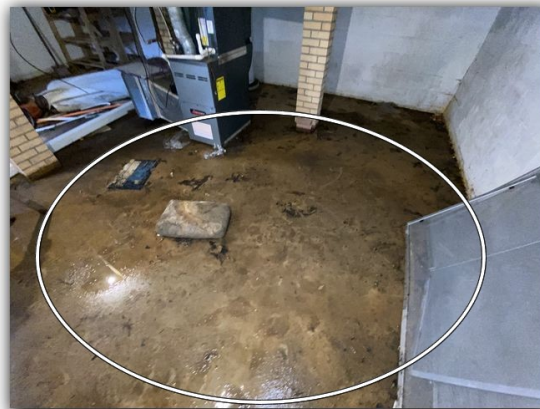
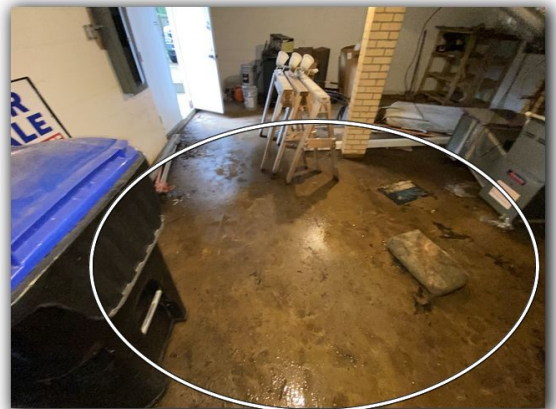
Water flowing from cut vent stack

I observed where basement found with pooled water on floor at beginning of inspection. Further evaluation did not find any obvious reason for water entry near walls and/or entry door. Area has presented with rain for 2 days including day of inspection. Inspector noted where plumbing vent stack / drain for kitchen sink appears to have been cut with kitchen drain replaced leaving old vent stack / drain line in place. Inspector got on roof area and poured water into plumbing vent stack on roof with water free flowing into basement area from cut drain line. Recommend evaluation for covering roof top vent stack cover or removing keeping water from flowing into basement.

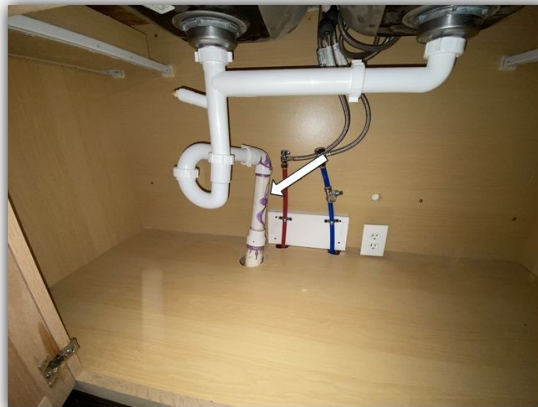
Kitchen sink

I observed where kitchen sink and laundry drain missing plumbing vent stacks at time of inspection. Sink and drainage lines need a vent because the pressure put on the drain pipe when water flows down the drain pipe needs to equalize. Recommend evaluation from qualified contractor for needed repairs allowing sink to drain as should.

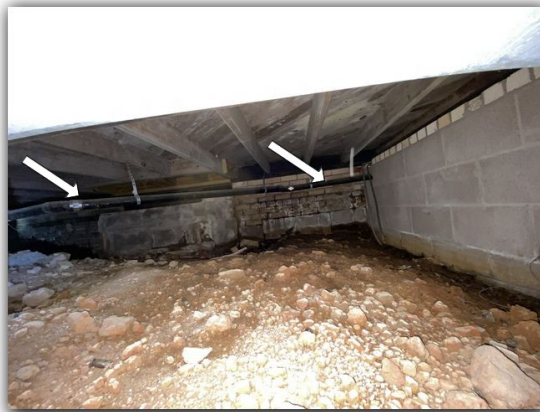
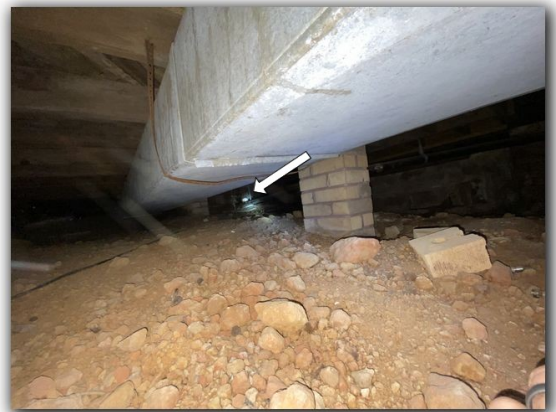
Crawlspace area

I observed long runs from various drainage fixtures in home to plumbing vent stacks at time of inspection. Fixtures include washing machine drainage and kitchen sink. Plumbing vent stack for kitchen sink appears to have been cut running newer drain lines under home. This is good news but the run to plumbing vent stack is approximately 35 feet terminating into master bathroom vent stack. Span chart may vary but rule of thumb is the distance between your trap and the vent should be no more than 6 feet. In other words, for the vent to work properly, it needs to feed into the drain line within 6 feet of the trap-ways that connect to it.

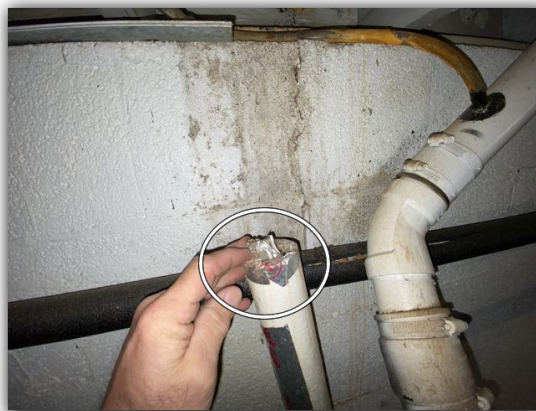
I observed where plumbing vent stack found in basement area with foil tape covering covering opening at time of inspection. This may not be appropriate and could deteriorate over time allowing unpleasant fumes to make entry into basement area.

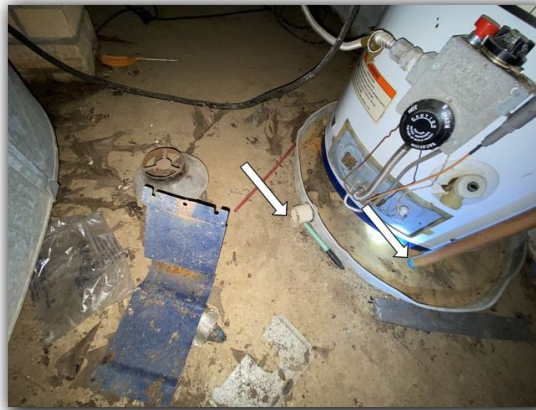
- Water heater sitting on basement floor without any drainage found for emergency catch pan or TP drain line. If heater were to fail water could fill basement area.

- I observed where the water heater drain pan did not drain appropriately at time of inspection. Water heater and Temperature Pressure Relief drain line terminate into pan with no way for water to drain as should. The drain should terminate into a suitably located indirect waste receptor, floor drain, extend to the exterior of the building, and/or suitable location. Recommend evaluation for repairs allowing water heater to have appropriate protection.

- I observed where Temperature / Pressure Relief Valve drain line missing at time of inspection. Temperature/pressure-relief or TPR valves are safety devices installed on water heating appliances, such as boilers and domestic water supply heaters. TPRs are designed to automatically release water in the event that pressure or temperature in the water tank exceeds safe levels. Noted drain lines should be installed so as to drain by flow of gravity. Recommend evaluation for appropriate repairs.
