David K. Smith
Professional Home Inspector Lic #21666

PROPERTY INSPECTION REPORT

Concerning: 1234 Drive, Somewhere, TX 75605
(Address or Other Identification of Inspected Property)

By: David Smith, Lic #21666 04/07/2023
(Name and License Number of Inspector) (Date)

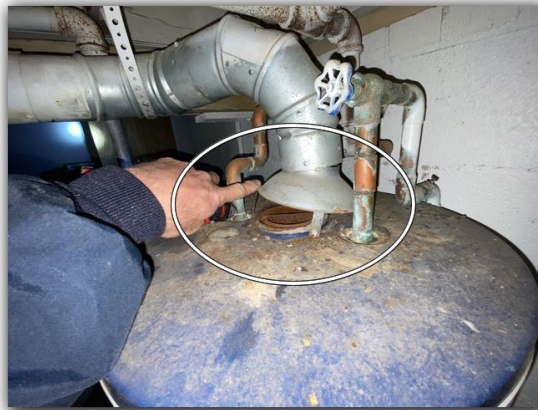
I observed where water heater draft hood appears to be displaced at time of inspection. Noted area obviously allowing conducive conditions for water heater exhaust to discharge into heater closet which could create possible fire hazard. Discharge into also creating conducive conditions for possible down draft without appropriate atmospheric pressure moving gasses to exterior allowing for possible elevated Carbon Monoxide build up. Recommend evaluation for obvious repairs allowing water heater to perform as safely as possible.

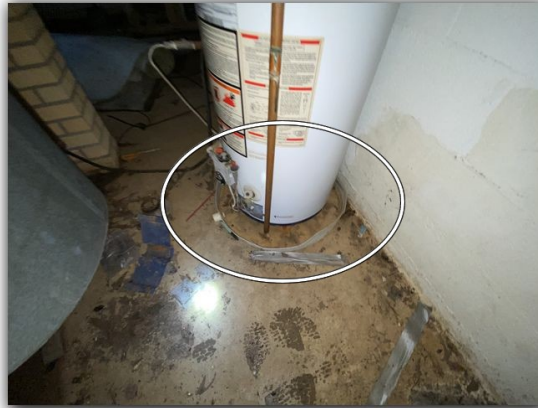
I observed where water heater located in basement sitting on floor at time of inspection. Water heaters having an ignition source should be elevated so that the source of ignition is not less than 18" above the garage / basement / stoarge floor unless entry door to garage cannot be opened. This is not the case with this heater and location. Vapors from these liquids are heavier than air and may concentrate just above floor level posing a possible explosion hazard in garages with a water heater. Recommend evaluation from qualified contractor for appropriate repairs allowing for normal and safe function

I observed where water heater located in basement sitting on floor at time of inspection. Water heaters having an ignition source should be elevated so that the source of ignition is not less than 18" above the garage / basement / storage floor unless entry door to garage cannot be opened. This is not the case with this heater and location. Vapors from these liquids are heavier than air and may concentrate just above floor level posing a possible explosion hazard in garages with a water heater. Recommend evaluation from qualified contractor for appropriate repairs allowing for normal and safe function

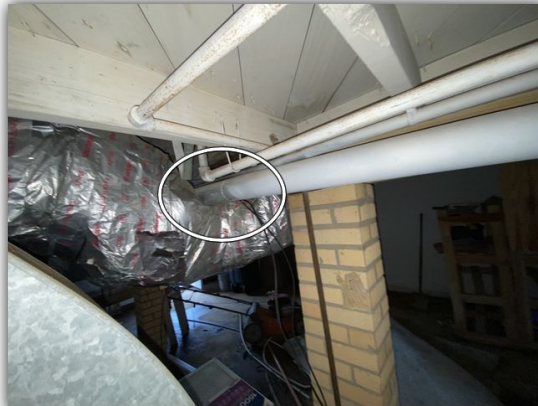
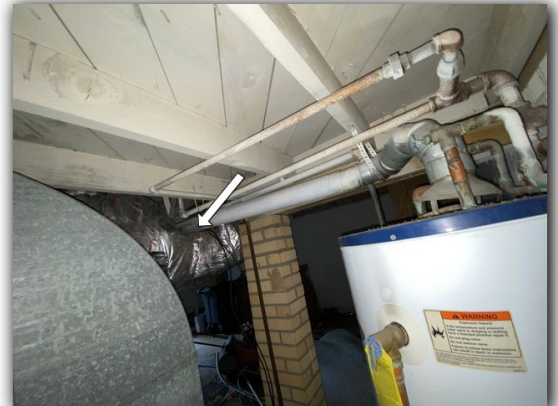
I observed where water heater flue in contact with AC duct in area above water heater at time of inspection. Note: temperatures of the vent pipe could transferred to the surrounding area (screws / paper / duct covering) and all the materials that are in the vent pipe vicinity. Air ducts can be incredibly dangerous. Not only is the dust collected highly flammable, but air ducts themselves provide a place where a fire can smolder and spread. Noted rise in temperature could be conducive for possible fire under the right conditions. Inspector unable to verify whether flue pipe is insulated at time of assessment. Double walled flues typically may need 1 - 3 inch clearance. Recommend evaluation for possible repairs allowing appropriate buffer per manufacturer specifications.

☑ I observed where water heater flue in contact with AC duct in area above water heater at time of inspection. Note: temperatures of the vent pipe could transferred to the surrounding area (screws / paper / duct covering) and all the materials that are in the vent pipe vicinity. Air ducts can be incredibly dangerous. Not only is the dust collected highly flammable, but air ducts themselves provide a place where a fire can smolder and spread. Noted rise in temperature could be conducive for possible fire under the right conditions. Inspector unable to verify whether flue pipe is insulated at time of assessment. Double walled flues typically may need 1 - 3 inch clearance. Recommend evaluation for possible repairs allowing appropriate buffer per manufacturer specifications.

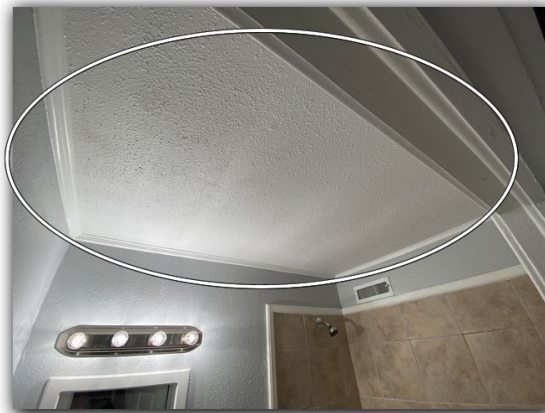
I observed where master bathroom missing an exhaust fan at time of inspection. Typically bathrooms are recommended to have an exhaust fan installed unless having access to or an operational window. Recommend evaluation for possible fan installation.

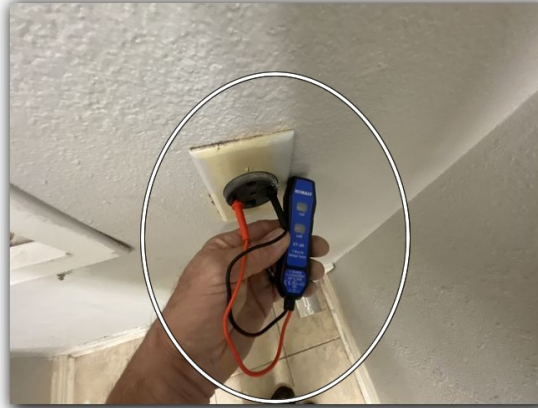
I observed where dryer receptacle does not appear to be working at time of inspection. Note: power on to dryer receptacle on panel. Recommend evaluation for repairs allowing receptacle to work as should.

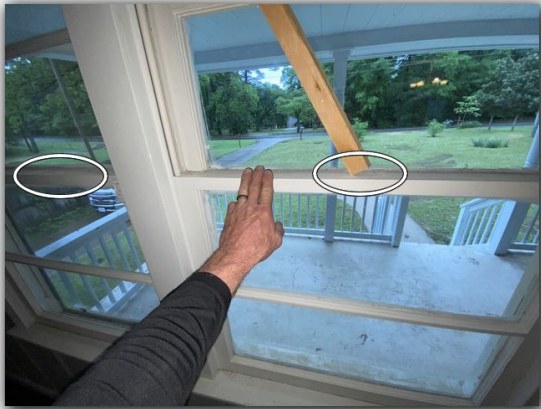
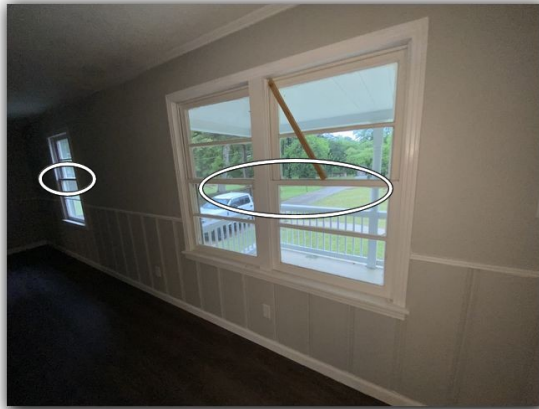
I observed various windows in home with damaged / missing window locks at time of inspection. Noted 'stick' placed in window for lock. Recommend evaluation for repairs allowing windows to lock securely as should.

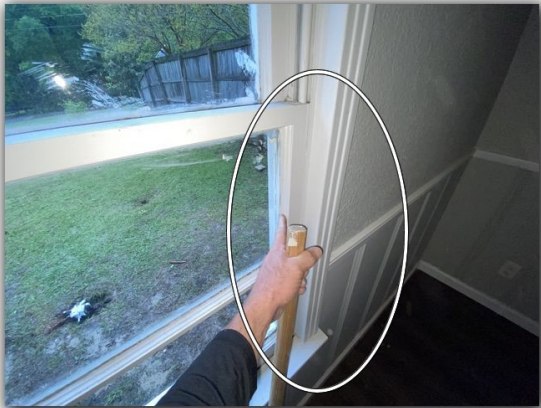
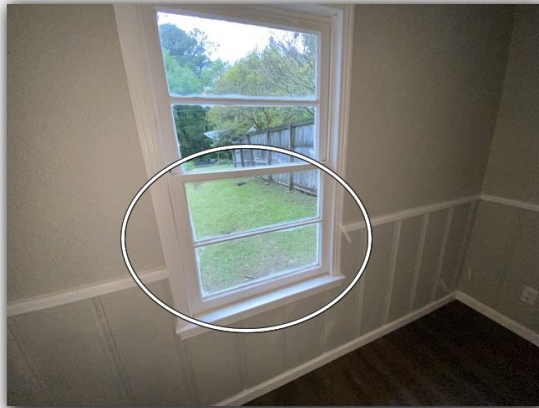
I observed where wood pane cased windows found to be painted shut at time of assessment. Windows in bedrooms / sleeping rooms should open allowing for functional emergency escape and rescue openings. Recommend evaluation for possible repairs if needed allowing for normal / safe function.

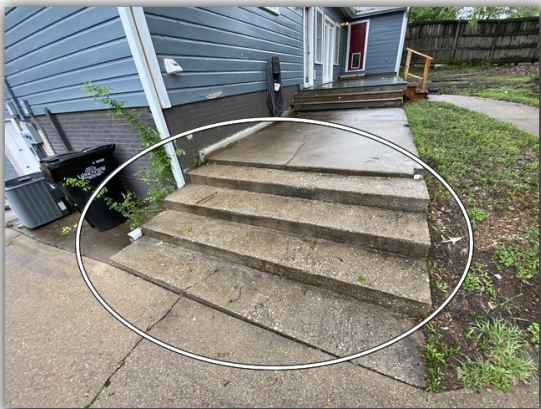
I observed where some of the exterior stairs do not have a hand rail on either side at time of inspection. Typically on any interior or exterior flight of stairs having more than 4 risers they should have a hand rail on one side of the stair. Would consider adding appropriate hand rail for safety purposes.

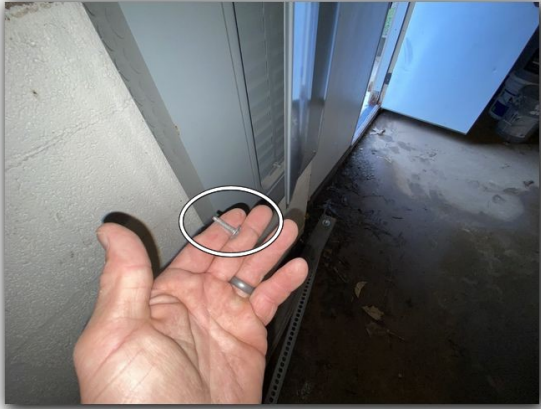
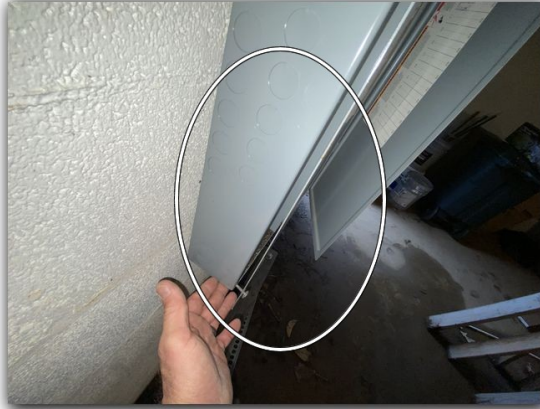
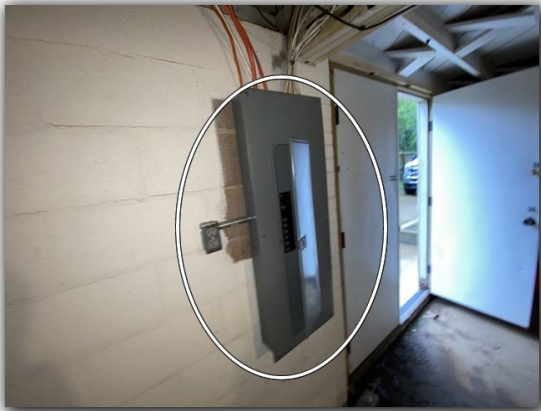
I observed where panel cover screws do not hold panel cover in place as should. It appears that securing screws are too small for cover. Attempts to screw in allowed screws 'pop out' when installed. Recommend evaluation for repairs allowing load center panel cover to be covered as should.

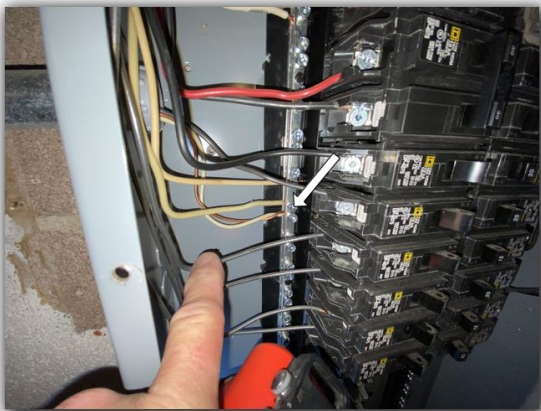
- Only 1 double tapped neutral / ground noted.

☑ I observed where ground bar has neutral and grounds double tapped at the time of inspection. Under today's code each grounded conductor should terminate within the panel board in an individual terminal that is not also used for another conductor. When the neutral is disconnected, the objective is to still have the equipment ground solidly connected to the grounding electrode. If both the neutral and grounded conductor is under the same terminal, this cannot be accomplished.

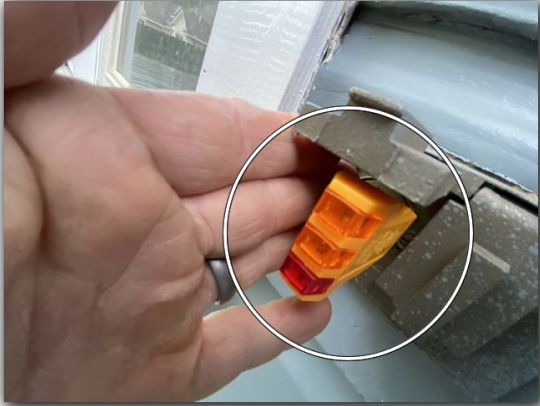
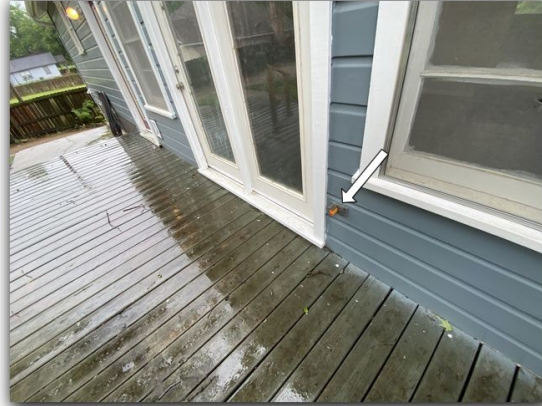
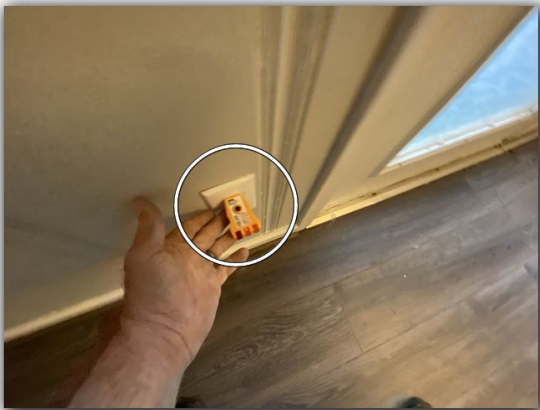
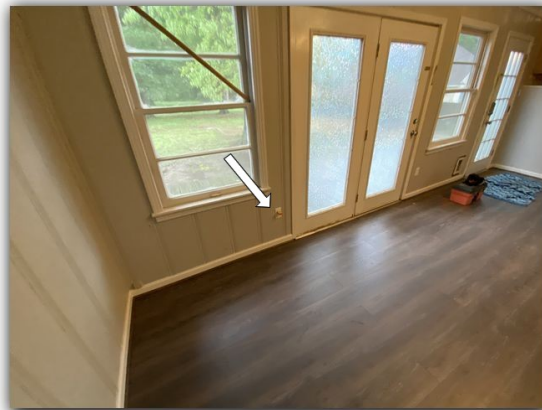
☑ I observed where exterior receptacle on back porch area did not present with power at time of inspection. Note: receptacle on interior wall adjacent to exterior receptacle found without power as well. Recommend evaluation for repairs allowing home receptacles to work as should.

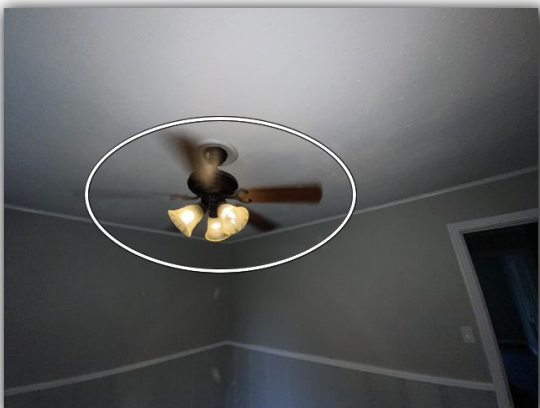
☑ I observed where ceiling fan in front left bedroom out of balance with operating at time of inspection. Noted 'wobble'

very obvious. Possible that fan blades may need to be tightened or adjusted to allow for normal use.

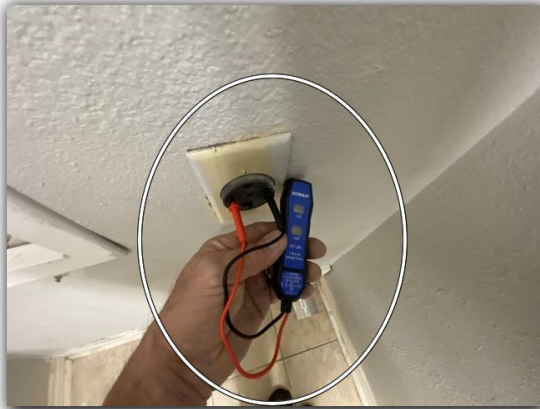
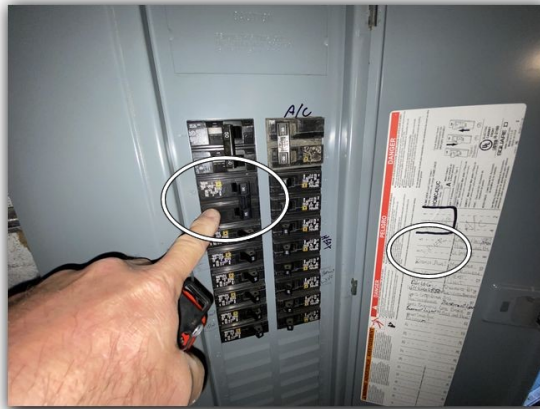
I observed where dryer receptacle does not appear to be working at time of inspection. Note: power on to dryer receptacle on panel. Recommend evaluation for repairs allowing receptacle to work as should.

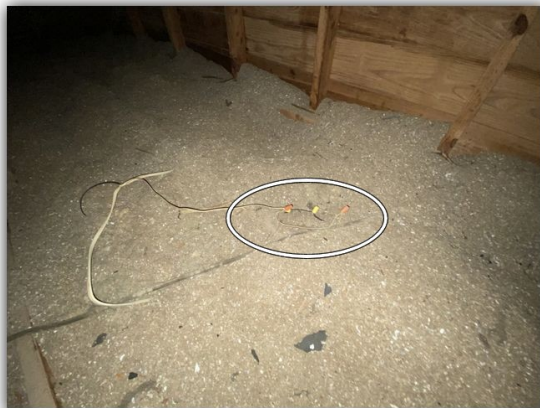
I observed various areas in attic presenting with open junction boxes and/or inappropriate splices made to wiring at time of inspection. Areas noted should be made up in approved or appropriate junction boxes. Recommend evaluation for repairs.

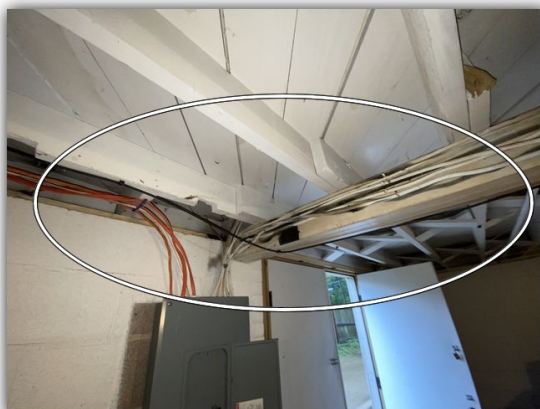
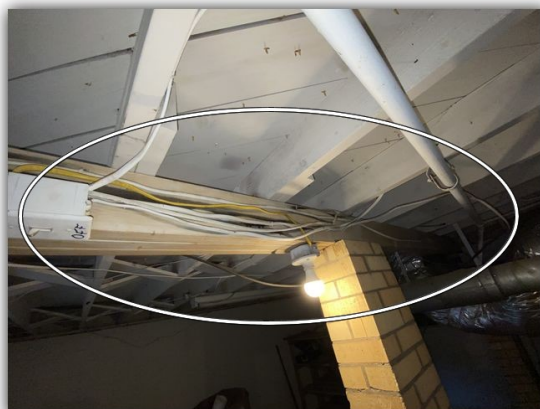
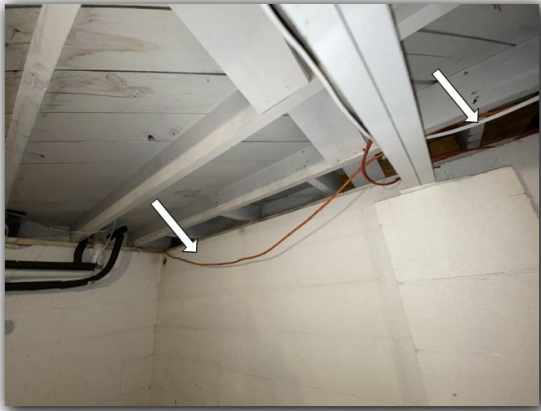
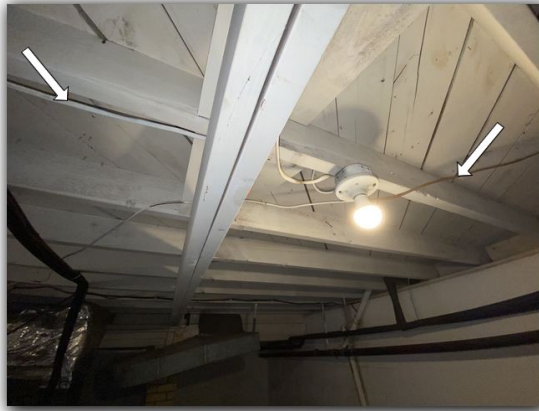
- Wires are "exposed" in basement and should be protected. Romex is fine when it is inside a wall/ceiling/floor because it is protected from puncture/cuts/etc.

I observed various areas with exposed electrical wiring at time of inspection. Romex is designed to be used inside walls, attics, and/or in conduit. Exposed wiring is subject to physical damage and should be protected. Recommend evaluation for enclosing noted wires in some fashion of conduit for added safety.

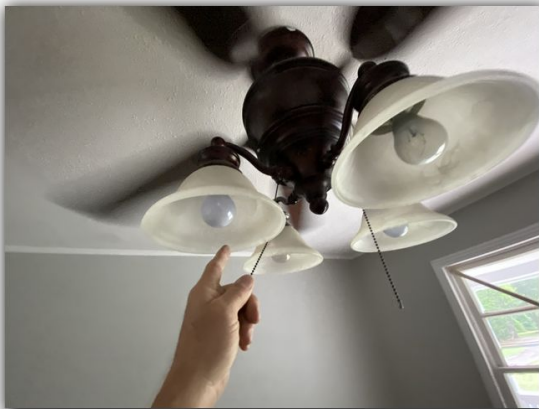
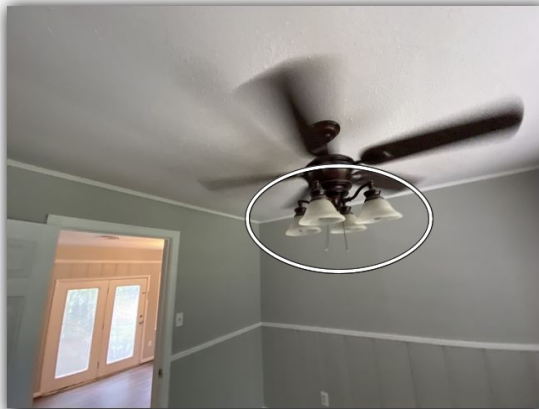
Front middle bedroom light kit would not turn on with 4 bulbs in place

I observed where various light fixtures / light kits would not turn on with attempts at time of inspection. Possible that bulbs / lamps may be burnt out but the number of fixtures not working may allow for reasons to think issues could be electrical.

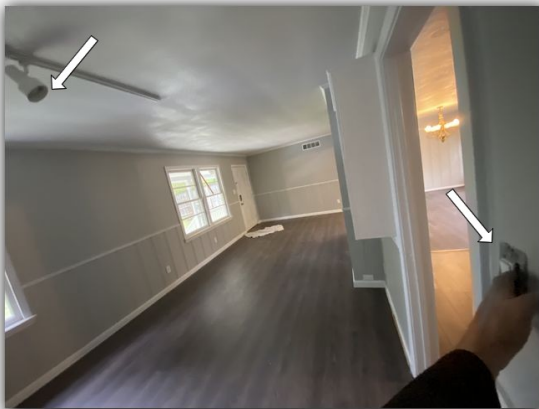
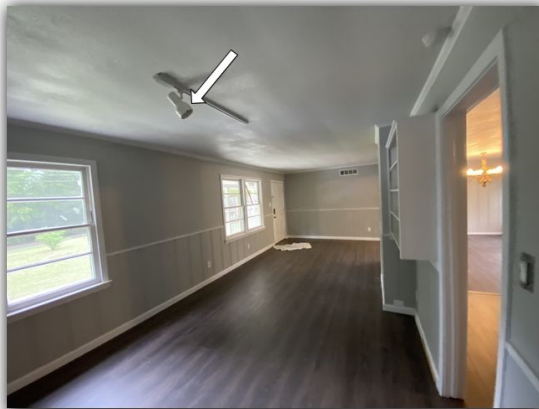
Track light in dining room would not turn on with attempts

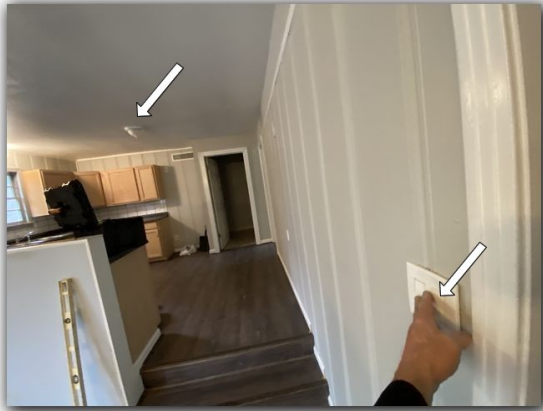
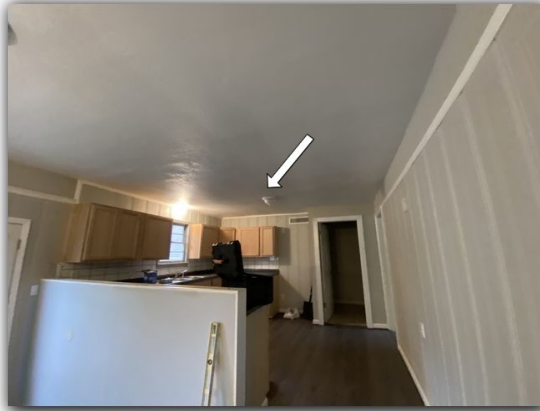
Kitchen light would not turn on with attempts

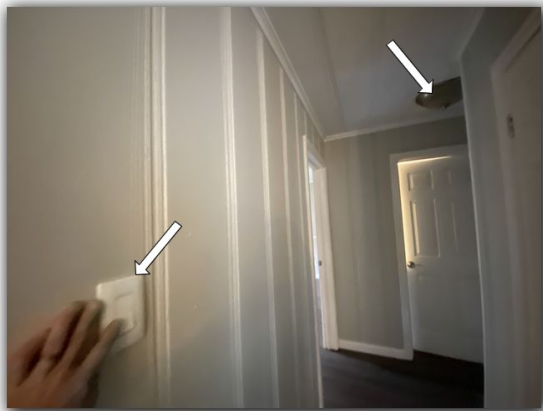
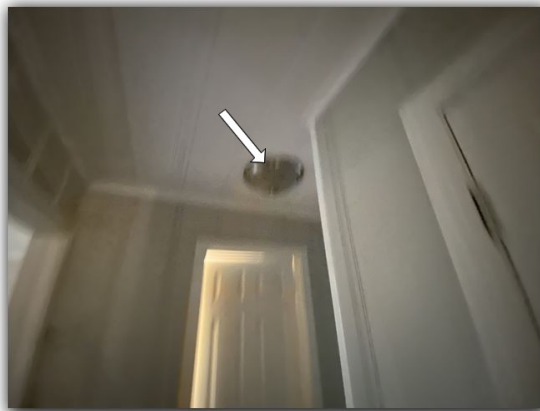
Hallway light would not turn on with attempts

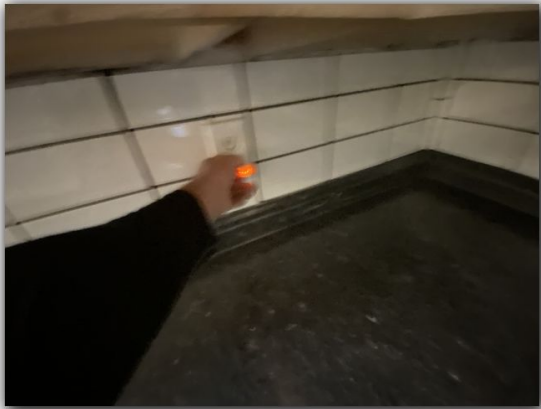
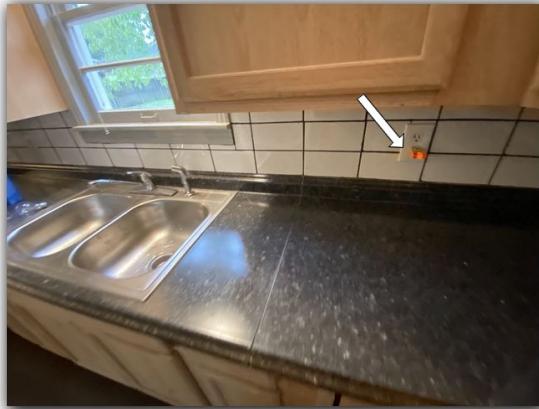
Missing GFCI protection in kitchen area

No GFCI/ARC Fault protection at one or more location. This is considered a recognized safety hazard. GFCI protection was not provided in the home at locations where it is now deemed necessary. GFCI protection may not have been required at the time the home was built, but for safety reasons it is recommended that GFCI protection be installed at all the following locations: • Bathrooms • Exterior • Garages • Crawlspace (at or below grade) • Unfinished basements • Kitchens • Laundry rooms • Within 6 feet of all plumbing fixtures. Recommend evaluation for possible repairs and / or replacement of deficient receptacles for added safety.

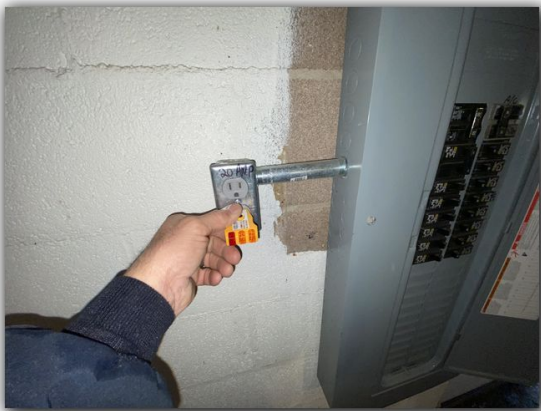
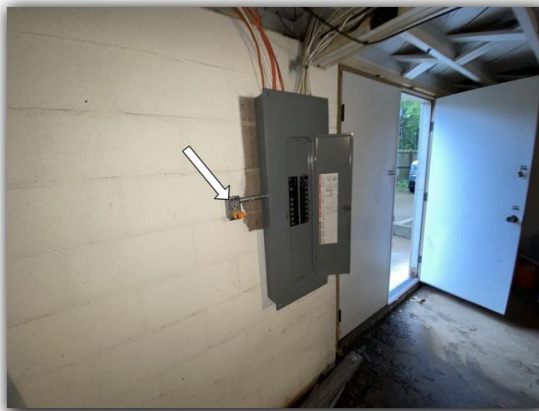
Missing GFCI protection in basement area

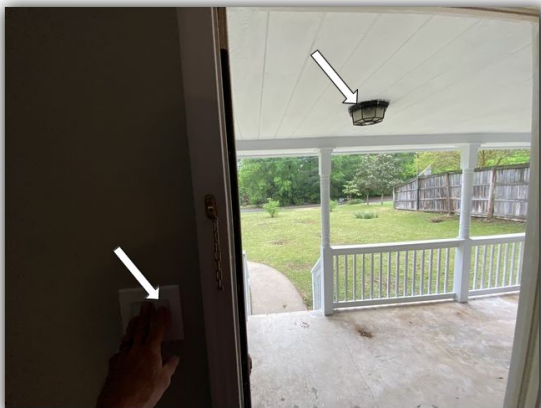
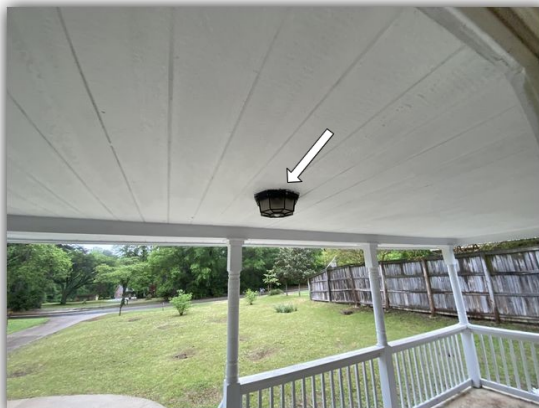
Front porch light would not turn on with attempts

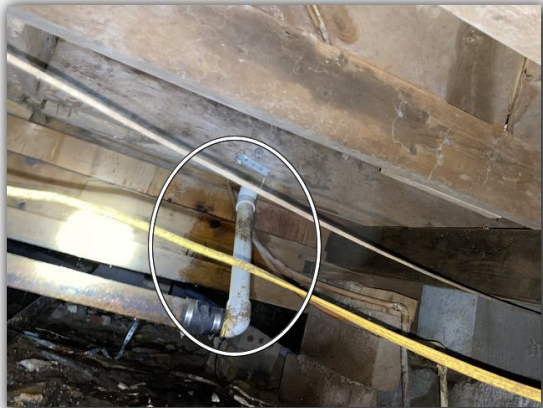
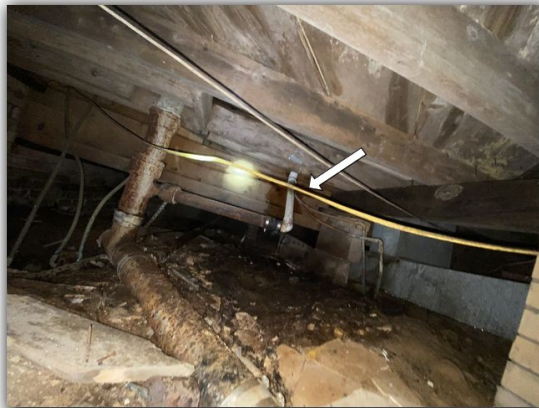
☑ I observed an obvious leak under master bathroom shower drain line at time of inspection. Inspector performs volume test in home running water for approximately 30 minutes. Obvious water under master bathroom shower and on ground. Recommend evaluation for repairs allowing shower drain to work as should.

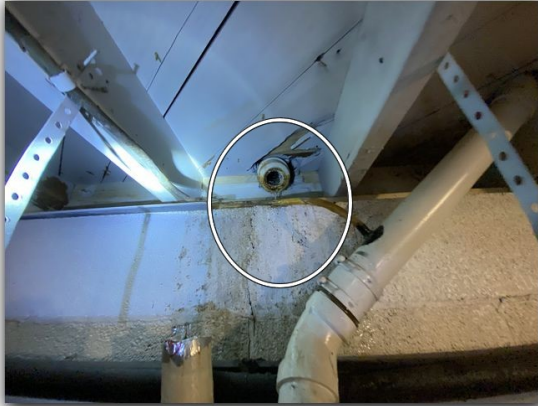
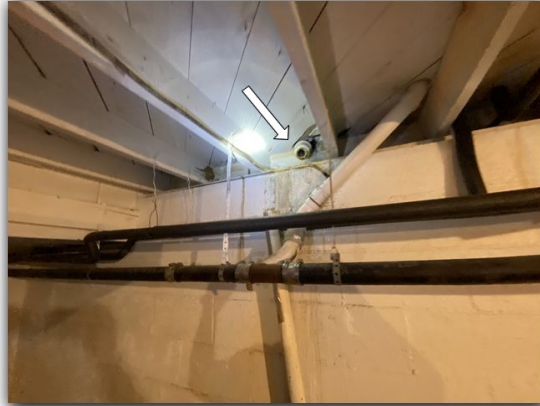
Water flowing from cut vent stack

I observed where basement found with pooled water on floor at beginning of inspection. Further evaluation did not find any obvious reason for water entry near walls and/or entry door. Area has presented with rain for 2 days including day of inspection. Inspector noted where plumbing vent stack / drain for kitchen sink appears to have been cut with kitchen drain replaced leaving old vent stack / drain line in place. Inspector got on roof area and poured water into plumbing vent stack on roof with water free flowing into basement area from cut drain line. Recommend evaluation for covering roof top vent stack cover or removing keeping water from flowing into basement.

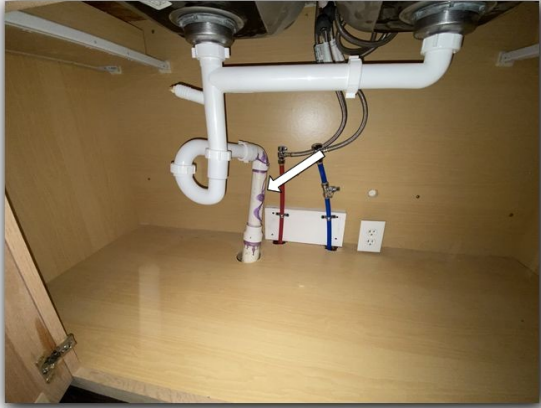
Kitchen sink

I observed where kitchen sink and laundry drain missing plumbing vent stacks at time of inspection. Sink and drainage lines need a vent because the pressure put on the drain pipe when water flows down the drain pipe needs to equalize. Recommend evaluation from qualified contractor for needed repairs allowing sink to drain as should.

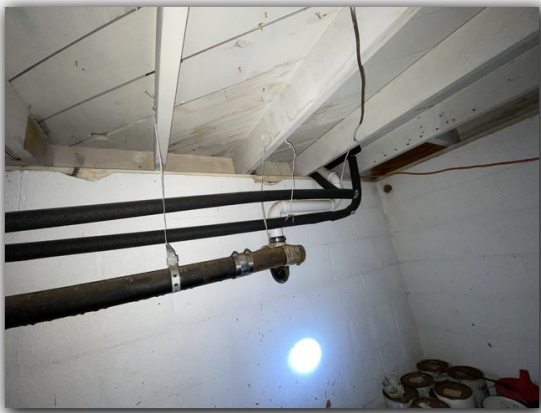
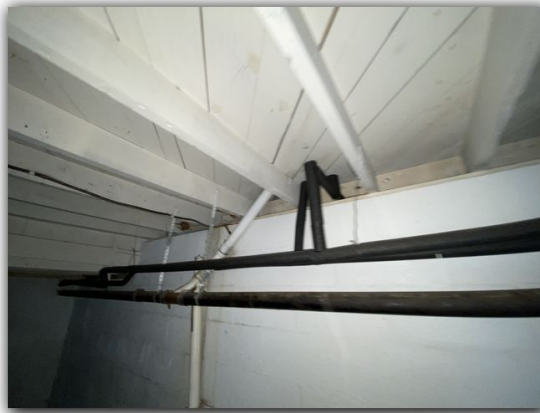
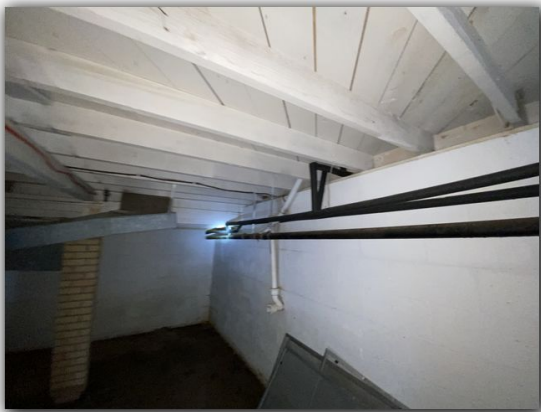
Basement area

I observed long runs from various drainage fixtures in home to plumbing vent stacks at time of inspection. Fixtures include washing machine drainage and kitchen sink. Plumbing vent stack for kitchen sink appears to have been cut running newer drain lines under home. This is good news but the run to plumbing vent stack is approximately 35 feet terminating into master bathroom vent stack. Span chart may vary but rule of thumb is the distance between your trap and the vent should be no more than 6 feet. In other words, for the vent to work properly, it needs to feed into the drain line within 6 feet of the trap-ways that connect to it.

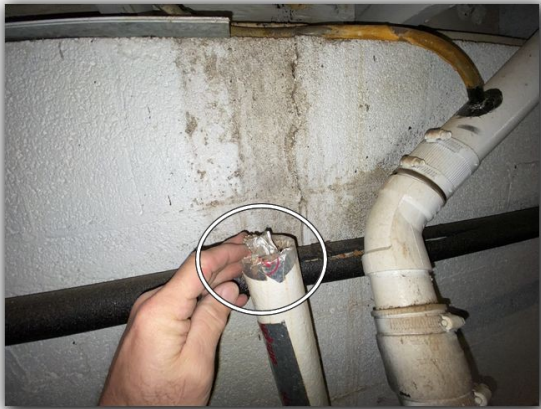
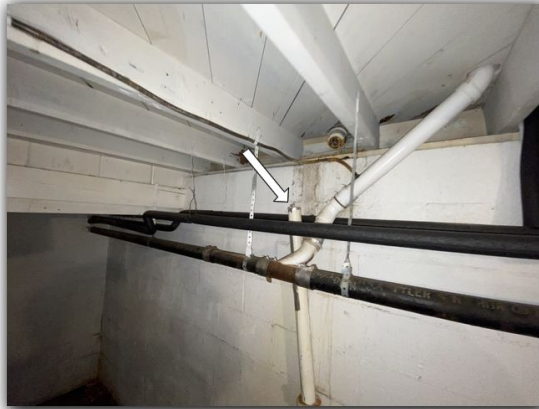
☑ I observed where plumbing vent stack found in basement area with foil tape covering covering opening at time of inspection. This may not be appropriate and could deteriorate over time allowing unpleasant fumes to make entry into basement area.

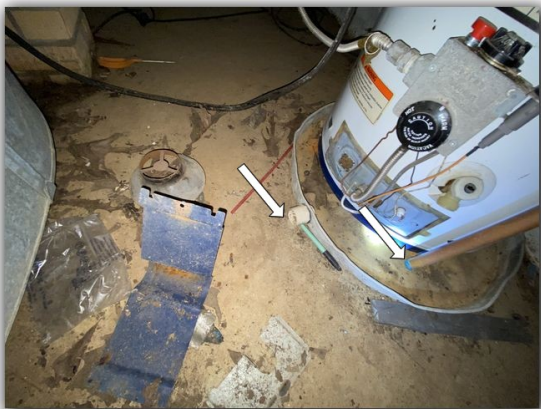
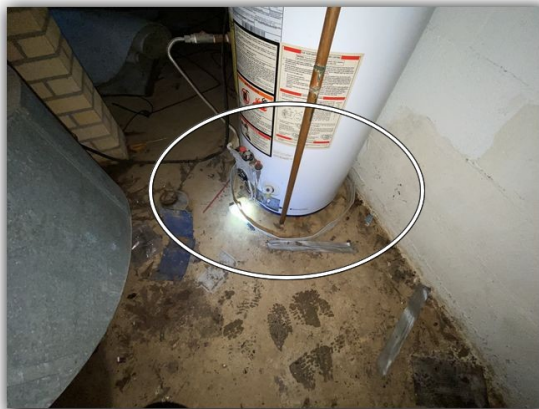
- Water heater sitting on basement floor without any drainage found for emergency catch pan or TP drain line. If heater were to fail water could fill basement area.

☑ I observed where the water heater drain pan did not drain appropriately at time of inspection. Water heater and Temperature Pressure Relief drain line terminate into pan with no way for water to drain as should. The drain should terminate into a suitably located indirect waste receptor, floor drain, extend to the exterior of the building, and/or suitable location. Recommend evaluation for repairs allowing water heater to have appropriate protection.

☑ I observed where Temperature / Pressure Relief Valve drain line missing at time of inspection. Temperature/pressure-relief or TPR valves are safety devices installed on water heating appliances, such as boilers and domestic water supply heaters. TPRs are designed to automatically release water in the event that pressure or temperature in the water tank exceeds safe levels. Noted drain lines should be installed so as to drain by flow of gravity. Recommend evaluation for appropriate repairs.

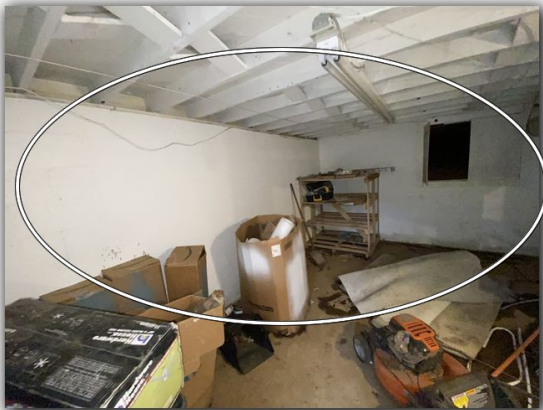
No ventilation in basement area

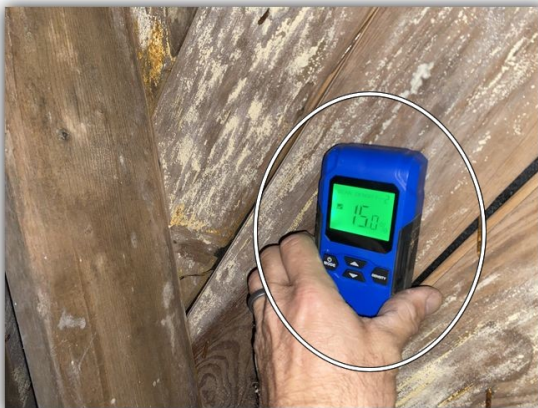
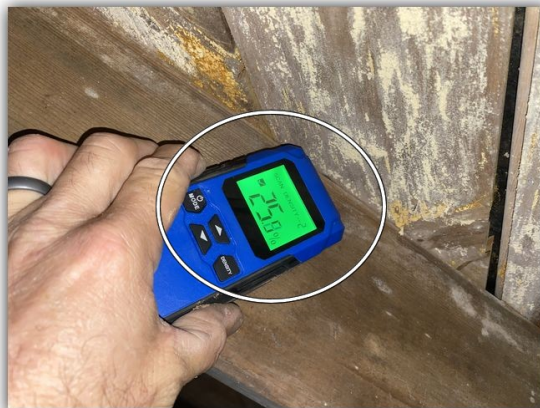
I observed where home presented with inadequate ventilation by *today's standards* for new construction. Typically a

good rule of thumb would recommend ventilation openings of not less than 1 square foot for each 150 square feet of crawl space. Noted conditions found with little ventilation openings with minor horizontal air flow noted. Recommend evaluation for adding appropriate ventilation into crawlspace allowing home to work as efficiently as possible. *Note: a great addition would be a possible moisture barrier placed on ground under home preventing unwanted moisture from making access to exposed areas of crawl space.*

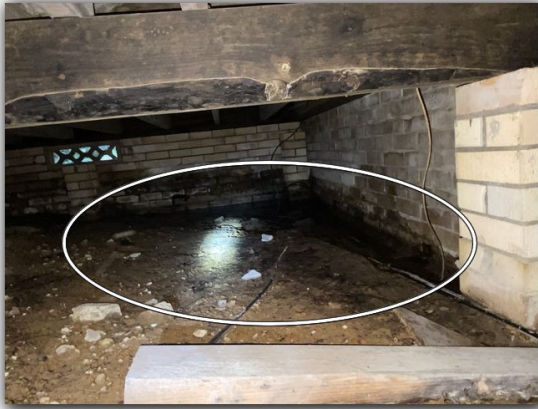
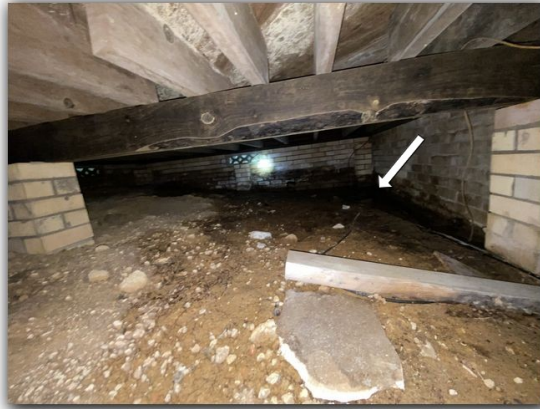
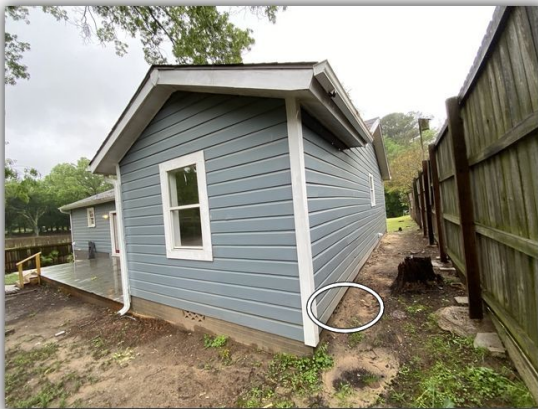
- Crawlspace vent noted near grade level.

I observed an area of pooled water under master bedroom area at time of inspection. It appears that water can make entry near left rear corner of home through crawl space vent that is ground / grade level. Recommend evaluations for repairs allowing water to move away from home as should.

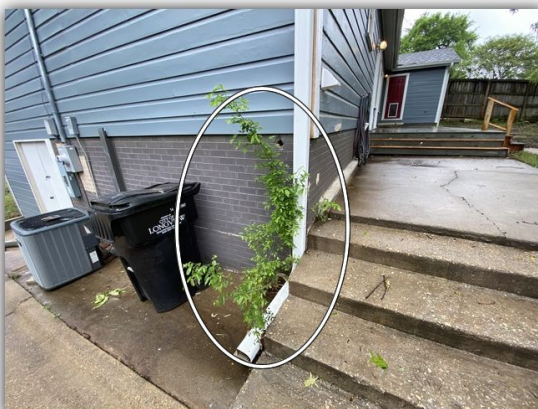
I observed where foliage found to be too close to the structure at time of inspection. It is recommended that bushes and vegetation should be at least 12 inches from wall contact. Recommend cutting or trimming noted vegetation allowing for

appropriate barrier.

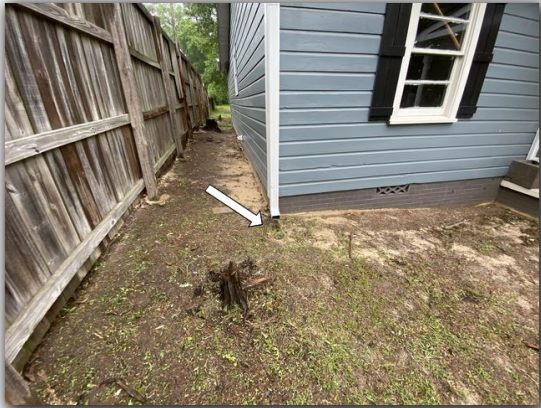
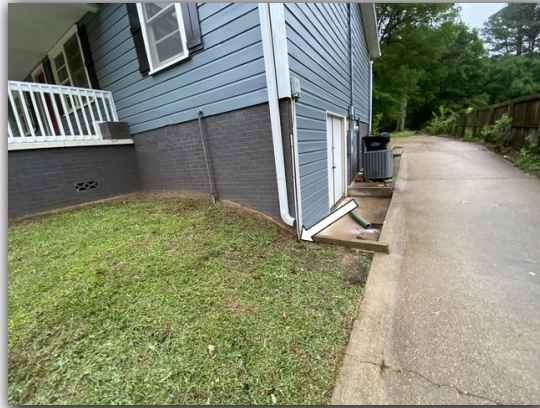
Gutters / down spouts found draining too close to the structure at the time of inspection. Water terminating near slab / veneer underpinning can create conducive conditions for possible undermining. Recommend termination point at least 16-24 inches from foundation. Recommend installing extensions onto gutters or adding splash blocks allowing water to move away from home efficiently.

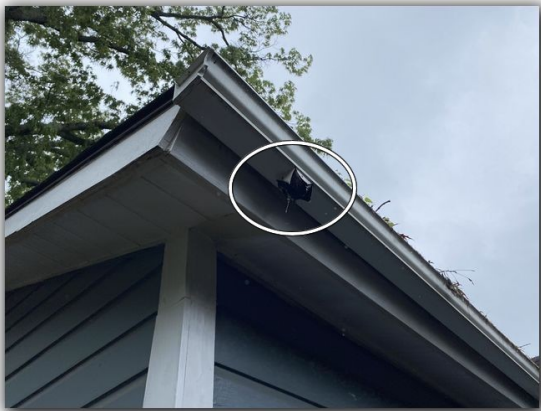
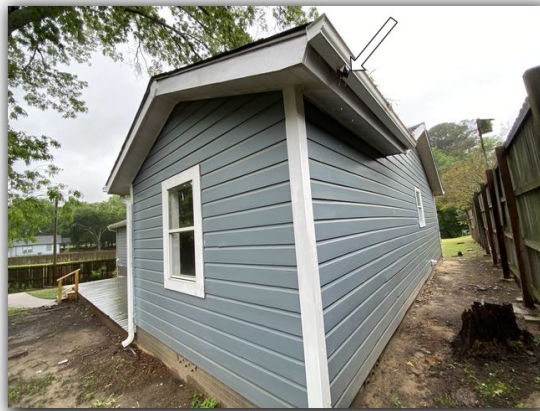
I observed an area near back left corner of home where down spout for home gutter appears to be missing at time of inspection. Recommend evaluation for repairs allowing water to run away from home as should.

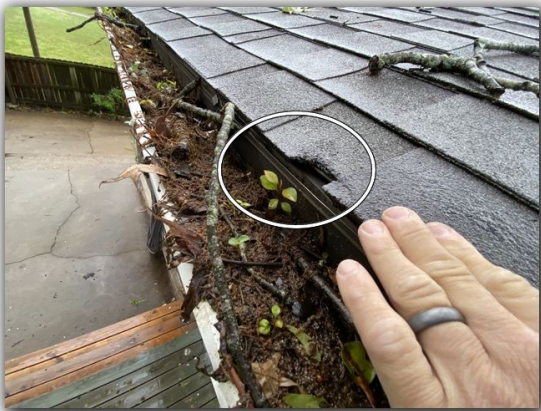
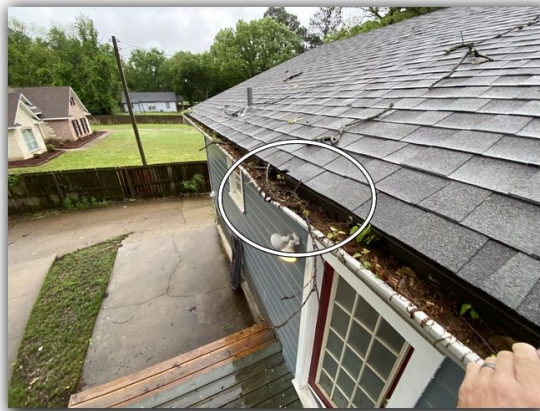
I observed an area of roof with damage from past limb strike at time of inspection. Noted area of damage to gutter as well.

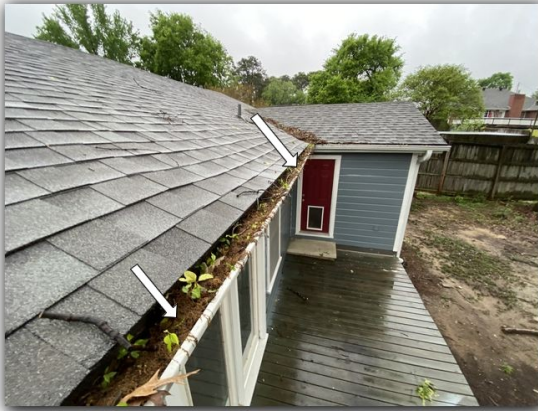
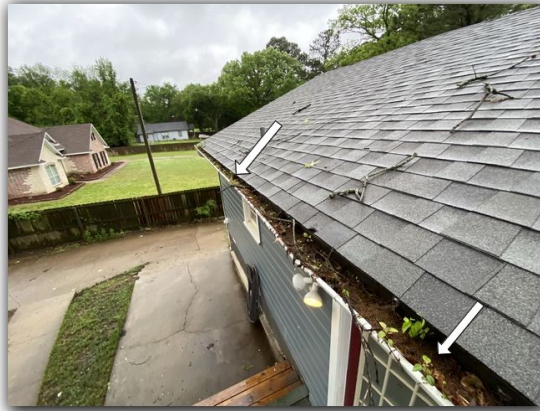
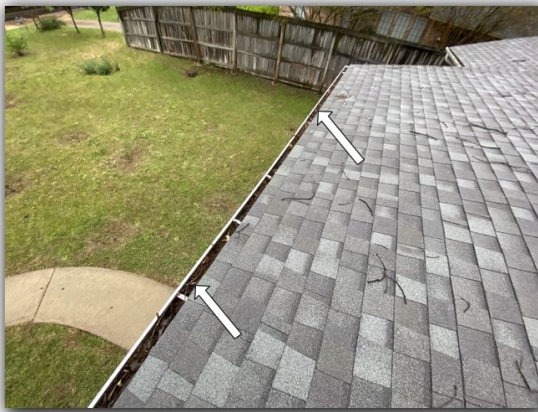
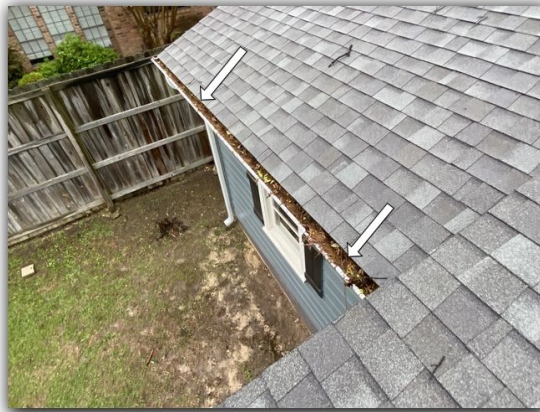
I observed where gutters filled with areas of debris at time of inspection. Debris in gutters are create conducive conditions for water penetrations and / or mechanical failure due to extreme water/debris weight or possible water leaking into living space / soffit areas. Recommend cleaning of gutters allowing water to flow / terminate from roof area as should.

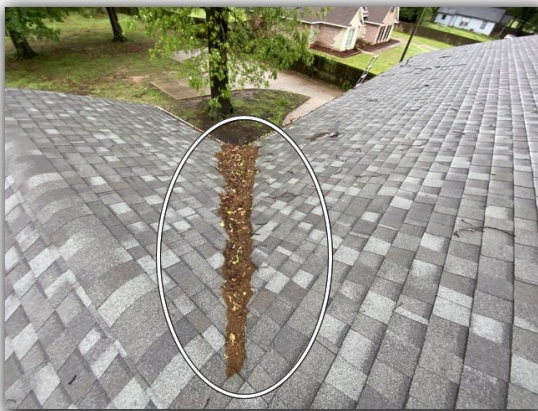
I observed roof area with moderate amounts of debris buildup at time of inspection. Debris buildup on roof area is conducive for water penetrations. Recommend cleaning roof area.

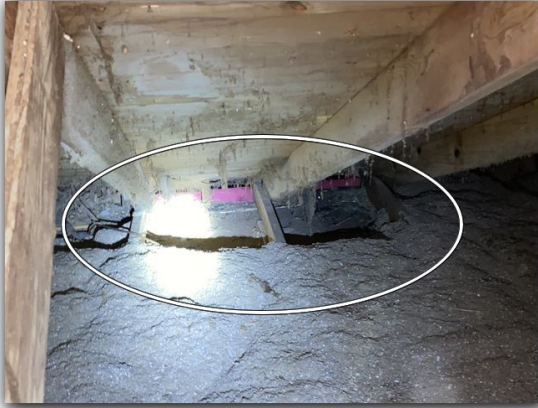
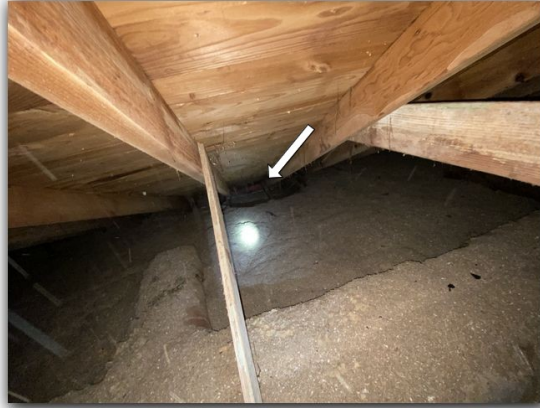
☑ I observed an area over kitchen / dining room area where insulation appears to have been removed at time of inspection. Area noted has only sheet rock separating home living area from a possibly very hot or very cold attic. Recommend evaluation for replacing missing insulation allowing home to work as efficiently as possible.

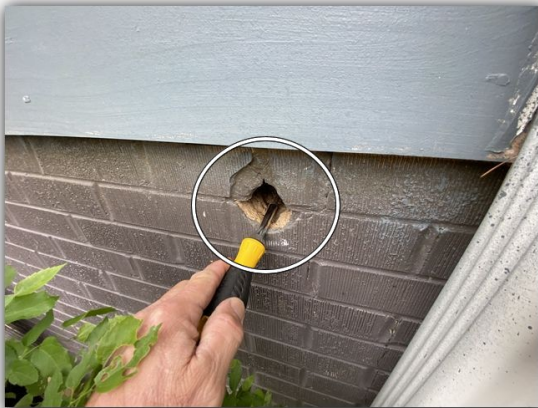
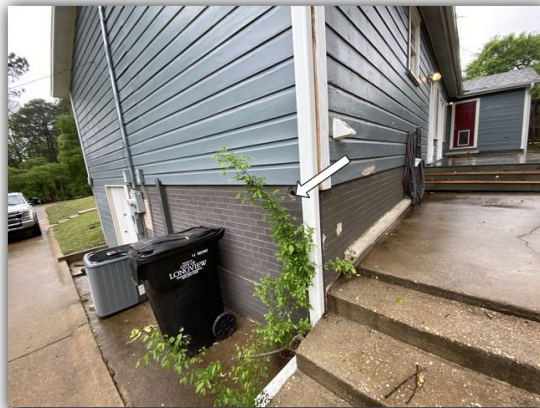
☑ I observed various areas on exterior brick veneer underpinning with minor openings noted at time of inspection. Areas noted create possible conducive conditions for water entry under the right conditions. Recommend evaluation for sealing noted gaps / separations with some fashion of water proofing material allowing home to work as efficiently as possible.

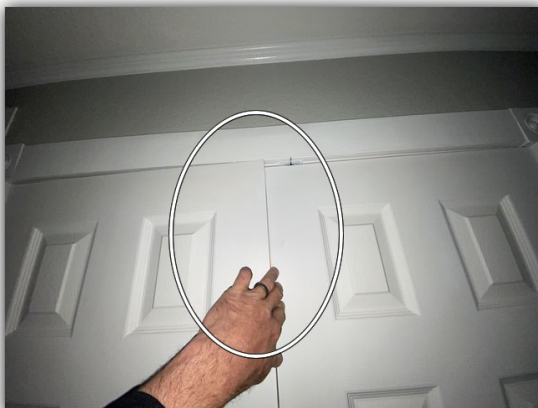
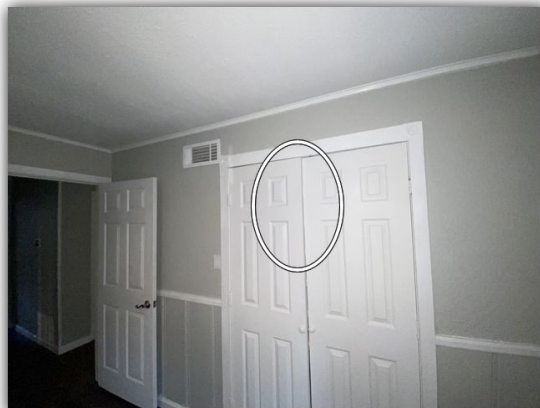
- Front left bedroom double closet doors

I observed where various doors in home appear to 'stick' when attempting to open/close at time of inspection. Recommend evaluation for possibly adjusting door(s) allowing door to work as should.

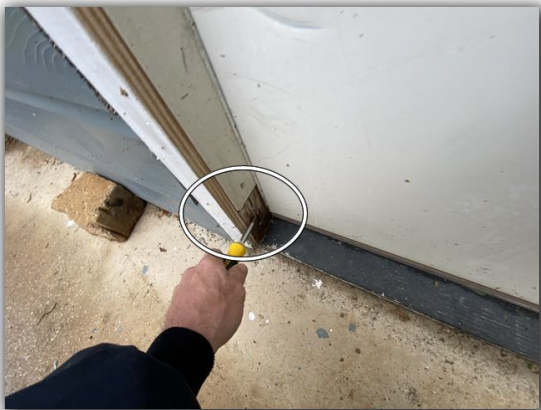
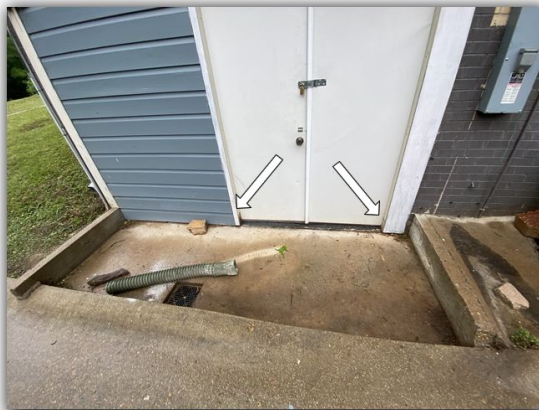
- Basement double doors have had door jams cut and replaced leaving areas of exposed wood.

I observed an areas on exterior of home found with exposed wood / door surround at time of inspection. Doors appear to be in good working condition with exposed wood / trim noted at time of assessment. Recommend evaluation for painted noted exposed wood keeping areas protected from possible moisture exposure / damage.

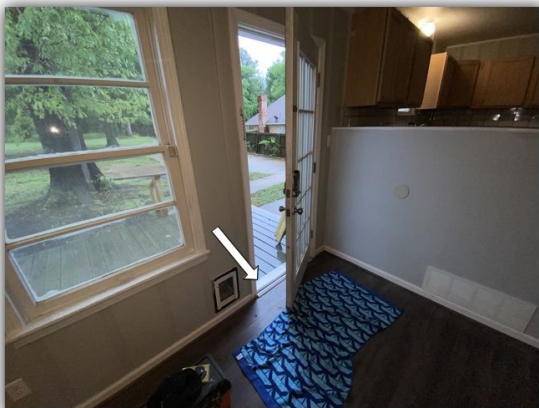
I observed where rear single entry / exit door near back of home found with door that appears to 'stick' when attempting to open/close at time of inspection. Recommend evaluation for possibly adjusting door(s) allowing door to work as should. Note: weather stripping near bottom of door may not be appropriate at time of inspection. Areas of weather stripping in place but inspector could still see day light near bottom of door when door closed.

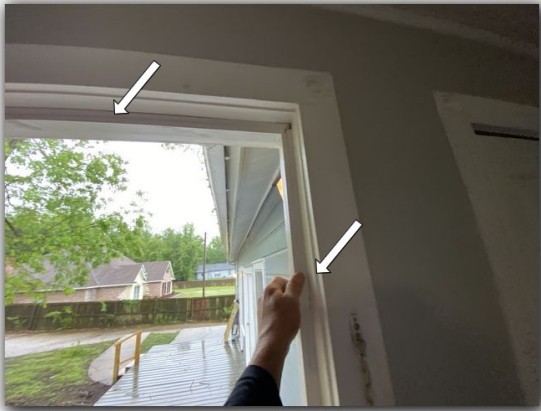
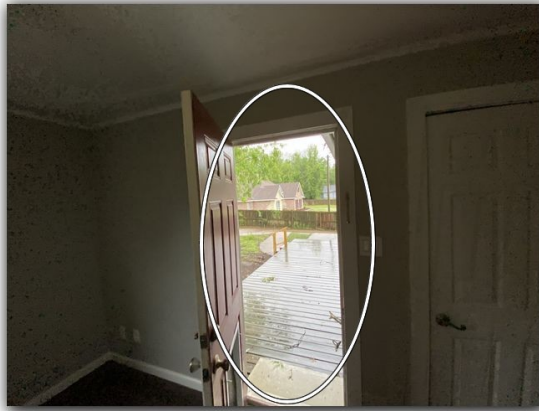
I observed areas of damaged weather stripping near master bedroom exterior door area at time of inspection. Missing weather stripping may allow conducive conditions for unconditioned air to make entry into home as well as conditioned air to escape. Recommend evaluation for repairs allowing home to work as efficiently as possible.
