David K. Smith
Professional Home Inspector Lic #21666

PROPERTY INSPECTION REPORT

Concerning: 1234 Drive, Somewhere, TX 75605
(Address or Other Identification of Inspected Property)

By: David Smith, Lic #21666 04/07/2023
(Name and License Number of Inspector) (Date)

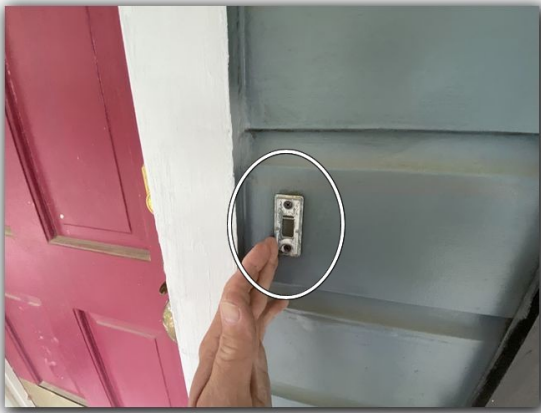
I observed where door bell button missing on home at time of inspection.

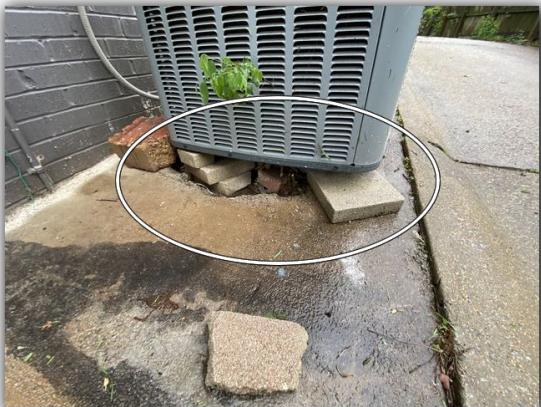
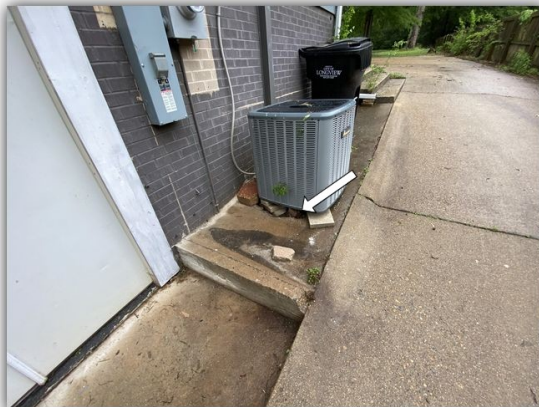
I observed where outside unit sitting on pieces of cement block(s) at time of inspection. Noted condition could allow for movement over time which could cause harm to outside unit. Typically outside condenser unit placed on solid flat surface or pad.

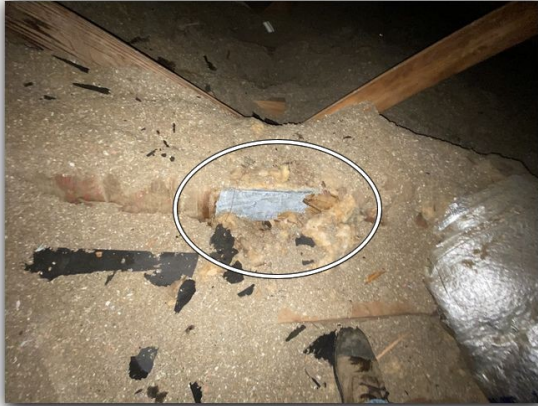
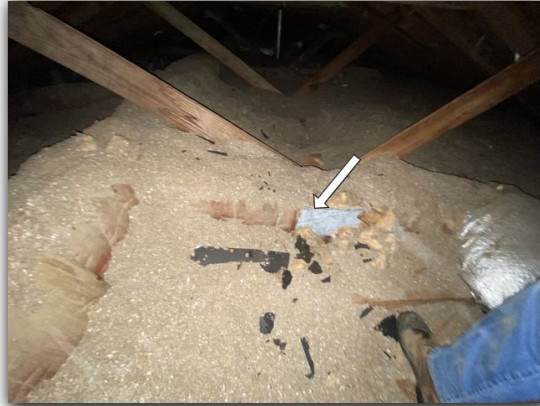
I observed an area in attic where it appears that outer shell of covering insulation has separated from metal ductwork at time of inspection. Areas such as this allow hot / cold duct in an unconditioned attic to possible create moisture / condensation. Recommend evaluation for repairs allowing home to work as efficiently as possible.

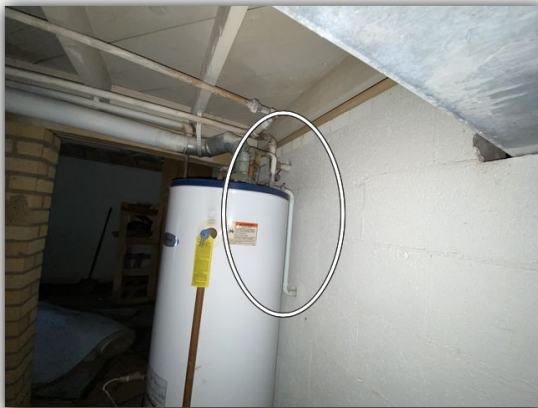
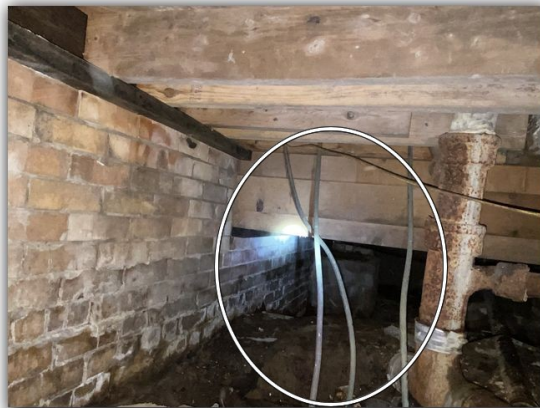
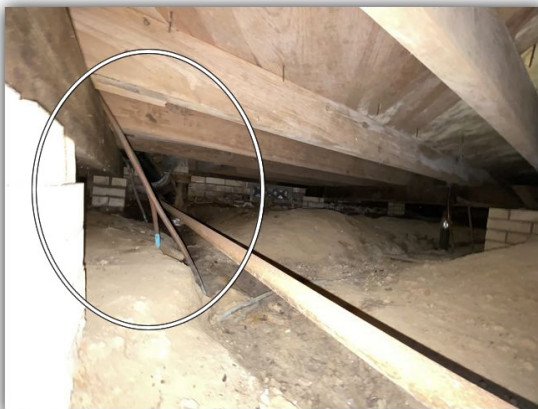
I observed where water lines under home were without adequate insulation at time of inspection. Areas such as this crawlspace could be exposed to freezing temperatures creating conducive conditions for possible pipes to burst. Recommend evaluation for appropriate installation of insulation over noted exposed main water lines keeping home working as efficiently as possible.

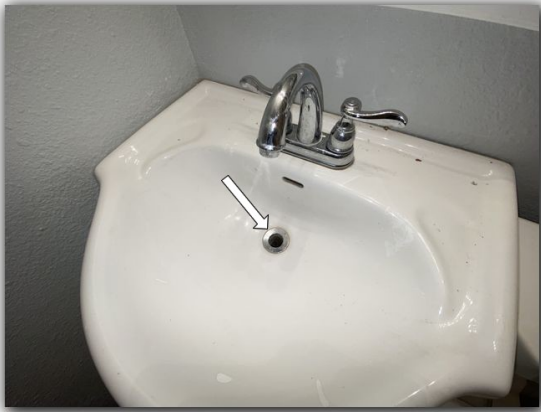
I observed where master bathroom sink drain stop was not installed appropriately at time of inspection. Recommend evaluation for installing drain stop per manufacturer specifications allowing drain stop to work as should.

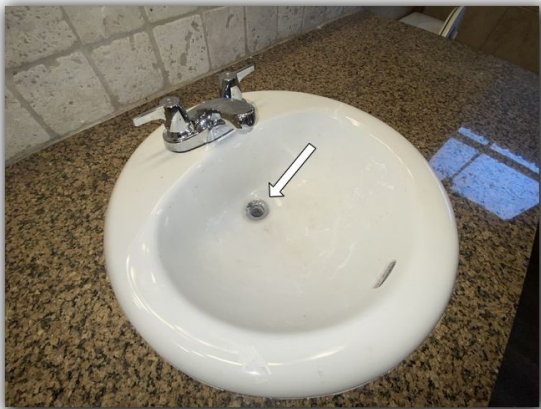
I observed where hallway bathroom sink drain stop was not installed appropriately at time of inspection. Recommend evaluation for installing drain stop per manufacturer specifications allowing drain stop to work as should.

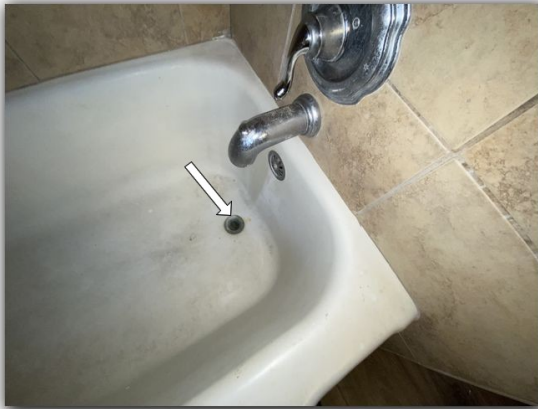
I observed where hallway bathroom tub drain stop was not installed appropriately at time of inspection. Recommend evaluation for installing drain stop per manufacturer specifications allowing drain stop to work as should.

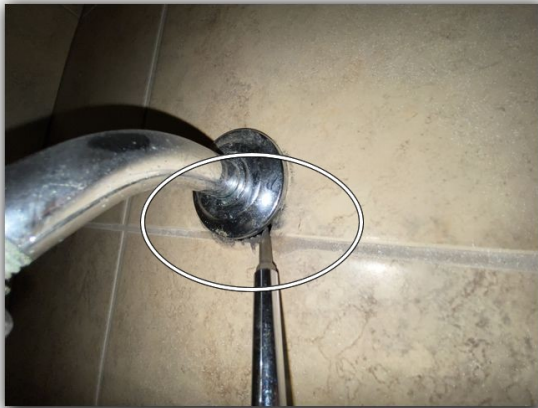
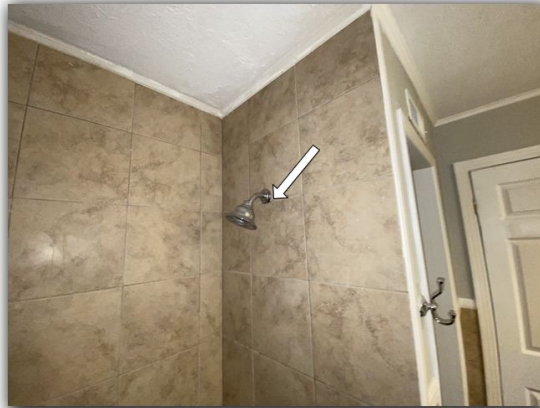
I observed areas of minor separation between shower / tub fixtures and surround. Noted areas allowing for conducive conditions for water entry under the right conditions. Recommend evaluation for sealing noted separations allowing shower / tub to work as efficiently as possible.

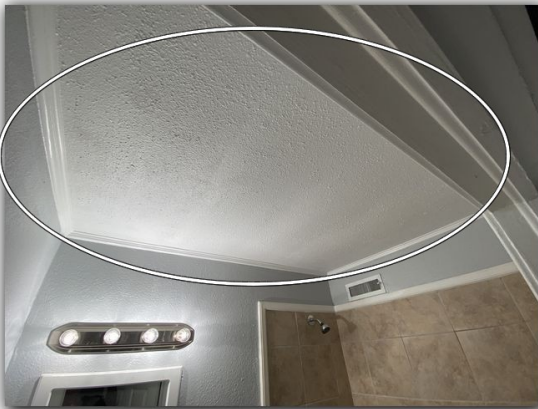
I observed where master bathroom missing an exhaust fan at time of inspection. Typically bathrooms are recommended to have an exhaust fan installed unless having access to or an operational window. Recommend evaluation for possible fan installation.

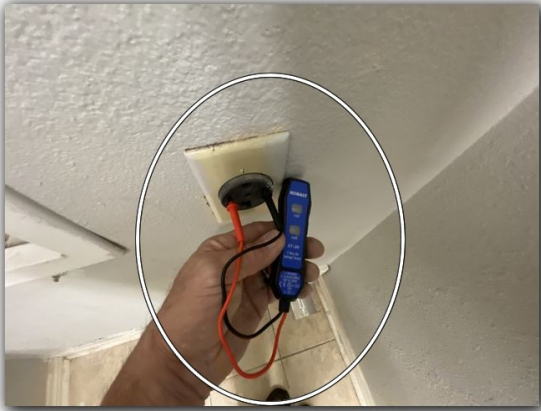
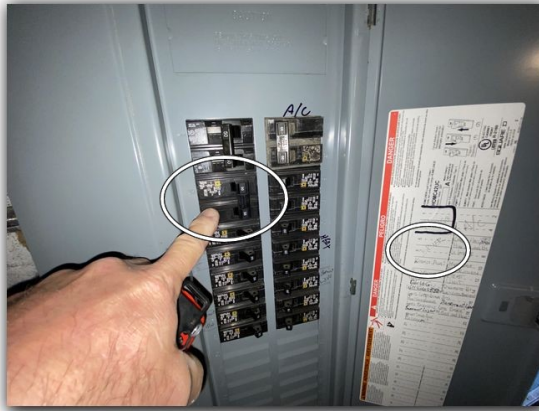
I observed where dryer receptacle does not appear to be working at time of inspection. Note: power on to dryer receptacle on panel. Recommend evaluation for repairs allowing receptacle to work as should.

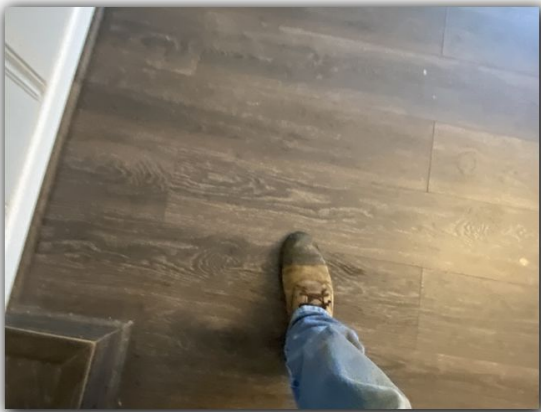
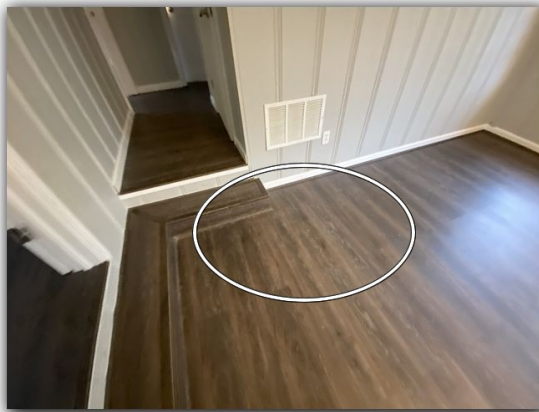
Dining room area

I observed where various areas in home presented with floors that appear to buckle or cup at time of inspection. This can be caused by any number of potential issues. Humidity, possible water leaks, installation prior to allowing floors to adjust and/or acclimate to environment, or possibly installed without allowing room for expansion. In this case it appears that thermal expansion is the culprit. The fix might be to pull quarter round or trim around the edge and see if there is adequate expansion / gap allowing for possible movement making adjustments if needed. Recommend evaluation for repairs if desired monitoring noted areas for any noticeable changes.

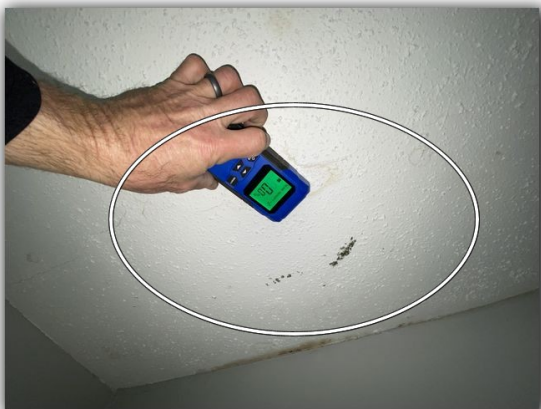
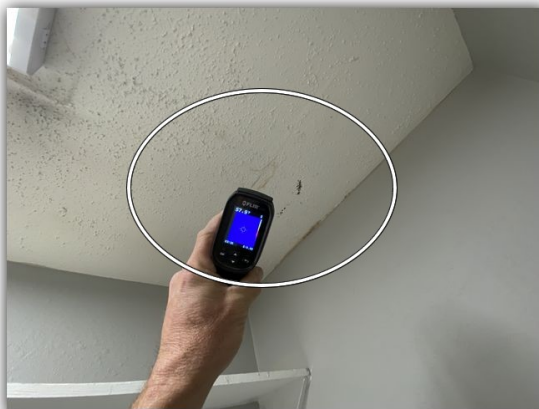
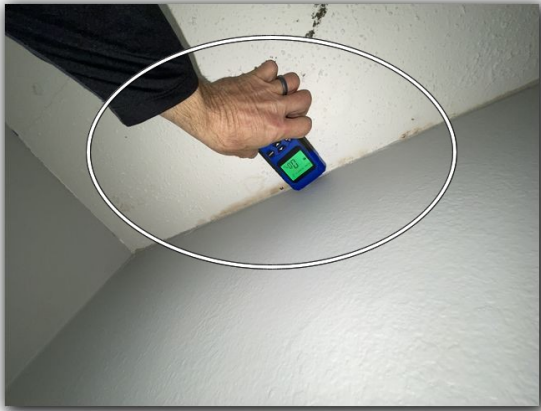
Laundry room

I observed an area an possible moisture staining / moisture damage noted over laundry area at time of inspection. Further evaluation did not find obvious evidence of moisture when assessed with moisture meter and thermal camera. Attic area found evidence of moisture with roof area finding where newer roof has been installed. Appears that roof has received possible limb strike from tree above. Most likely newer roof as remedied any past moisture entry issues. (Note: inspector can not verify this at time of inspection.) Recommend repairs to ceiling if desired monitoring noted areas for any noticeable changes.

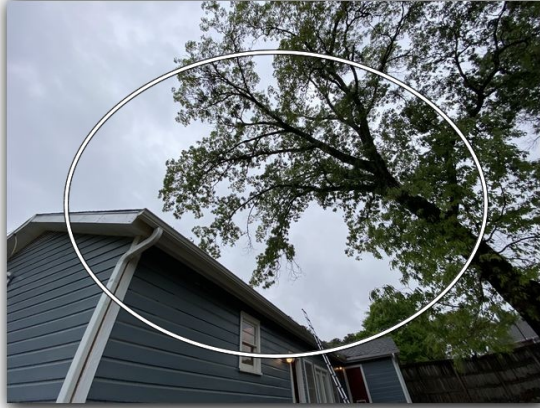
I observed where larger tree in back yard with obvious large limbs over home at time of inspection. Possible that falling limbs could come in contact with home / roof structure. Recommend possible evaluation from tree specialist / arborist to assess for possible removal of unsafe limbs if needed.
